SEISMIC RETROFIT OF NON-PRISMATIC RC BRIDGE COLUMNS WITH FIBROUS COMPOSITES

M. Saiid SAIIDI¹, David H SANDERS², Faramarz GORDANINEJAD³, Frank M MARTINOVIC⁴ And Brett A MCELHANEY⁵

This paper describes the experimental part of a study on shake table response of reinforced concrete columns with structural flares. One as-built and two retrofitted 0.3-scale specimens are discussed. Two fiber-reinforced plastic (FRP) jackets, one with glass fibers and the other with carbon fibers were studied. The primary function of the retrofit was to improve the shear capacity of the columns. Both retrofit methods were found to be effective in changing the failure mode from flexure/shear to flexure and in improving the displacement ductility. The mechanical performance of the glass fiber and carbon fiber composites was nearly the same.

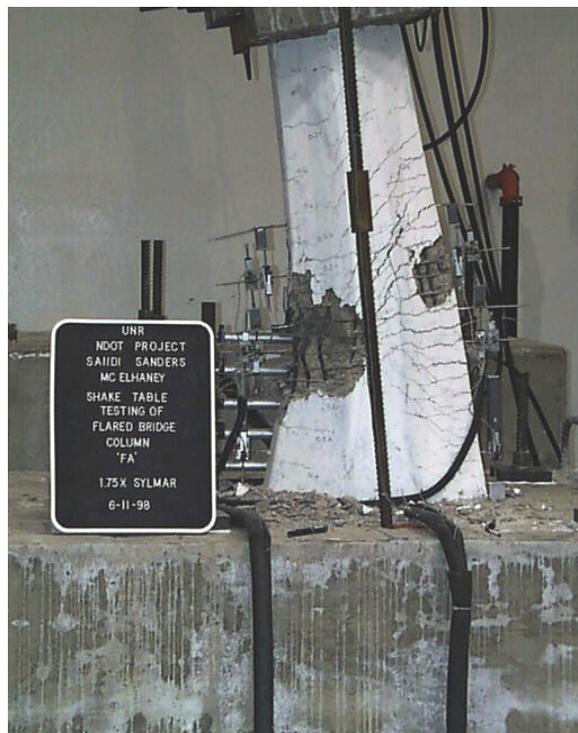
Fig. 3 – The Failure of Specimen FA

Flexural and shear cracks were became visible during the third earthquake run in Specimen FA. As the amplitude of table acceleration increased, cracks became wider and concrete began to spall in the compression areas under bending. Spalling of the concrete was followed by an outward buckling of the longitudinal bars and rupture of some of the ties. During the last run with the peak table acceleration of 1 g, several of the longitudinal bars ruptured due to low-cycle fatigue. Figure 3 shows FA at the end of the test. The test data showed that many of the column ties yielded under the peak load and that the shear capacity of the column in the plastic hinge zone had been reached. The envelope of the measured load-displacement curves for FA is compared with those of the retrofitted specimens in subsequent sections. More details about the performance of the specimen are presented in [McElhane, et al., 1999].

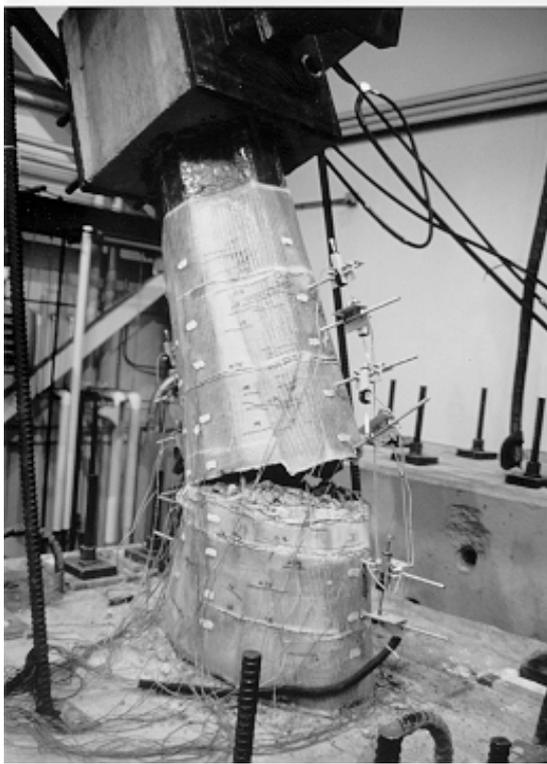
Fig. 4 - The Failure of Specimen FRG

The response of the two retrofitted specimens was generally the same. Minor cracking of epoxy was observed during Run 2. In subsequent runs, more cracks were observed mostly at the junction of composite straps and in the plastic hinge zone, where a smaller number of composite wraps had been installed. No shear cracks were visible in the plastic hinge area. Following the tests, the composite jackets were removed in the plastic hinge area. Again, no shear cracks were observed. Both specimens failed in flexure due to the rupture of the longitudinal bars in the preassigned plastic hinge area. Figure 4 shows FRG at the completion of the test.
