## **EXPERIMENTAL STUDY ON REINFORCED CONCRETE COLUMN STRENGTHENED WITH FERROCEMENT JACKET**

### **SUMMARY**

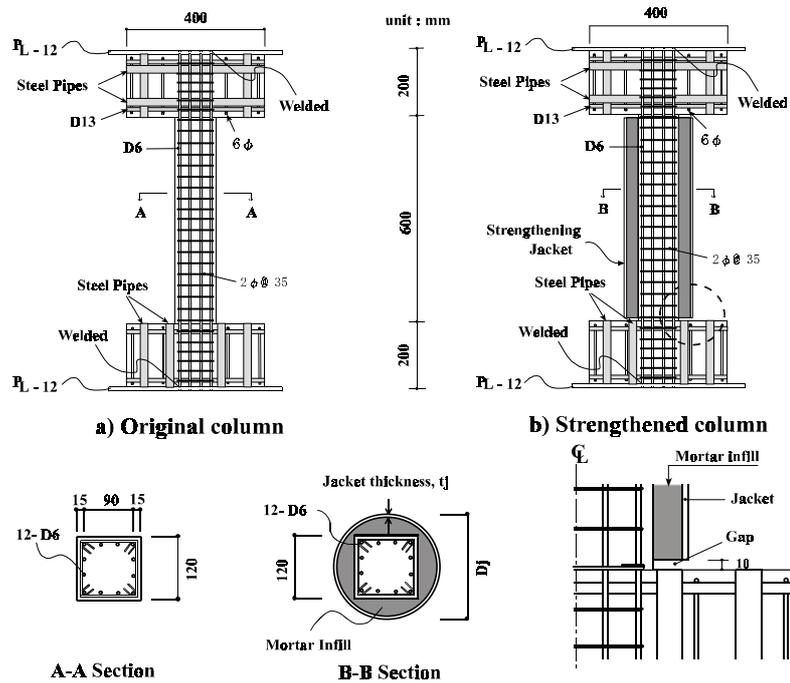
Figure 1: Column Details

The cross sections of the origin column were 120 mm square and had a height of 600 mm. As shown in Figure 1, the as-built columns were reinforced with 12 deformed D-6 (diameter = 6.35 mm) distributed evenly around the perimeter of the column cross section. Round R-2 (diameter = 2 mm) hoops spaced at 35 mm intervals were used as transverse reinforcement. The ratio of nominal shear strength of the as-built columns calculated based on AIJ code approach [2] to shear force required to develop the theoretical nominal flexural strength was designed to be unity. Details of the test columns are shown in Table 1.

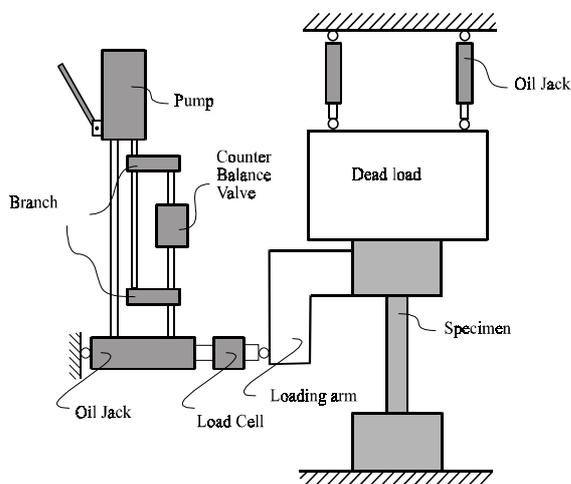
Fig. 2 Loading System

The top and bottom stubs of the column specimen were post tensioned to 13 pieces of steel plates acting as a constant axial load and the reaction floor beam, respectively. This loading system, as shown in Figure 2, displaced the tested columns in a double bending condition similar to the actual case in a moment-resisting frame. To assure that the top and bottom stubs were consistently parallel during testing, a parallel keeping systems which consist of 8 units identical oil jacks with 300 mm stroke were used and connected with high pressure flexible hoses. Configuration of oil jacks of the loading arrangement I is shown in Figure 3. For loading arrangement I, the parallelism of the top and bottom stubs of columns while in testing was relied upon self adjustment of the oil jacks. Mean while, in loading arrangement II, a pump was used to adjust any rotation of the top stub during testing. Specimens CS-1, CS-2, and SCSP were tested using loading arrangement I whereas columns SCCF and SCFC were tested using loading arrangement II. Detail explanation of the loading system is

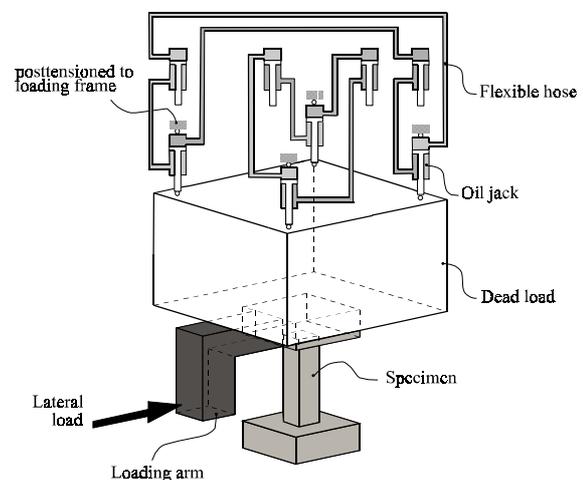
Fig. 3 Oil Jack Arrangement I

The lateral load was applied by a 500 mm stroke hydraulic jack with capacity of 200 kN connected to the L-shape loading arm at the mid height of the column. The applied lateral load was monitored and recorded using a calibrated load cell. The ratio of applied axial load to the column axial load capacity varies from 8.5 % to 9.8 %

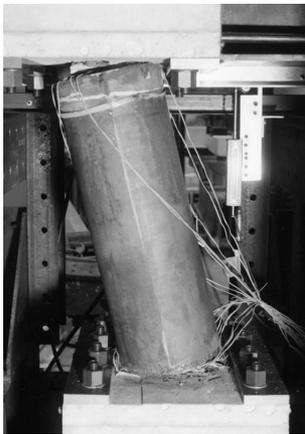
a) Column SCFC under testing

As shown in Figure 4a, the parallel keeping system of loading arrangement II used to load column SCFC was able to control the top stub consistently parallel to the bottom stub even after an extremely large lateral

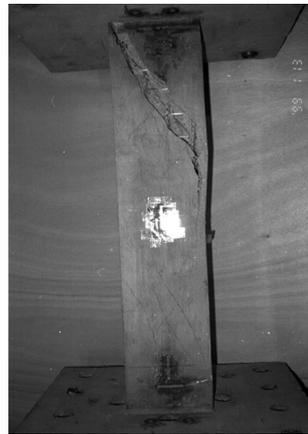
b) Column CS-2

Both control specimens develop similar cracks pattern and achieved almost similar shear strength. Flexural cracks perpendicular to the column axis developed first in the regions close to the top and bottom end of the columns. As the displacement increased, incline cracks were started to develop. Figure 4b exhibits shear failure of column CS-1 with inclined cracking, spalling of cover concrete, and rupture of two out of four exposed transverse reinforcements. For SCSP, SCCF, and SCFC columns, first cracks were observed at the boundary of the top and bottom stubs and column. At later stages of loading, cracks also observed within 10-mm gaps. No crack was observed within strengthening jacket of SCFC specimen.

The control specimens developed shear failure at drift ratio less than 2.5 % and failed by disintegration of core concrete resulting from lack of concrete confinement and yielding of transverse reinforcement. On the other hand, strengthened specimen exhibited ductile flexural deformation. However, due to safety reason, testing of both specimens SCSP and ASCF has to be stopped even before their shear strength did not drop to 85 % of maximum shear strength achieved yet.

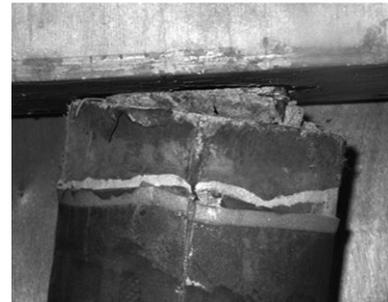
c) Column SCFC

The damages to the strengthened specimens were concentrated at the boundary of the column sections and the top and bottom stubs, and within the gaps as shown in Figure 4c. The employment of circular jackets prevented the strengthened columns SCSP, SCCF, and SCFC from brittle shear failure as happened to the control specimens. Although, in case of column SCFC, very large lateral displacement was applied and the concrete within the gaps was fracture, no physical damage was observed on strengthening jackets throughout the test. It is

It was indicated from SCFC column that concrete within the gaps was fracture and this fracture extended about 10 mm into infill mortar within strengthening jacket and adjacent stub as well. Nevertheless, no single longitudinal bar was fracture in SCFC column despite of large lateral displacement with drift ratio of more than 22 % was imposed. This result shows similar behavior with two RC columns loaded to their complete collapse as reported by the first author elsewhere [16] where the first longitudinal bar fracture was observed when the columns drift ratio was about 23 % and 28 %.

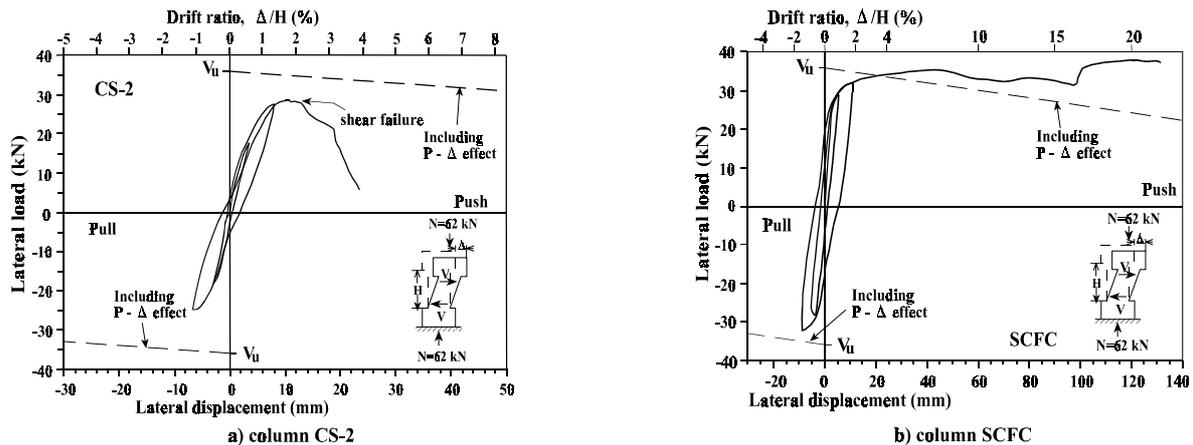
**Figure 5: Typical Lateral Load-Displacement Relationship of Specimens**

Figure 5 show examples of the experimental lateral load-displacement relationship of the tested column specimens. Also shown in these figures is the theoretical lateral load  $V_u$ , calculated based on additional theorem. This theoretical load is plotted as dashed lines that reduce with increase in displacement due to the P- $\Delta$  effect. Details explanation of this theorem are available in Takiguchi et al. [13, 15]. Both control specimens CS-1 and CS-2 could not develop their flexural strength. The maximum measured strength were about 83 % of the theoretical strength calculated including the P- $\Delta$  effect. The CS-1 specimen exhibiting brittle shear failure before two full cycle lateral load was completed at drift ratio about 1.7 %. Similarly, as shown in Figure 5a, even though a limited ductile response was achieved, CS-2 column failed in sudden shear failure at drift ratio about

2.3 % followed by rapid degradation of lateral resistance.

As it can be seen from Figure 5b, the SCFC specimen exhibited extremely stable and ductile response. After the maximum strength was achieved, the lateral load resistance was gradually decreased. At drift ratio about 15.5 %, the lateral load increased and reached a new highest lateral load. This enhancement was due to additional strength from longitudinal jacket that was being supported on the top and bottom stubs.

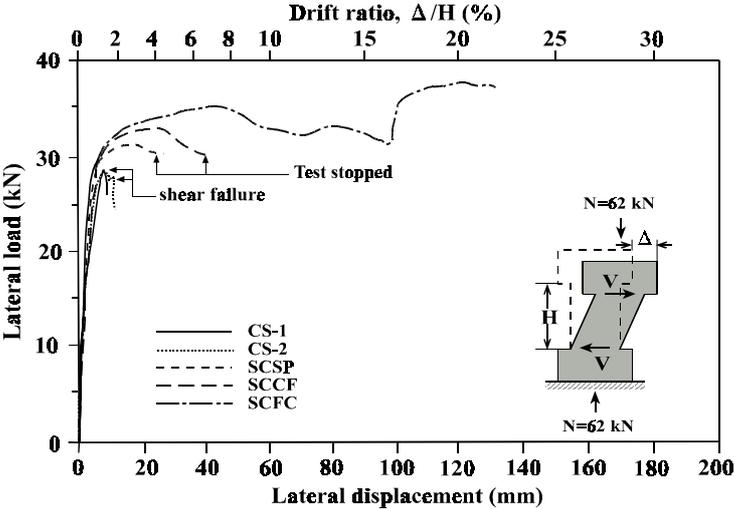
**Figure 6: Lateral Load-Displacement Envelopes**

A direct comparison of the lateral load-displacement peak envelopes of the tested columns is provided in Figure 6. From this figure it can be seen that both control specimen exhibited very poor behavior. However ductility, strength, stiffness, and energy dissipation were improved significantly when a shear failure type of the origin column were strengthened with circular jackets. Although the gaps of 10 mm were provided between strengthening jacket and the adjacent stubs to prevent an increase in flexural capacity, the strengthened columns showed significant increase in flexural capacity. One of the reasons of flexural capacity enhancement of strengthened columns is probably due to increase in core concrete compressive strength due to confinement provided by steel jacket, carbon fiber sheet, and ferrocement jacket.

As summarized in Table 3, compared to average initial stiffness of both control specimens, the initial stiffness of

columns SCFC was improved about 45 %. Although the enhancement of stiffness and strength was not always desirable since the strengthened column would attract more earthquake force, nevertheless as pointed out by Priestley et al. [9], the non-strengthened columns would experienced less shear force if selective strengthening columns is adopted in the overall strengthening design. Note that the enhancement in flexural capacity and the consequent increase in shear demand were not critical since strengthened jacket provided higher shear strength.
