SURVEY AND ASSESSMENT OF SEISMIC SAFETY OF MULTI-STOREYED BUILDINGS IN GUWAHATI, INDIA

SUMMARY

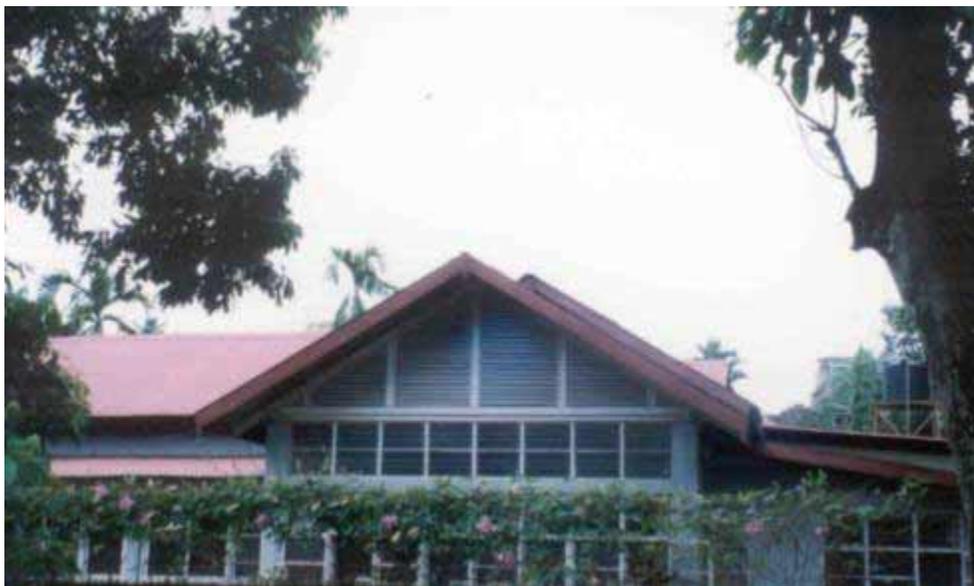
However, the great Assam earthquake of 1897 had flattened almost all the brick masonry structures in the township of Guwahati. Learning from this devastation, the so-called 'Assam type' construction (Figure 1) evolved. It is a combination of the traditional timber framed construction with half brick masonry cladding. The single storey 'Assam type' construction became a common structural and architectural form, which was not only adequately earthquake resistant but also suitable for the prolonged rainfall in the region. The Assam earthquake of 1950 left the 'Assam type' single storey constructions mostly untouched, while causing severe damage to the few buildings that had two or three stories.

Figure 1: Typical Modern Assam Type House in Guwahati

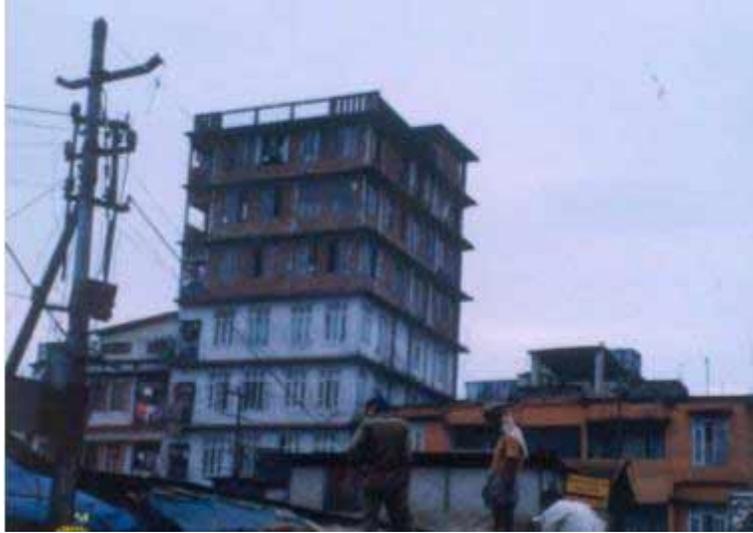
Number of so-called “non-engineered” multi-storeyed buildings exists in Guwahati. Figure 2 shows a building located in a “commercial” area, which initially existed as a four-storey building and later expanded up to seven storeys. The columns are fairly slender, and it is fairly certain that the building has poor lateral load resistance. However, there is increasing awareness among professional builders regarding the need to adopt properly engineered construction for multi-storeyed buildings. But most of these recent high-rise engineered buildings have open ground storey, and the increased vulnerability of such ‘soft storey’ construction has not been understood. In some cases, isolated multi-storeyed buildings are positioned so close to one another as to render them vulnerable to possible ‘pounding’ in the event of a high intensity high duration earthquake.

Figure 2: Addition of extra stories

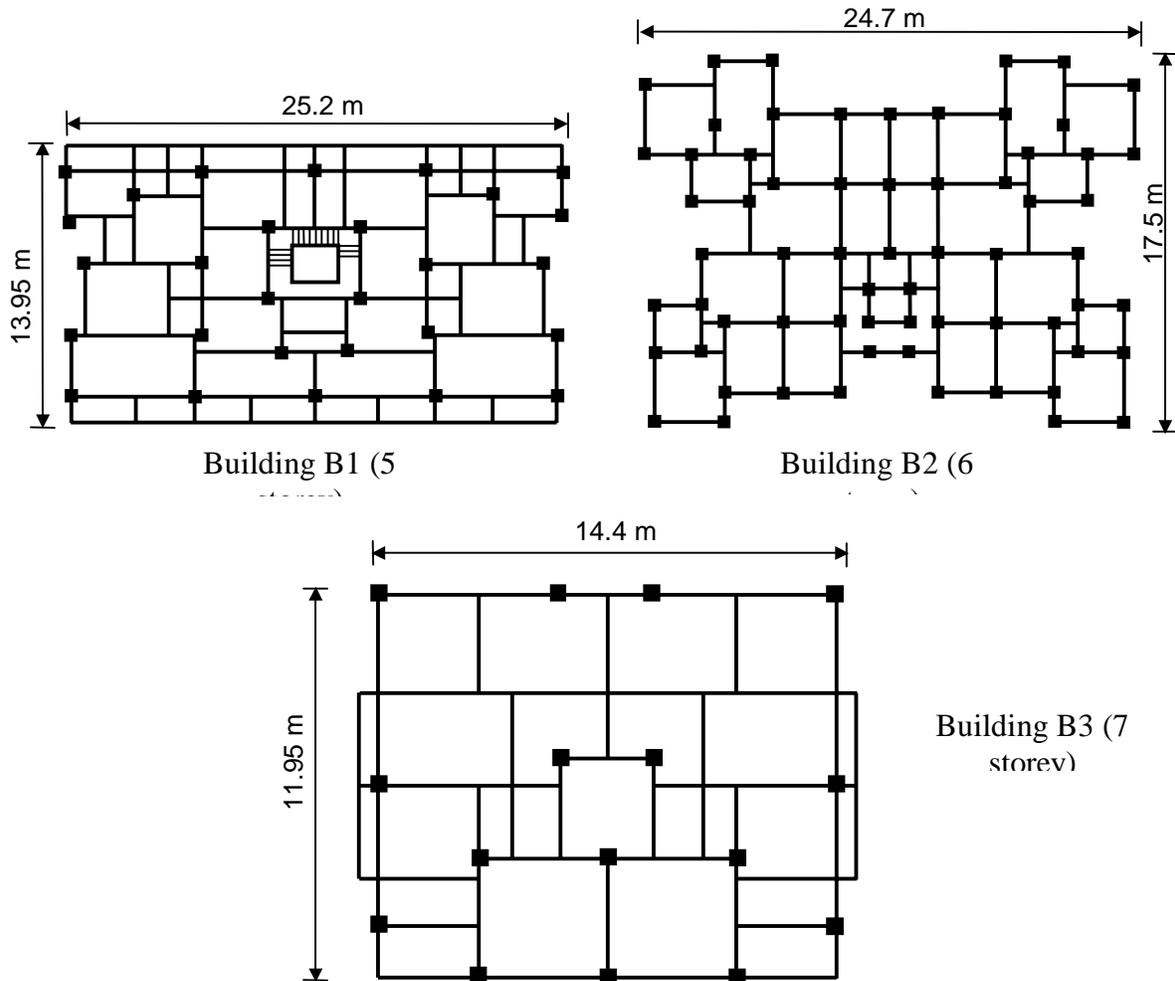
The three buildings presented in this paper are residential, ordinary moment resisting RC framed buildings in Guwahati. Figure 3 shows the typical floor plans of the three buildings, B1, B2 and B3. Building B1 is a Ground+4 storey building (15.7 m height from the ground level), Building B2 is a Ground+5 storey building (18.9 m height from the ground level) and Building B3 is a Ground+6 storey building (20.7 m height from the ground level). In all of the buildings, infill walls are absent in the ground storey (open ground storey) for car parking. Plan dimensions of Buildings B1, B2 and B3 are $13.95m \times 25.2m$, $17.5m \times 24.7m$ and $11.95m \times 14.4m$ respectively. M15 grade of concrete and Fe 415 grade of steel were used for the construction of all three buildings.

Figure 3: Typical floor plans of Building B1, Building B2 and Building B3.

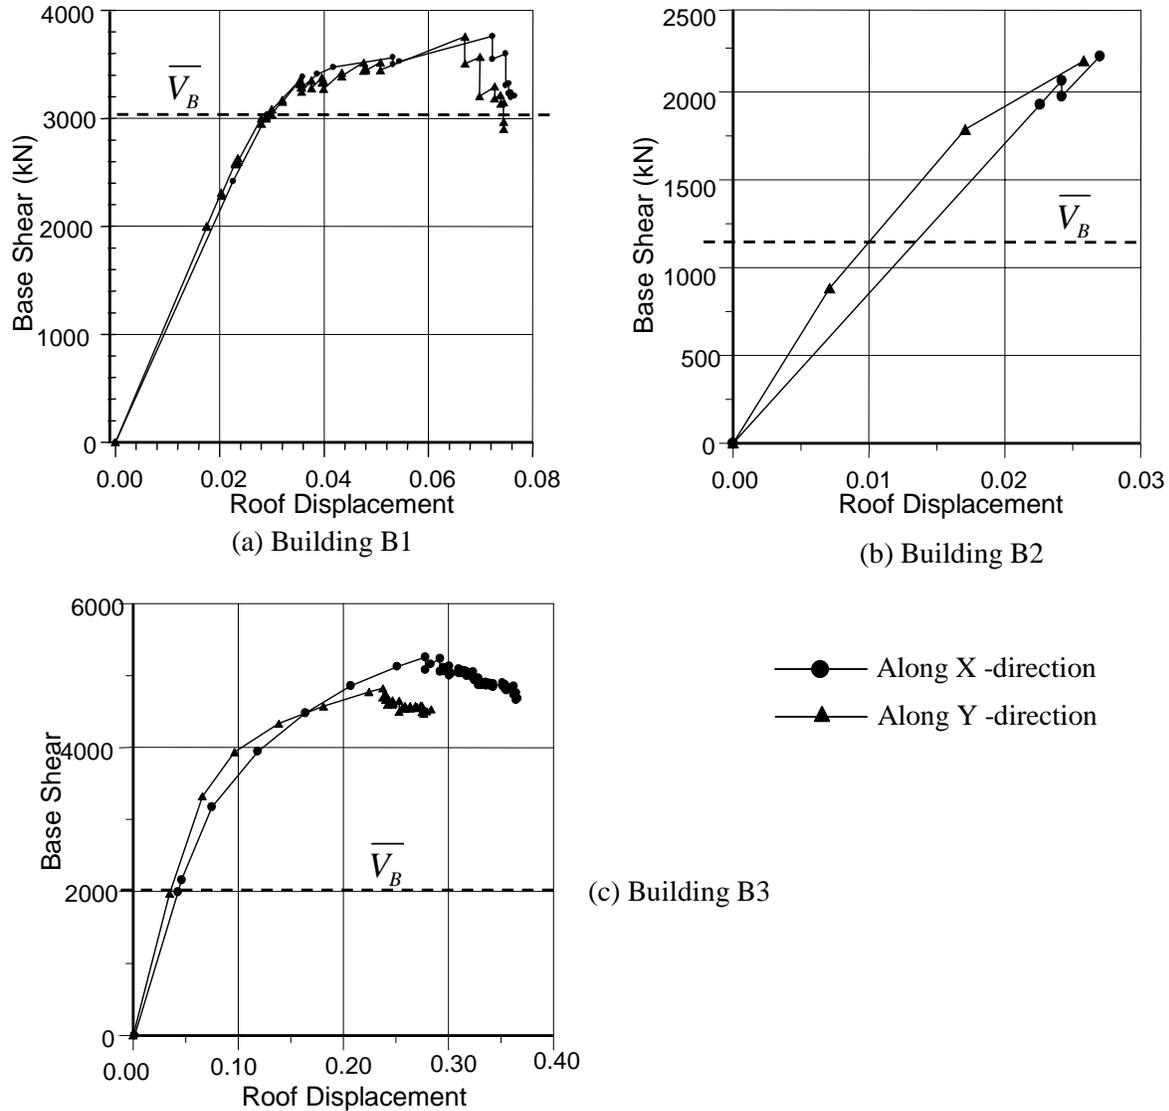
Figure 5 shows the pushover curves for the three buildings. All the buildings have sufficiently large strength as compared to \overline{V}_B , but Buildings B1 and B2 have failed to achieve the target displacements prior to the formation of mechanisms. However, Building B3 reached the target displacement marginally.

Figure 5: Pushover curves for X- and Y- direction.

In a pushover analysis, when the demand spectrum for DBE is plotted along with the capacity spectrum in an Acceleration Displacement Response Spectrum format, the two curves may meet to give a performance point. Capacity spectrum corresponds to the base shear versus roof displacement curve. For Buildings B1 and B2, the pushover analyses in either direction failed to give performance points before the formation of mechanisms, indicating unacceptable performance and need to be retrofitting. It needs to be retrofitted. The flexural hinges in ground storey columns went beyond life safety. But in the case of Building B3, the pushover analyses in both the directions gave performance points, before the mechanisms formed. The drift corresponding to the performance point is well below the 'life safety' limit and there is no hinge in the structure at the performance point beyond the life safety. Beyond the performance points, the capacity goes on increasing till the mechanism forms, whereas the demand reduces due to increased damping and equivalent time period. So, the building has achieved life safety performance level under DBE. It does not need any global retrofitting. Some of the frame sections do not satisfy the code criteria according to elastic analysis and these need local retrofitting.
