SEISMIC PERFORMANCE OF WOOD HOUSES BY FULL-SCALE SHAKING TESTS OF TWO-STORIED POST AND BEAM WOODEN FRAMES

SUMMARY

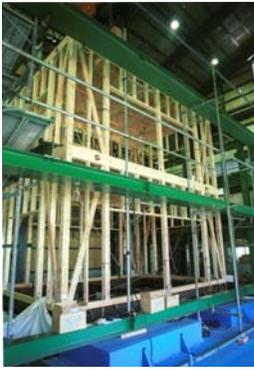
Fig.2 Specimen with wooden braces.

The second specimen, called *frame with wooden braces*, was built from the frame specimen by adding wooden braces, as shown in Figs. 2(a) and 2(b). The cross-section and material of the braces are listed in Table 1. Braces were installed between neighboring corner columns and floor columns in diagonal directions. Plate metal connectors were used to fasten the two ends of wooden braces to columns and beams. Nails were used to fasten braces to supporting columns in the middle.

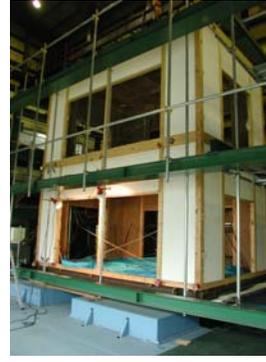
Fig.3 Specimen with mud-walls.

The third specimen was *Frame with mud-walls*, also constructed based on the frame specimen by installing mud walls, as shown in Figs. 3(a) and 3(b). It should be pointed out that all supporting columns and hanging columns were removed for the convenience of building mud-walls. The thickness of mud-walls was 60mm. Two types of mud-walls were distinguished according to their seismic roles. One is called seismic walls between neighboring corner columns and floor columns. Mud-wall was constructed in a common way used in Kyoto, Japan. Inside the walls, ribs were added to reinforce the walls, called "nuki" in Japanese. In each seismic wall, one vertical "nuki" and three horizontal "nuki" were added, while in each hanging wall, two horizontal and one vertical. The size and material of "nuki" are also listed in Table 1. Finish coating was applied after undercoating, and a 2mm-thick layer of white plaster covered the outside of the mud-walls.

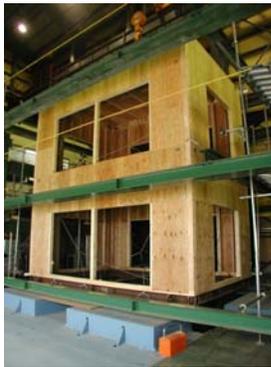
Fig.4 Specimen with plywood-walls.

In the specimen called *frame with plywood-walls*, as shown in Figs. 4(a) and 4(b), plywood panels of 12mm thickness were placed onto columns and beams of the frame specimen. N50 steel nails were used to fasten the panels with a uniform space of 150mm. The difference of seismic walls and hanging walls is the same as the case of mud-walls.

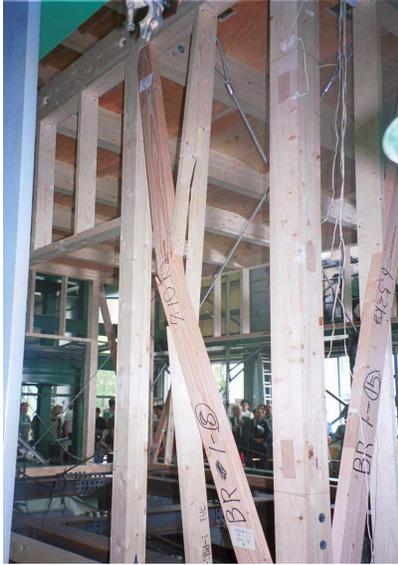
Fig.5 Break of wooden brace in first story.

Creaking sounds were heard at the two end joints of four braces in the first story starting from the deformation angle of $1/220\text{rad}$ (100Gal). As the deformation angle increased to $1/87\text{rad}$ (150Gal), cracks occurred at the joints of the braces and the supporting columns. When the angle reached $1/32\text{rad}$ (350Gal), one brace was broken, as shown in Fig. 5. Then three braces in the front and back were broken sequentially at the angles of $1/27\text{rad}$ (400Gal), $1/23\text{rad}$ (600Gal), and $1/15\text{rad}$ (800Gal). At the same time as the four brace was broken at $1/15\text{rad}$ (800Gal), cracks were observed in a corner column at the ceiling height of the first story. Cracks in another corner column at the same height appeared when the angle reached $1/9\text{rad}$ (1000Gal). And immediately the other two corner columns were cracked. The situation of destruction is shown in Fig. 6. All damages took place in the first story.

From the above destruction process, it was found that the break of the first brace at an angle of $1/30\text{rad}$ was a critical point for the frame. After this point, other braces, as well as corner columns, were cracked quite fast. Similar observation was also found in previous research^[1] from static and dynamic tests. Therefore, it could be concluded that wooden brace may lose seismic resistant capacity at the specimen deformation angle of about $1/30\text{rad}$.

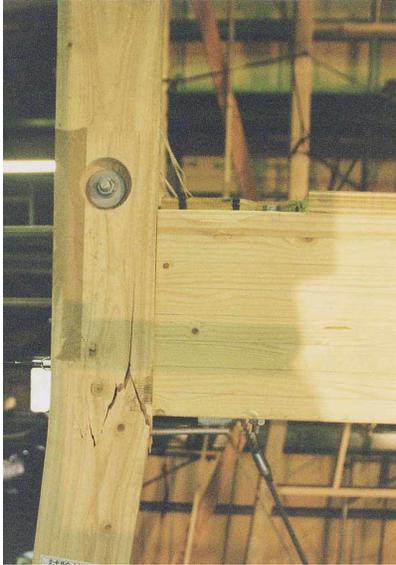
Fig.6 Break of corners column at first story's ceiling.

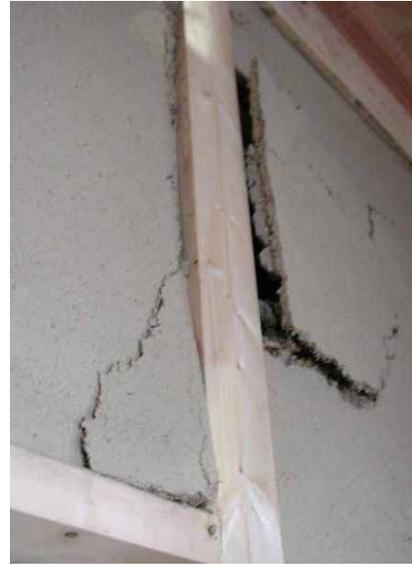
Fig.7 Separation of mud-walls from frame.

At the deformation angle of $1/230\text{rad}$ (100Gal), the first crack in a seismic wall started from a corner column at a height of 1600mm of the first story. The crack was in an inclined direction. When the deformation angle reached $1/155\text{rad}$ (150Gal), the first crack propagated further, more cracks appeared in the seismic walls of the second story and near H-connectors at three corners on the first floor. As the angle increased to $1/64\text{rad}$ (250Gal) and $1/51\text{rad}$ (300Gal), more cracks occurred in mud-walls in the first story and old cracks propagated longer and wider. When the angle reached $1/31\text{rad}$ (500Gal), hanging walls began to separate from floor columns, and one lintel in the first story started to fall out from floor columns. As the angle was increasing, cracks became visible on the inside of the walls, and four corners of each seismic wall and each hanging wall began floating away from the frame. The tests ended when many mud-walls of the specimen were damaged severely at the angle of $1/16$ (800Gal). Fig. 7 is a picture of such destruction state.

After the tests, it was found that all structural members, such as columns and beams, were not damaged. Thus, the mud-walls contributed quite high resistance to the specimen. During the test process, the initiation of small cracks in the walls and the propagation of the cracks to larger sizes released stresses, dissipated energy, and prevented the frame from destruction.

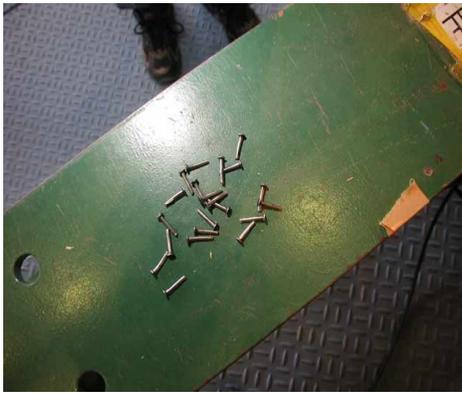
Fig.8 Fracture of nails used for plywood-walls.

Creaking sounds began to be heard at the deformation angle of $1/410\text{rad}$ (150Gal), and became clear at the angle of $1/290\text{rad}$ (200 Gal). When the angle reached $1/165\text{rad}$ (250Gal), it could be identified from the sounds that plywood panels collided with each other in the first story. As it reached $1/68\text{rad}$ (350Gal), nails at four corners of seismic walls in the first story started to bend, edges of two neighboring plywood panels began to fall apart from each other, and then the nails were pulled out from plywood surface. When the angle increased to $1/28\text{rad}$ (600Gal), fracture of nails along the perimeter of seismic walls took place, as shown in picture 8. The outside of seismic walls separated from the frame, and only middle areas were connected to the supporting columns by nails, as shown in picture 9. At the angle of $1/11\text{rad}$ (800Gal), cracks occurred in the lintels of the first story. Finally, the test stopped at the angle of $1/10\text{rad}$ (1000Gal), when the H-connectors at four corners on the first floor began to bend.

The destructive tests on the frame with plywood-walls showed that the plywood-walls lost the seismic resistance due to the bending and fracture of the connecting nails. However, the plywood-walls did provide considerable strength to the frame, and allowed largest deformations of the frame.

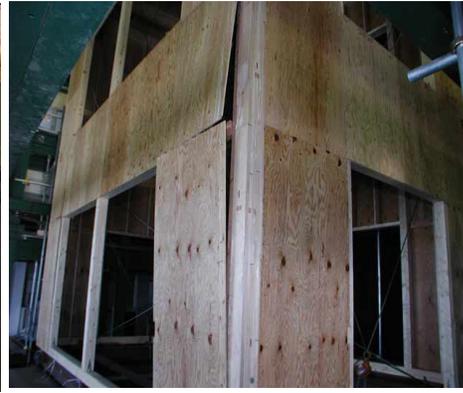
Fig.9 Separation of plywood-walls in first story.
