EXPERIMENTAL STUDY ON SEISMIC RETROFITTING OF MASONRY WALLS USING GFRP

SUMMARY

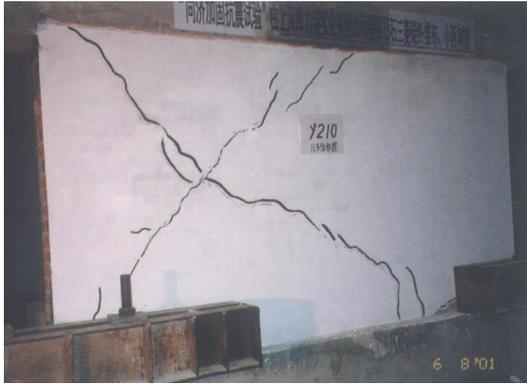
Fig. 3 X-shape cracking of masonry

The crack forms may be divided into three types: X cracking shape, appeared in X102, X208, Y210, XX210 (see Fig. 3); ladder-shape cracking, corresponding to X206, X308 (see Fig. 4); horizontal crack between brick, appeared in X202 and X108.

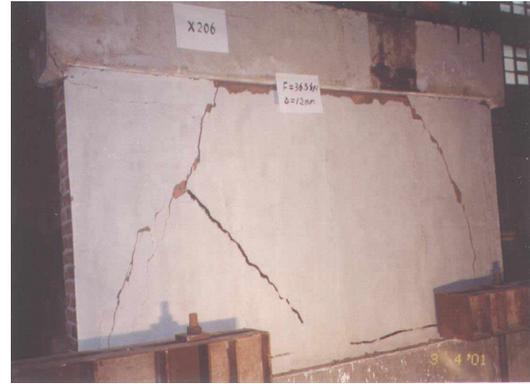
Fig. 4 Ladder-shape cracking of masonry

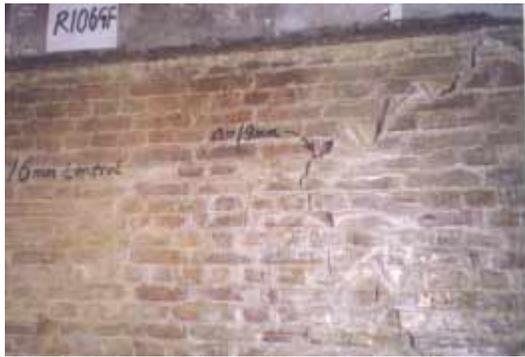
Fig. 5 Cracking of masonry strengthened with low-strength GFRP

Specimen of R106GF was strengthened with low-strength GFRP. Its cracking shape is X. Residual crack width reached 19mm (see Fig. 5 and 6).

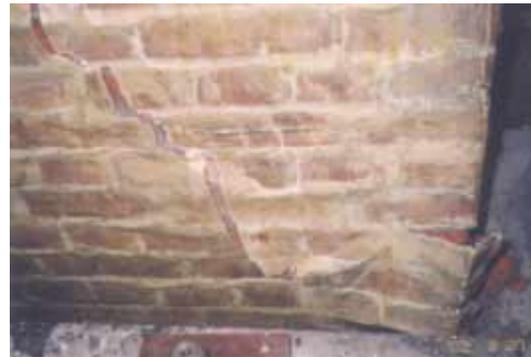
Fig. 6 Enlarged view of cracking

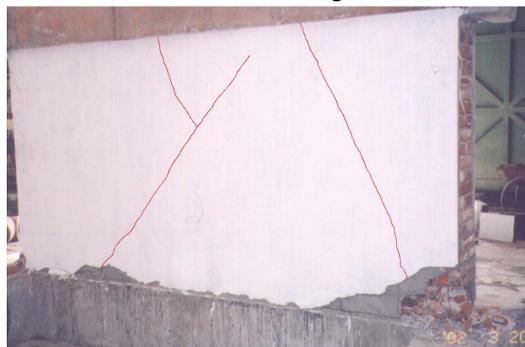
Fig. 7 Cracking of masonry strengthened with steel-mesh

Specimen of R106N was strengthened with steel-mesh reinforced cement layer. Its cracking shape is also X. Residual crack width is little. Footing wall brick severely crushed, cement mortar layer spilled and steel wires were exposed (see Fig. 7 and 8).

- (5) Footing walls brick damaged in all tests, although crack width was very fine (see Fig. 7) after strengthened. In this case, the shear capacity of walls depends on local compressive strength of masonry.

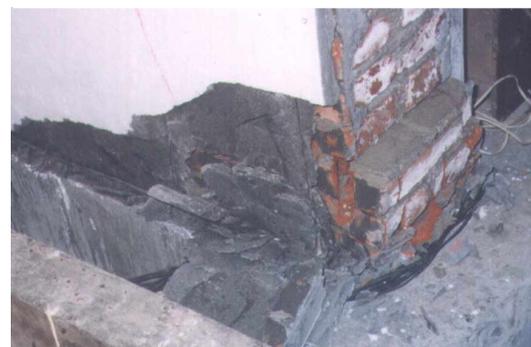
Fig. 8 Crushing of footing wall brick in specimen strengthened with steel-mesh

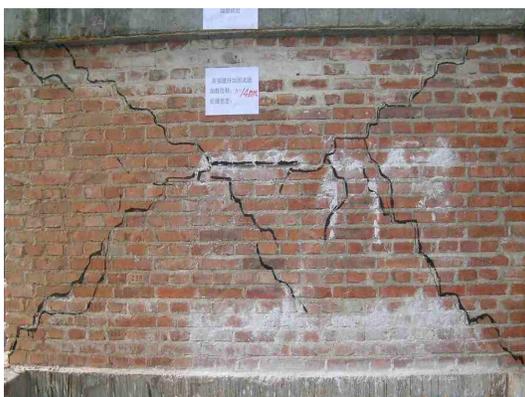
Fig. 9 Masonry failure mode in HR1106GF

Splitting failure with a clear X crack pattern was also obtained in all one-side reinforced masonry walls, ultimate load of specimen HR1206GF was 1.189-time of HR1106GF (see Fig. 9 ~ 10, HR1206GF had the same crack pattern). The failure mode of specimens was brick splitting. In the test process, rupture and debonding of GFRP sheets was not been found.

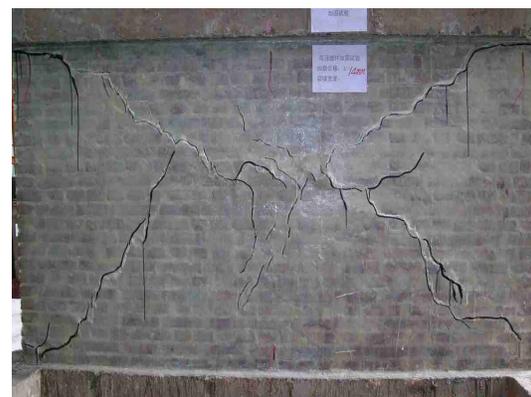
Fig. 10 GFRP failure mode in HR1106GF

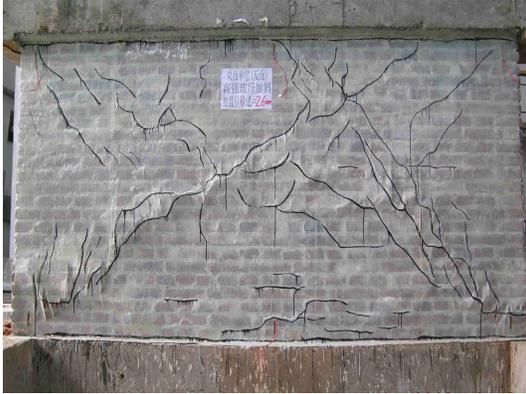
Fig. 11 Failure mode of HR2106GF

In the specimen HR2106GF, failure mode is still the splitting of masonry substrate (see Fig. 11), and few GFRP sheets were rupture and debonding in the test process. But for specimen HR2206GF, the failure reason is the sudden loss of collaboration between reinforcement and substrate due to debonding of the superficial part of masonry (see Fig. 12). The unreinforced masonry typical sudden failure was noticeably improved by the GFRP strengthening, where crack wide spreading provided sufficient signals of incipient crisis well before collapse.

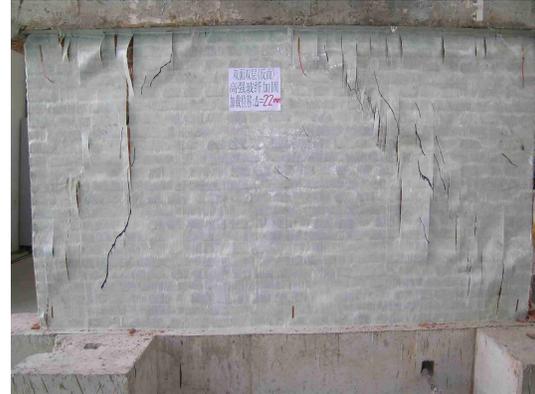
Fig. 12 Failure mode HR2206GF

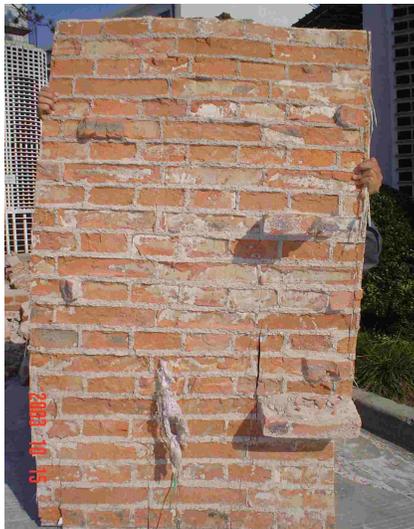
Fig. 13 Failure mode of interface

In all cases the rupture was due to detachment of the brick superficial skin. Tore out GFRP sheets from the masonry, a piece of mortar and brick was bonded on the surface of GFRP sheets (see Fig. 13). Even a few bricks were drawn out from masonry.

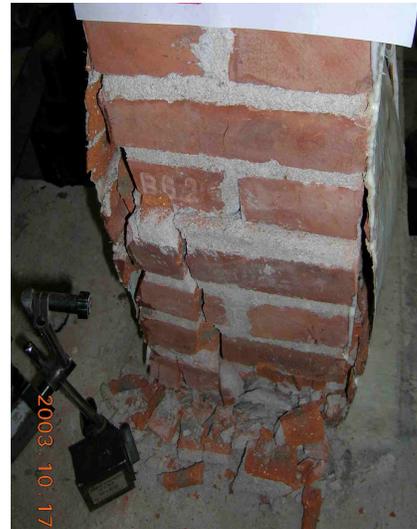
Fig. 14 Crushing of footing wall brick

In the test process, we could see that footing wall brick was always been crushed at first (see Fig.14). Then the crack width of masonry began to develop rapidly. Finally, brick split and specimen was totally damaged.
