## **EARTHQUAKE EVALUATION OF A HISTORICAL BUILDING IN SAN JUAN CITY – ARGENTINA**

**S. B. Aladro, C. A. Monguilner, M. E. Castro<sup>1</sup>**

### **SUMMARY**

This research focuses on the seismic capacity of a historical building in San Juan city, in the Argentina's center western region. Firstly, it aims at determining if the building will be able to bear strong future earthquakes satisfactorily. Secondly, it supplies criteria for its preservation. An exhaustive analysis has been carried out, applying a method that compares its demand with its capacity.

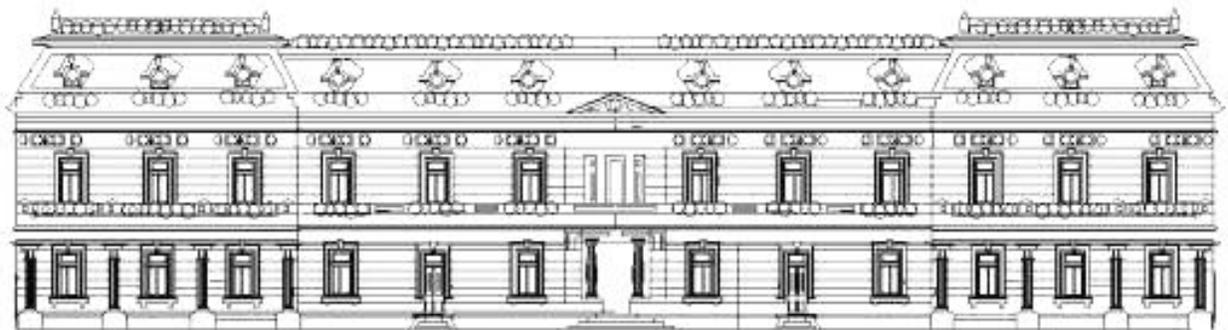
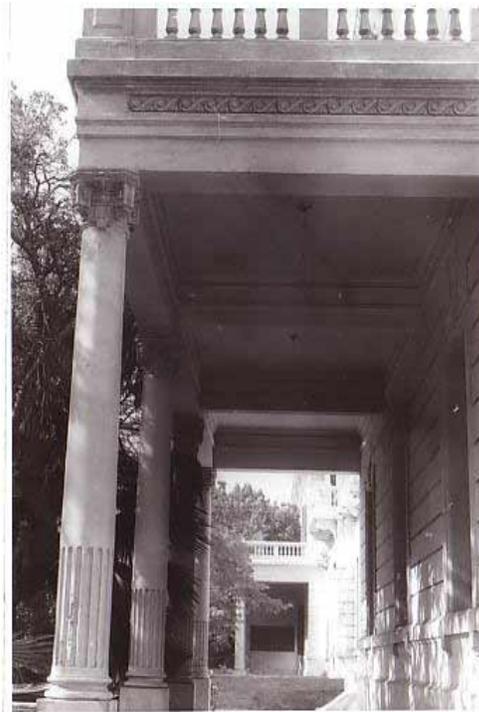
fig N° 1

This three-storey masonry building was constructed with beams, columns and slabs of reinforced concrete, following suitable building techniques of the time (figs. N° 1, 2, 3). Due to its cultural value, it is very important to preserve it. So the evaluation of its seismic capacity was carried out so as to assure a satisfactory behaviour during strong earthquakes in the future. Although the hospital has already resisted some destructive earthquakes, slight deterioration or lack of maintenance could undermine its seismic stability.

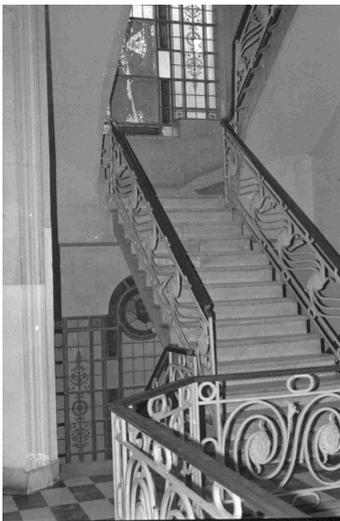
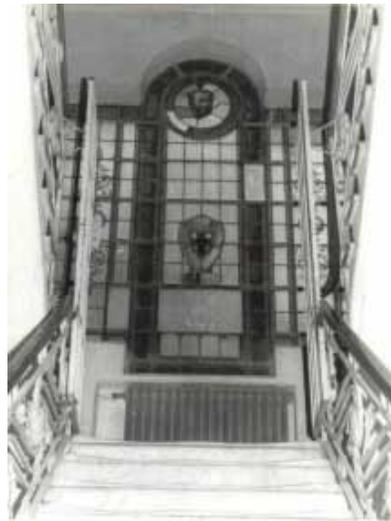
**fig N° 4**

The building under study, the Rawson Hospital Central Section, has a triple-height central hall lit by a zenithal vitreous window. In them the corridors are developed over this space. A sculptural stair, whose rests show vitreous windows supported by iron brackets, connects the different floors (fig N° 4).

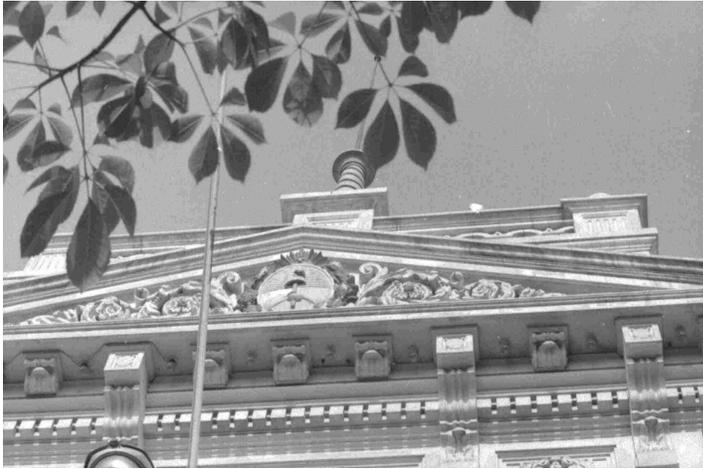
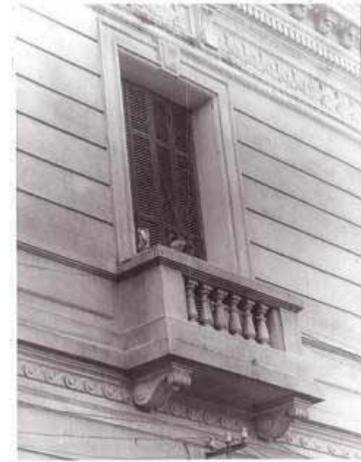
**fig N° 5**

The slab and the attic are made of concrete, and the windowsills and projections have small vaults and slate lining. The building displays cedar woodwork and marble steps in the entrances (fig N° 5).

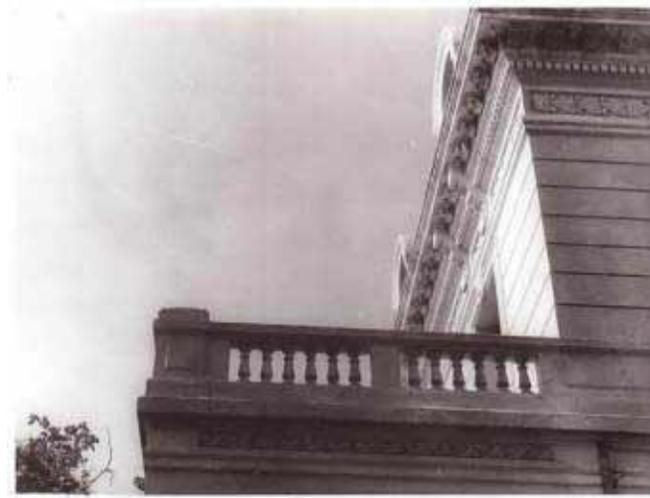
**fig N° 6**

The architectural ornaments, moldings, balustrades and other details are made of iron and mortar. Bricks are believed to have been locally produced, but the rest of the materials were imported from Europe, since concrete was still unknown by the native constructors of the time (fig N° 6).
