FORENSIC ENGINEERING STUDIES ON HISTORICAL EARTHQUAKES IN ROMANIA

Emil-Sever GEORGESCU¹

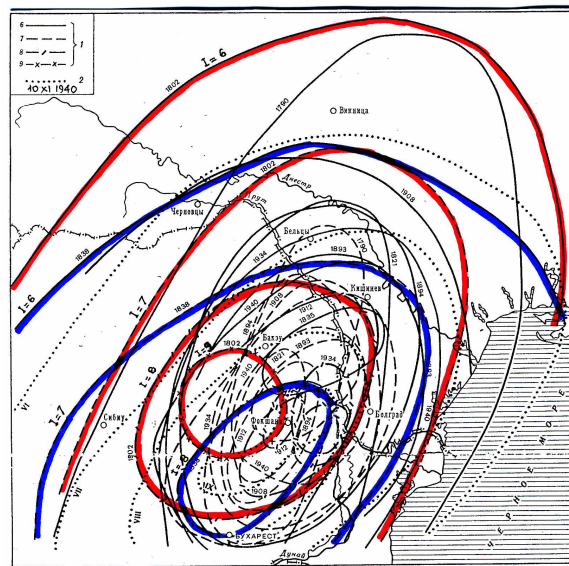
Fig. 1. Areas affected by different intensities in case of 10 Vrancea historical earthquakes. Isoseismal lines of 1802 motion (in red) and 1838 motion (in blue) are thicker (adapted after Moskalenko, 1980) [3].

seismologists, as well as of Russian seismologists. Several authors considered that the 1802 earthquake ellipses have a slightly different orientation, more obvious of the area with $I = IX$ MSK, while other earthquakes obviously show “shifted ellipses” towards N-E or S-W.

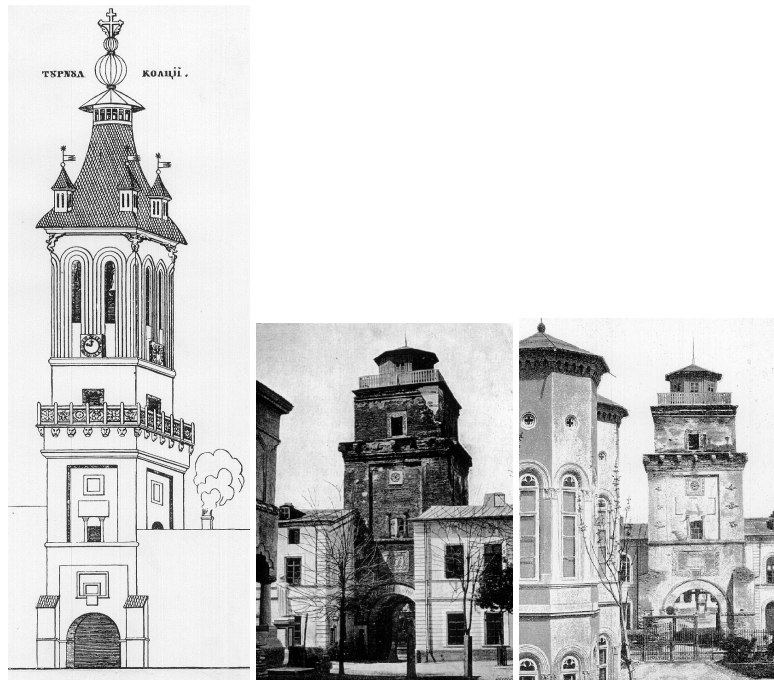
Figure 3. The Coltzea Tower between 1715 and 1802, (Drawing by N. Otetelesanu 1838), (to the left) and the damaged Tower, repaired after 1847, with additional timber stories for firetower, as seen from the East side (middle photo) and West side (right photo) (Photos around 1869, by Carol Popp de Szathmary) [8, 9]

The main data on structure can be found in the drawing published by Otetelesanu, 1838 [8, 9], as it was “initially” built (Fig.3, left). Besides Doussault engravings, Angerer in 1856 and Szathmary in 1869-1870 left us some photographs (Fig. 3, center and right), while Niculescu got images before the tower was

demolished (1887 -1888). The Coltzea Tower was a main gate and bell tower of the Coltzea Monastery. It was the first building of this kind and height in European / Germanic style, in the Kingdoms of Wallachia and Moldavia. The thick walls were made of masonry, the strong foundation walls of raw stone. The entrance gate was on the ground floor, under a large vault, having buttresses at corners. [8, 9, 10]

The “History of Bucharest”, Ionnescu-Gion, 1899 [12], mentions that in 1802 the upper part collapsed, falling towards North – East, confirming the general direction of isoseismal ellipses caused by great Vrancea earthquakes. The remaining part showed corner damage towards N- E, below the former level of the clock, as represented in the drawings of Doussault in 1843 and in other photographs in 1856, 1870 and 1887. After the collapse, of the upper part in the 1802 earthquake, the remaining part withstood until 1888, when it was demolished for urban planning purposes. For all these reasons, the Coltzea Tower was

The present forensic analysis of all images pointed out that the lower part of the Tower was not even cracked even after almost 170 years of existence, despite being subject to at least 18 large Vrancea earthquakes (magnitude over $M_s=6$, intensity over $MSK=7$). Out of these, the Coltzea Tower resisted the earthquakes of 1738, 1740, and 1790. The remained part resisted some other large earthquakes, as that of 1829 and 1838 etc. Since many other buildings have been entirely destroyed by these earthquakes, the behavior of the Tower can be considered as a proof of a Local Seismic Culture.

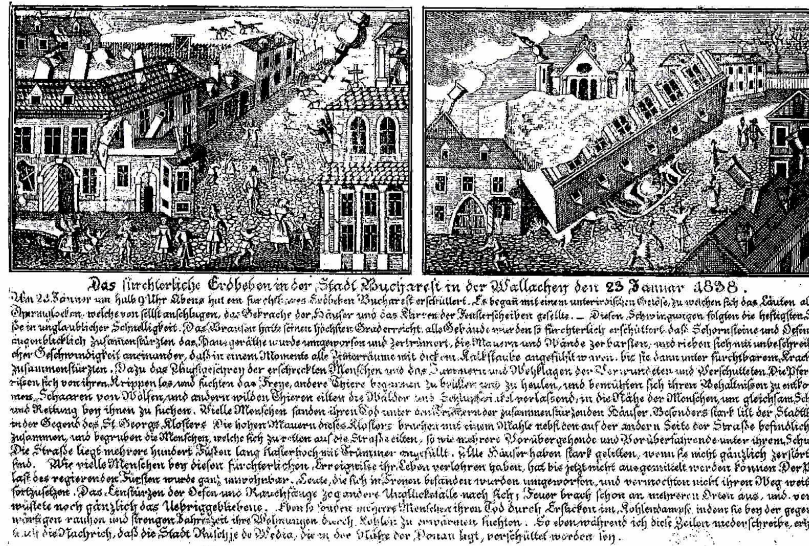
**Fig. 5. Earthquake of January 23, 1838, in Bucharest.
 (Wood Engraving, Romanian Academy Collection)**

The most circulated image of this earthquake is a wood engraving with a text in German: „The terrible earthquake of the Bucharest town in Wallachia, of January 23, 1838”. The pair of drawings in this image have been considered since then as a „true” report of disaster reported in the text, but the reality seems to be different. As it was the case of other engravings, they were most probably manufactured somewhere in the Germanic culture area of Europe, showing some stereotype patterns. [16, 17].

Thus, the church structure is not a local type one, the collapse of entire „block” masonry building is not possible, although there is no snow, there is a sledge with horses and passengers, seems to be just caught under it quite artificially...The collapse mechanism of chimneys and towers is unrealistic but similar to the „Nuremberg style” of the ages...

The text itself seems to originate from a foreigner that lived in Bucharest, it contains some actual and other possibly less realistic data, as the damage to masonry buildings, to St. George Monastery are confirmed, but official data indicated quite few victims. Thus, the number of fires deaths by suffocation, as well as the wolfs entrance in town can be a rumor or fantasy
