**13<sup>th</sup> World Conference on Earthquake Engineering  
Vancouver, B.C., Canada  
August 1-6, 2004  
Paper No. 2563**

## **IMPLICATIONS OF DESIGN AND CONSTRUCTION DECISIONS ON EARTHQUAKE DAMAGE OF MASONRY BUILDINGS**

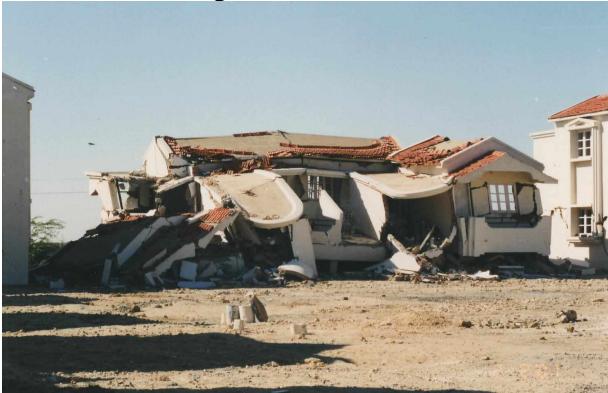
**Fig. 1: Collapsed building built on drain side.  
Retaining wall at back also failed**

Location plays a very important role in earthquake damage. It involves associated seismic risk and site soil condition. Any type of soil failure may lead to building damage. If the building is located next to a depression or open drain damage will be more to the building. In Kutch earthquake such behaviour was noticed in one building complex of Samkhiali Bose P.R. [5], where twelve similar housing units of two storeys were located on a site in the outskirts of the Samakhiali town in the Rapar taluka of Gujarat state. This triangular site is located roughly along a drain. A level difference of around three metre existed between the drain, which was running parallel to one side of the site, and the ground level at the site of construction. Seeing to the area it could be appreciated that the ground before the construction of the buildings would have been undulating. For providing a flat surface to the construction site these undulating tracts of land were filled up with soil. Along the side adjoining the drain a random rubble stone masonry retaining wall of nearly one and a half m. height was constructed. The visual examination of the site showed that the filled up soil at the site was not adequately compacted. Even the original soil up to a particular depth below this filled up soil may not have been in an adequately pre-consolidated state as the site was used for agricultural purposes before the construction of these structures. It was noticed that damage was more in the buildings located along the drain as compared to other buildings. One building was totally destroyed where even the retaining wall along it failed and suffered damage Figure 1. Similarly in Haritpawan Gurukul of Swaminarayan a residential high school having reinforced concrete framed structure, at Ganga Rampar near Bhuj having three wings showed more damage to its west wing along a deep drain Figure 2. Similarly if the building is located on hillock the damage will be more. This was noticed in Latur Osmanabad earthquake Sinvhal A., Bose P. R. et al [6] and in Kutch earthquake Figure 3. It seems the energy of waves which are coming to the side of depression or at the top of hillock and the energy of the waves reflecting back from there is getting concentrated. Further it is well known that damage will be more on loose filled ground. However other reasons can further intensify the damage at such locations Bose P.R. [5].

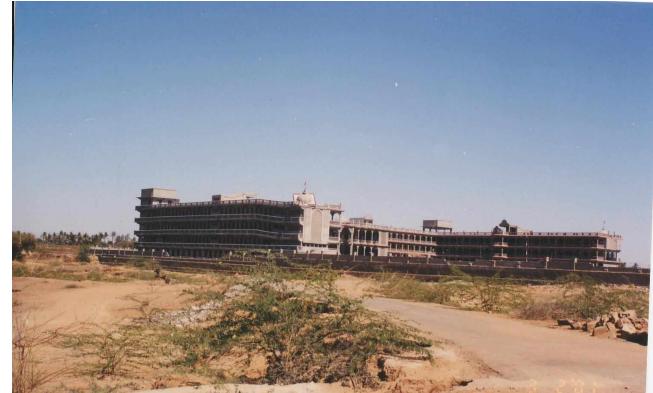
**Fig. 2: Maximum damage was found in the west wing located along drain**

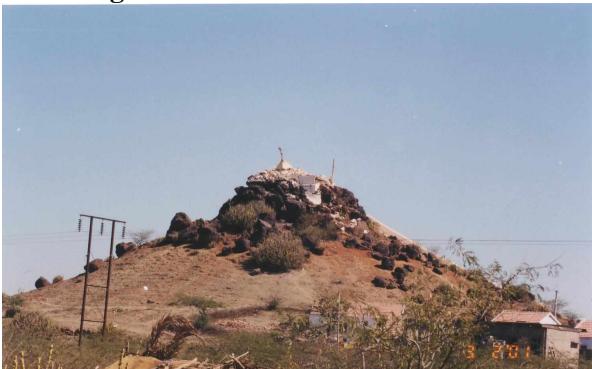
**Fig. 3: Temple collapsed at the top of hillock while other masonry structures located on its foot remained standing near Bachau in Kutch.**

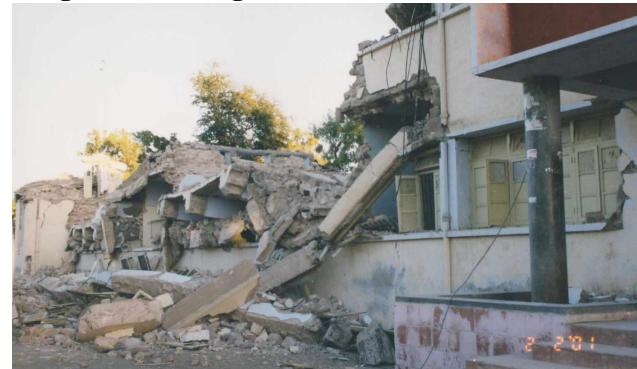
**Fig. 4: Collapsed two story college building had linear plan with too many openings in front.**

Too many openings may reduce the wall strength and masonry between openings may collapse during earthquake. In school and colleges a linear architectural plan is followed. At Bhuj in Lallan College in most of the building blocks having such linear plan front portion had too many windows and doors. This resulted in very long continuous beams supported on thick masonry piers at lintel level in both the storeys. Then again the masonry wall was raised on the top of this beam to support the transverse beams of T-beam floor and roof. This is a usual construction practice in schools and colleges to make the row of rooms in different phases. This sometimes causes discontinuity in the longitudinal beams also. This construction practice is adopted at most of the places due to lack of funds, whenever some money is received from some source few rooms are added to the existing building by college authorities. In these blocks the masonry pier collapsed which caused the collapse of longitudinal beams and then the entire floor and roof Figure 4. All structural elements built separately behaved separately without any monolithic connection. A small amount of vertical steel in the masonry piers and anchoring it to roof slab could have saved these buildings.

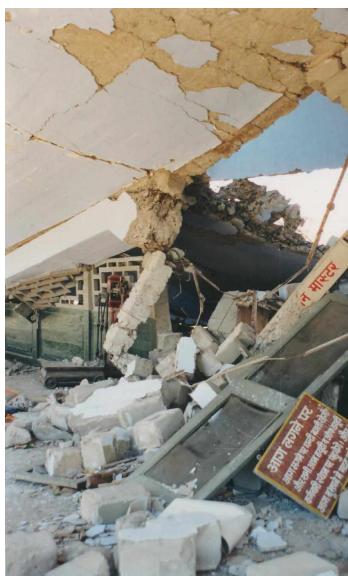
**Fig. 5:** Bachau Station Building showing the condition of a reinforced concrete column provided in masonry building.

In developing countries it is a common practice to provide reinforced concrete columns in combination with masonry. It is provided as independent member just to replace masonry to get open spaces. Such columns are not designed to resist earthquake force and nominal steel is provided without ductile detailing Bureau of Indian Standards [7]. When earthquake occurs they attract lateral force beyond their capacity. This leads to catastrophic collapse or partial collapse Figure 5. At present no special guidelines are available for such buildings, Bureau of Indian Standards [7-11].

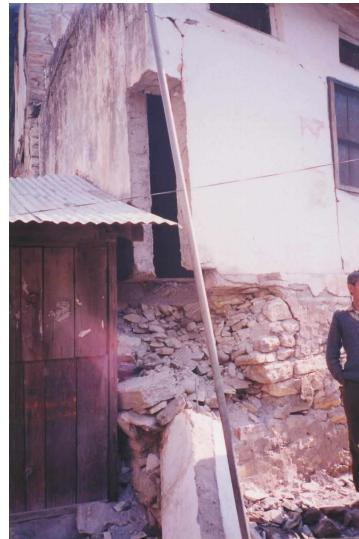
**Fig. 6:** In Chamoli Earthquake, column raised on the top of the stone wall slipped from its place due to lack of connection.

It is common practice that when family size is increased additional rooms are added in existing building and in traditional stone houses new material is used generally brick or concrete. Mostly such extension has no connection with old existing structural system. This new structural system simply slips from its place at the time of earthquake Figure 6-8 .

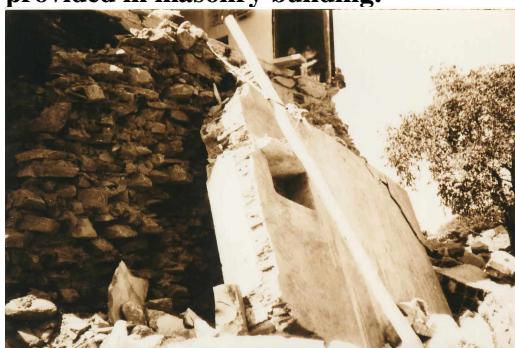
**Fig. 7:** In Killari earthquake a brick wall raised to construct first floor on the top of stone wall without connecting it to old stone wall, simply slipped from first floor to ground.

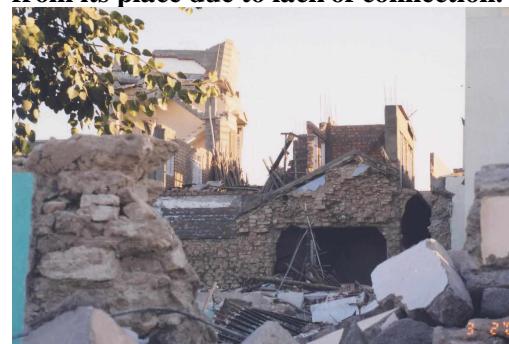
**Fig. 8:** In Anjar, RCC framed building was under construction on the top of old stone masonry building when authors visited this highly damaged area.

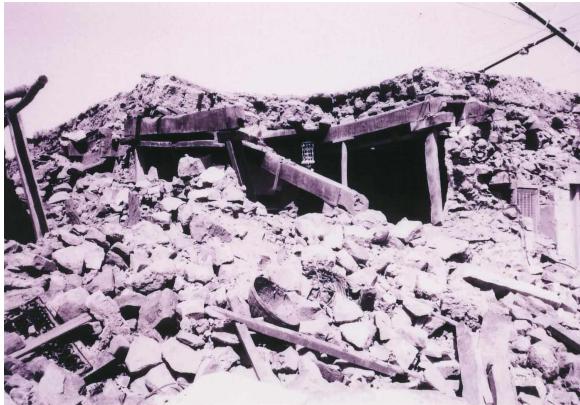
**Fig. 9:** In Killari in 1993 many traditional buildings with vertical timber frame inside survived the earthquake even with heavy roofs. Newly built houses without timber frame but with similar heavy roof of timber and earth were razed to ground.

With passage of time in rural areas people start making the buildings without following the norms of the regional old construction practice which has inbuilt resistance against earthquake resistance. Sometimes this happens because of economic constraints. In killari old houses having timber frame inside stone walls were not collapsed even in the presence of heavy roof, and people were not killed while new houses built using only stone walls were razed to ground Figure 9.

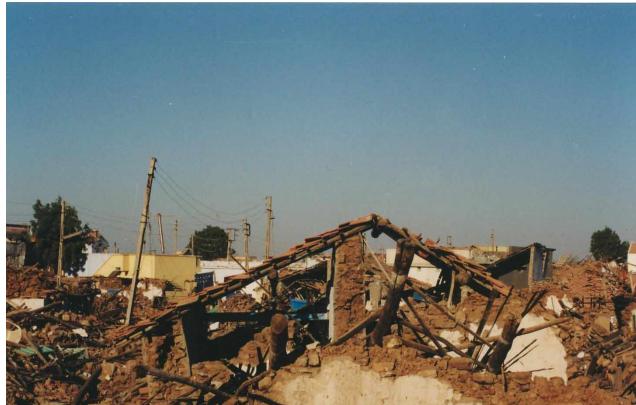
**Fig. 10:** Traditional house in Kutch area showing high central wall and attic for storage.

In Kutch area near Anjar the traditional village house consisted of random rubble stone masonry laid in mud mortar having central wall five metre high and sidewalls three metre high. At this level, transverse wooden beams are provided to create a storage attic. This is achieved with the help of wooden members split bamboo pieces, jute, bushes etc. to create storage floor figure 10. These houses suffered extensive damage due to high walls without earthquake bands and because of lack of integral action between various wooden members. In the walled city of Bhuj walls are made either of random rubble or of dressed stone and are laid in lime or mud mortar. The traditional timber roof is made almost in similar manner with attic. In Bhuj, being an urban area, this storage attic was converted into a living space like dining space. Laying a layer of lime surkhi or cement mortar or plain makes this floor concrete above the old attic floor Figure 11. These buildings were also collapsed or heavily damaged in old Bhuj. It seems that in some buildings the traditional roof was removed and replaced by reinforced concrete slab keeping the attic slab as it is. These buildings tumbled down due to heavy roof and flexible floor [12].

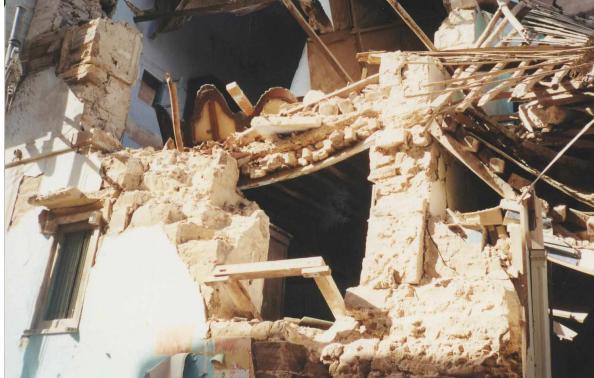
**Fig. 11:** In urban area attic of traditional house shown in Fig. 10 was converted into living space. Later traditional roof must have been replaced by concrete slabs. Such buildings killed many persons in Bhuj.

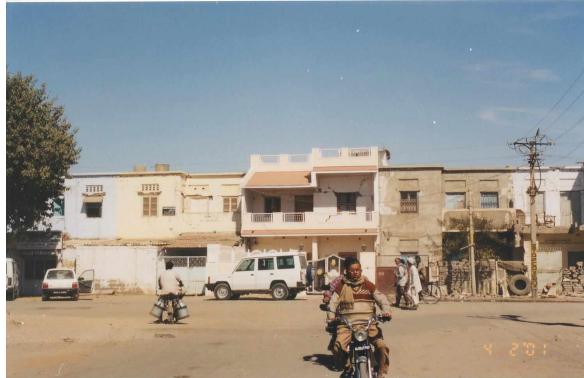
**Fig. 12:** At Gandhidham in this complex of well built row houses made of reinforced hollow block masonry, minor damage occurred only in the renovated house.

Renovation of building is very common especially in urban areas. At the time of renovation the structural system is disturbed and only vertical load is considered and earthquake is forgotten and most of the times walls are removed and vertical load is transferred to other walls. In Kutch at Gandhidham in Sindhi colony two story buildings built by Sindhi Resettlement Corporation in 1956, using hollow blocks of size 6"x8"x16", with reinforcement, looked intact, with some cracks only in the renovated building Figure 12.
