PSEUDO-DYNAMIC TESTING OF UNREINFORCED MASONRY BUILDING WITH FLEXIBLE DIAPHRAGM

SUMMARY

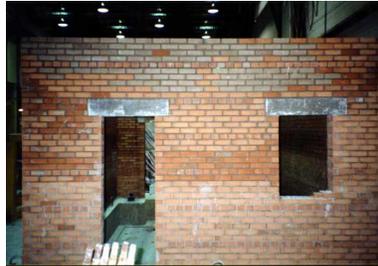
The single-story full-scale unreinforced brick masonry building constructed for this experimental program is shown in Fig.1. This rectangular shaped building was constructed with two wythes solid brick walls (collar joint filled) and type O mortar was used to replicate old construction methods and materials. The specimen has two load-bearing shear walls, each with two openings (a window and a door). Shear walls were designed such that all piers would successively develop a pier-rocking behavior during seismic response. This rigid-body mechanism is recognized by the UCBC to be a favorable stable failure mechanism. The specimen has a flexible diaphragm constructed with wood joists and covered with diagonal boards with a straight board overlay (Fig. 2). The diaphragm was anchored to the walls with through-wall bolts in accordance to the special procedure of the UCBC. Material properties were obtained from simple component tests, such as a three-point flexural bending test of a small beam in order to determine the tensile strength of the mortar used.

Figure 1 URM specimen

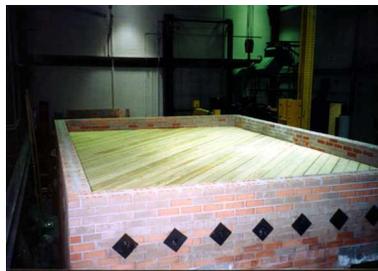
Figure 2 Wood diaphragm

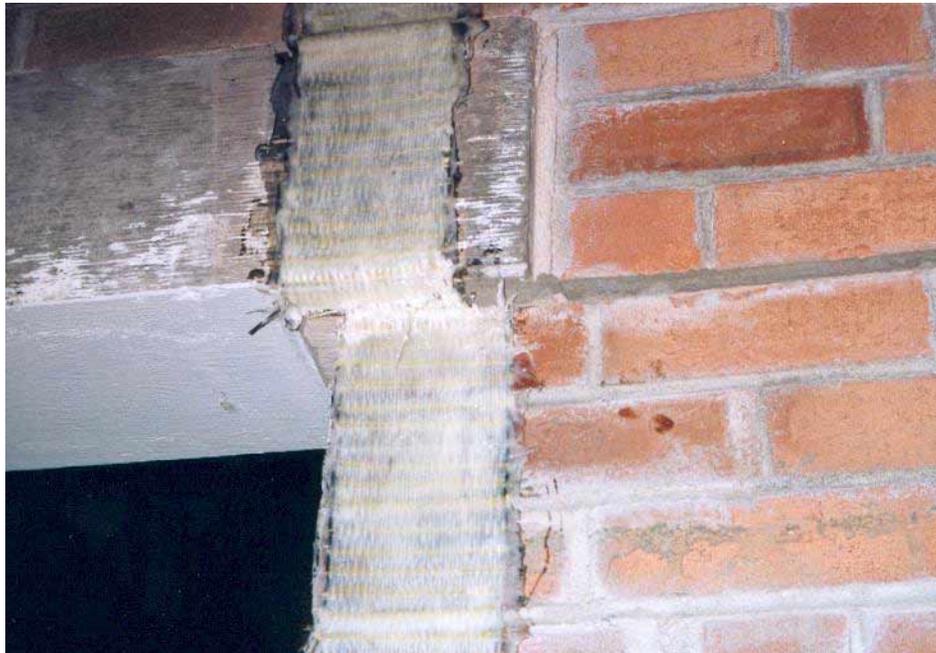
Figure 10 Tyfo strip failed in shear
