RECTANGULAR CONCRETE COLUMNS RETROFITTED BY EXTERNAL PRESTRESSING FOR SEISMIC SHEAR RESISTANCE

SUMMARY

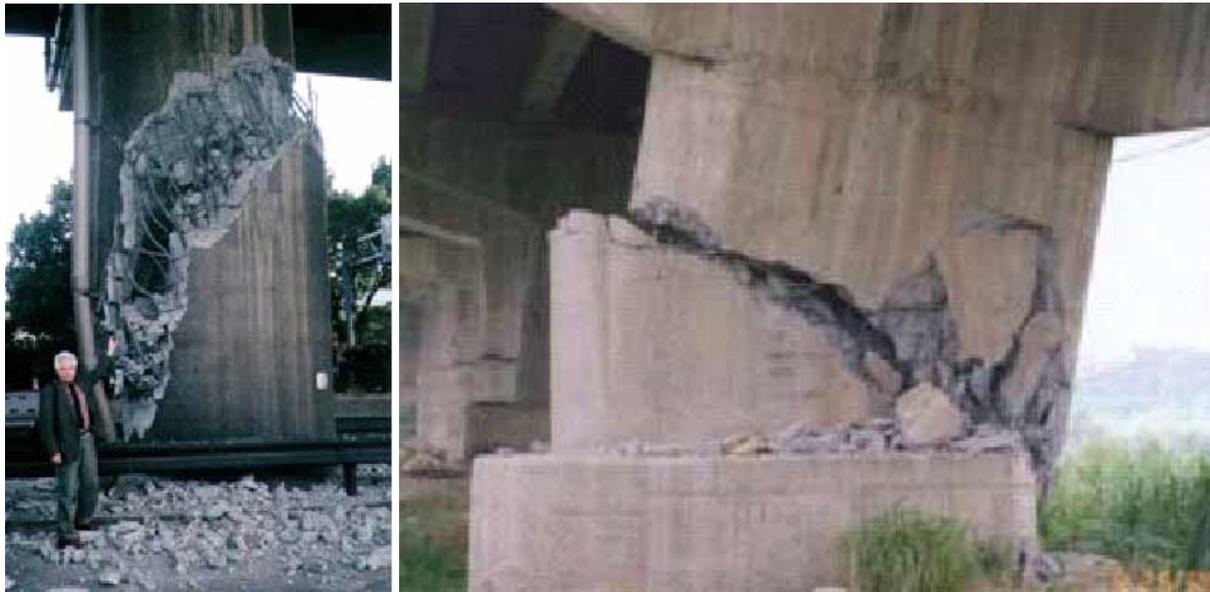
(a) 1995 Kobe Earthquake

(b) 1999 Taiwan Earthquake

Figure 1 Examples of shear failures in bridge columns

Performance of concrete structures during recent earthquakes demonstrated the vulnerability of columns to structural damage. In particular, it was observed that building and bridge columns erected prior to 1970's lacked proper seismic design and detailing practices, leading to complete structural collapse, as shown in Figure 1. The cause of failure of six of the seven bridge structures that failed in the 1994 Northridge earthquake has been attributed to column shear failure [1]. Bridge columns prior to the 1971 San Fernando earthquake were commonly designed to have very little transverse reinforcement, often consisting of No. 3 (9.5 mm diameter) or No.4 (12.7 mm diameter) ties at 12 in. (305mm) on centres,

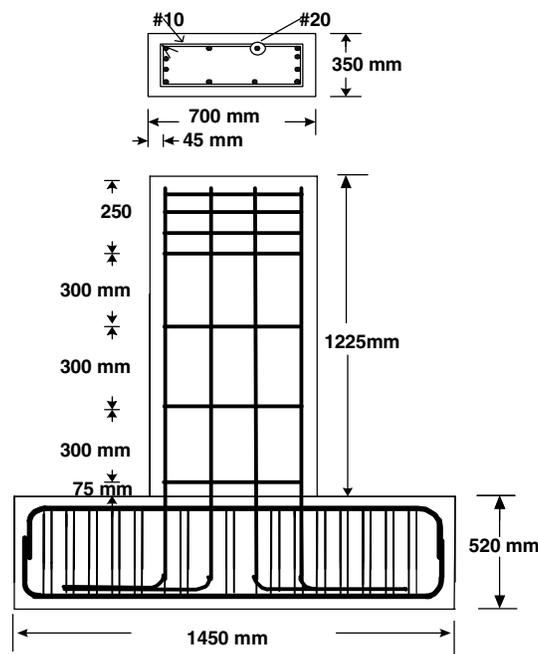
Figure 2 Details of test columns

Two companion columns with 1225 mm height were constructed, which had a shear span of 1500 mm after the installation of the top loading beam and the shear span was measured to the point of application of horizontal force. The resulting shear span-to-depth ratio was 2.14, placing the column in a shear dominant range. The reinforcement consisted of twelve #20 (19.5 mm diameter) longitudinal bars and #10 (11.3 mm diameter) hoops with 135° hooks at both ends. The spacing of hoops was 300 mm, starting at 75 mm above the column base. A heavily reinforced footing was prepared for each column. Figure 2 illustrates the geometric details of column specimens tested.

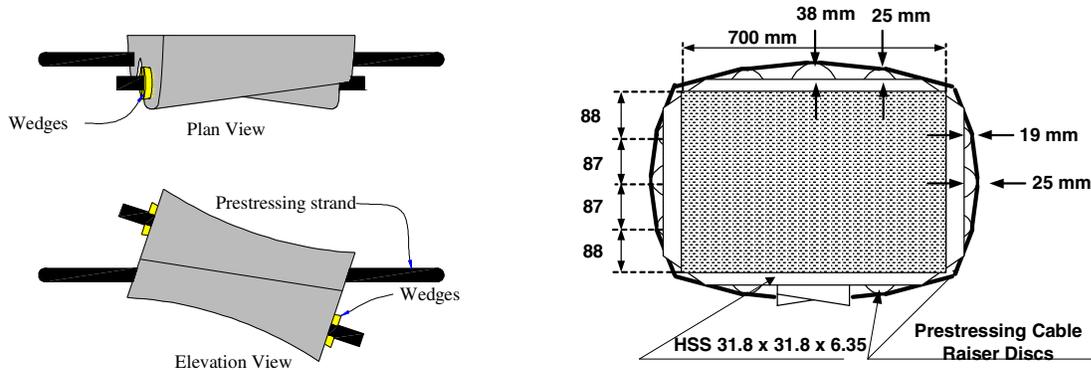
Figure 3 Details of the prestressing anchor and the raiser frames

One of the columns in the pair was retrofitted by transverse prestressing. This was done by means of 7-wire strands, which were placed at every 150 mm, starting at 75 mm from the column base. Hollow steel sections (HSS 31.8x31.8x6.35mm) were placed on each face with three semi-circular disks welded on them, forming a frame around the column at each strand location. The height and location of semi-circular raiser disks were calculated to make transverse forces as equally distributed as practically possible. A specially manufactured anchor was used to perform prestressing of each strand. The anchor was placed on one of the steel hollow sections, replacing one of the semi-circular disks, while enabling the prestressing

of strands. Figure 3 illustrates the details of the anchor, as well as the raiser frames. A small piece of greased steel strip was placed around each corner to prevent damage to the corners of columns and to allow the strands slide freely during prestressing. Figure 4 illustrates a typical view of the retrofitted column.

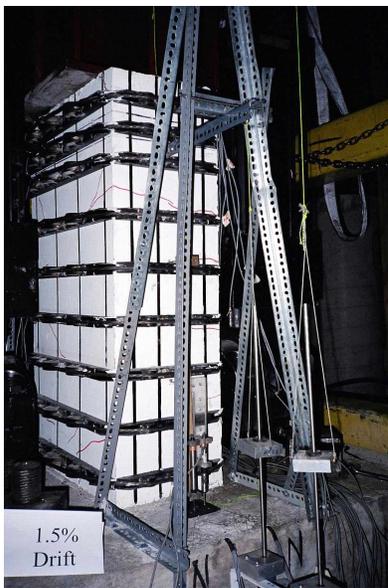
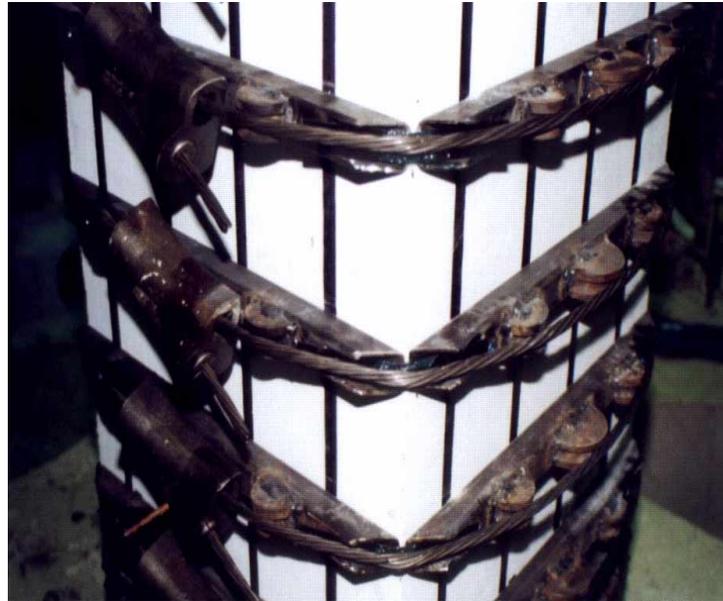
Figure 4 Views of retrofitted column

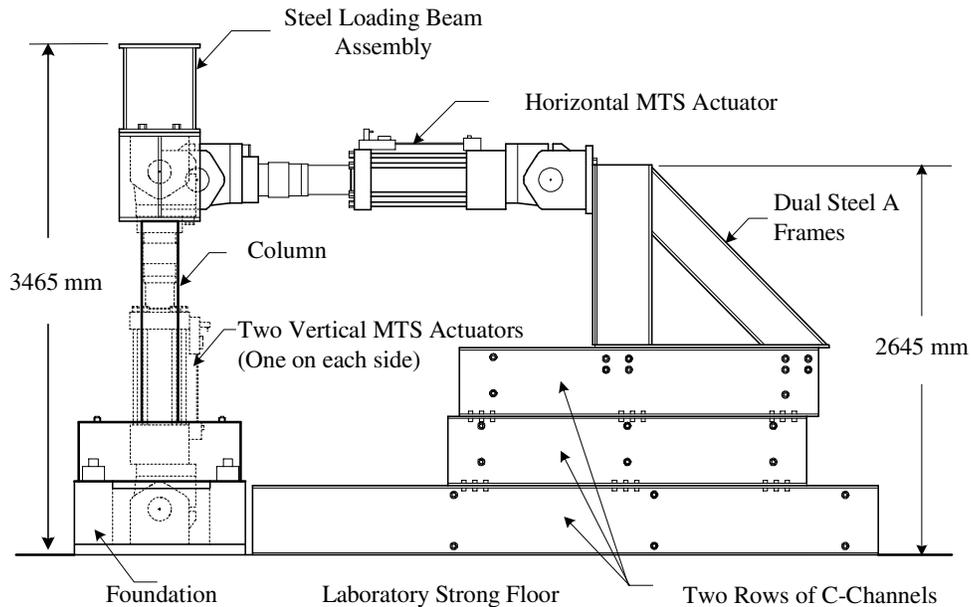
Figure 5 Test setup

The tests were conducted using three computer servo-controlled MTS hydraulic actuators with 1000 kN capacity. The column footing was fixed to the laboratory strong floor by using four high strength bolts. The lateral deformation reversals were applied by a 1000 kN double-acting servo-hydraulic actuator,

connected to a steel loading collar on the top of the column, and operated in deformation controlled mode. Two other actuators were placed vertically on either side of the columns to provide constant axial compression, simulating gravity load. The level of axial compression was equal to 15% of the column concentric capacity, representing a typical gravity load on bridge columns. This corresponded approximately to 693 kN of force per actuator, producing a total force of 1386 kN. Figure 5 illustrates the test set-up.

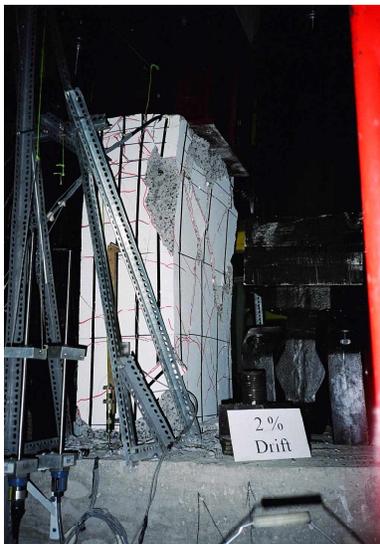
Figure 6 SC-C at 2% drift

The performance of each specimen was monitored during testing. Column SC-C was the control column, which reflected non-seismic design practices in existing bridge columns. Flexural cracks were observed after the first cycle of loading at 0.5% lateral drift on the North and South faces of column, which were perpendicular to the direction of lateral loading. Flexural cracks propagated into the sides in the form of inclined shear cracks during the third cycle of 0.5% drift ratio. When the load was increased to 1% lateral drift ratio, the spalling and crushing of concrete was observed near the base within the bottom 75 mm of column. The previous shear cracks propagated further to column sides, as new cracks have formed. The column reached its peak resistance during the first cycle of 1.5% drift ratio, and further cycling resulted in

strength decay. Moment resistance in the direction of first load excursion (loading towards North) dropped by approximately 25% at the end of the third cycle. This level of strength drop was considered to be significant enough to label the drift capacity to be 1.0 %, since the columns could not sustain three cycles at 1.5% drift level without experiencing less than 20% strength decay. During subsequent deformation cycles the diagonal cracks as well as flexural cracks within the lower 350 mm segment widened. The crack at column-footing interface also widened as the longitudinal bars continued extending within the footing. Figure 6 illustrates the column at the end of test. Experimentally recorded moment-lateral drift hysteretic relationship for the column is shown in Figure 7. The moment values plotted were computed from recorded horizontal forces and the horizontal and vertical components of axial load, including the $P-\Delta$ moment. It is clear from the hysteretic relationship shown in Figure 7 that the column experienced severe strength degradation immediately after the cycles at 1% lateral drift. The moment resistance dropped below 50% of maximum recorded during 2% drift cycles and the test was discontinued. The hysteresis loops show some pinching, signifying shear dominant response. The failure was triggered insufficient transverse reinforcement against diagonal tension.

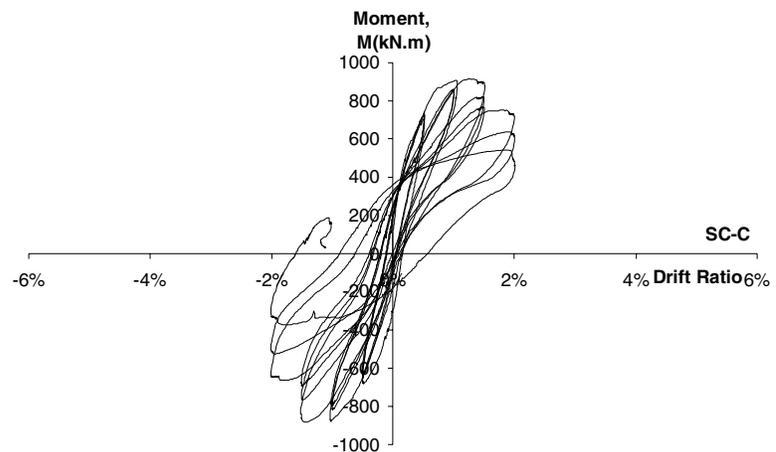
Figure 7 Hysteretic moment-drift relationship for SC-C

When the moment-deformation hysteretic relationships are compared, it can be seen that Column SC-R, with seismic retrofitting was able to sustain about 4 times the lateral drift sustained by the control column SC-C. This is attributed to the improvement in shear resistance. Transverse prestressing counteracted diagonal tension and improved concrete shear resistance by delaying the formation of diagonal cracks. Beyond diagonal cracking, the prestressing continued to control cracking, improving aggregate interlock at higher inelastic deformations and providing additional transverse shear reinforcement. This resulted in a significant overall increase in column shear resistance, changing the mode of mode from shear to flexure. The column then behaved in ductile flexure mode, exhibiting improved deformability. Further improvement in deformability was achieved due to the confinement of compression concrete, which delayed concrete crushing in flexure.

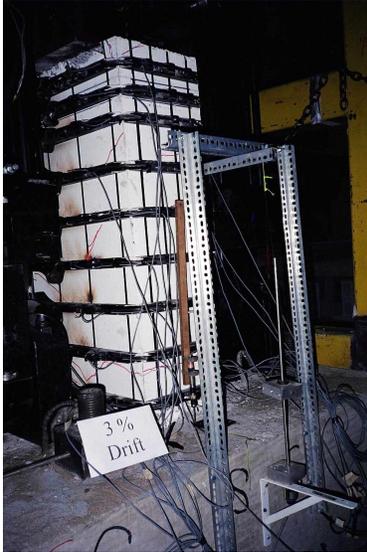
Figure 8 SC-R at 3% drift

Column SC-R was the companion column to SC-C, with identical geometric and material properties. However, this column was retrofitted by external prestressing in transverse direction, as explained earlier. The same loading scheme that was used for the previous column was also used for this column. The first flexural hairline crack was observed during the third cycle at 1%. The number of flexural cracks increased during subsequent cycles of the same deformation level. A crack formed at column-footing interface on the south side during the third cycle at 1% drift. The first set of shear cracks were observed on both side faces, during 2nd cycle of 1.5% drift when the lateral force was at 590 kN. The first cycle at 2% drift resulted in additional hairline flexural cracks on the North and South faces. The crack at column-footing interface widened and became longer during the 2nd cycle at 2% drift. Some crushing of cover concrete was observed near the base during the third cycle of the same deformation level. Increased diagonal shear cracks were observed during 3% drift cycles with widening of one of the cracks. However, the crack was well under control due to external prestressing. The column maintained its strength until 4% lateral drift and experienced some strength decay beyond this deformation level. Figure 8 illustrates the column at the end of 3% drift cycles, with virtually no damage. The hysteretic moment-lateral drift relationship is plotted in Figure 9, showing stable loops until after 4% lateral drift.

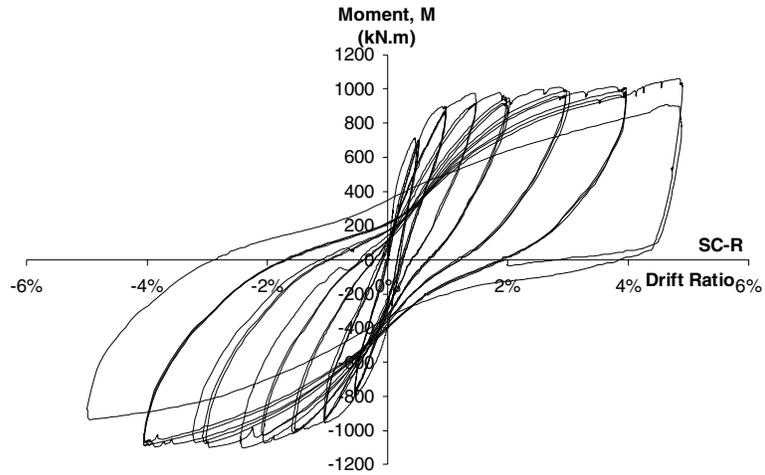
Figure 9 Hysteretic moment-drift relationship for SC-R

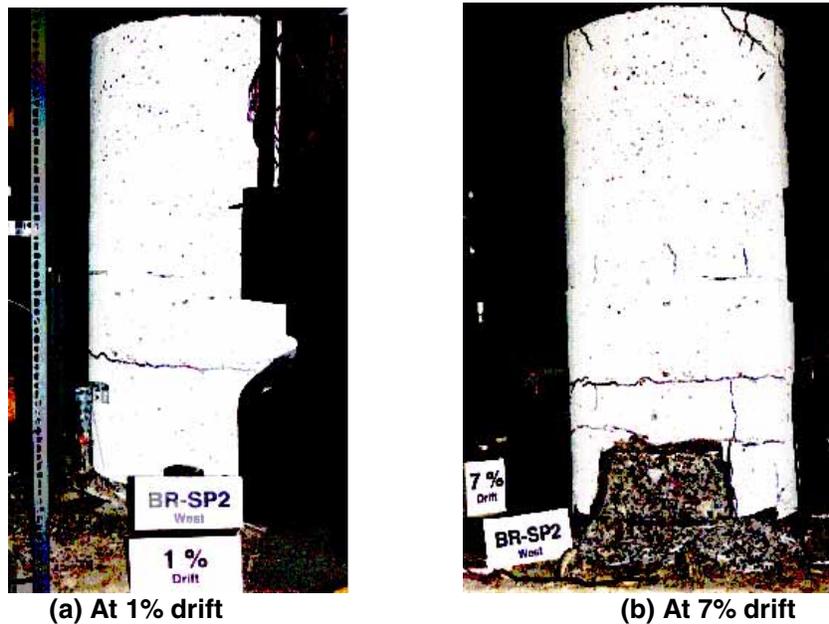
Figure 10 A circular column with protective concrete jacket

Once the retrofit design is completed and applied in the field, the prestressing hardware must be protected against weathering (corrosion) and other external effects. While there may be a variety of techniques to cover the steel hardware, shotcreting is one of the most practical approaches for bridge columns. Fiber-reinforced concrete jacket is another technique that has been tried and tested in laboratory on a circular column [3]. The column was subjected to simulated seismic loading and the jacket was able to maintain its integrity until after 3% lateral drift ratio. It suffered only hairline cracks and survived up to 7% lateral drift with some spalling of the jacket cover near the column base. Figure 10 illustrates the performance of concrete jacket over prestressing hardware at 1% and 7% lateral drift. Another effective technique for protection of prestressing hardware in interior applications may be fire-resistant drywall.
