FULL SCALE ON LINE TEST ON TWO STORY MASONRY BUILDING USING HANDMADE BRICKS

SUMMARY

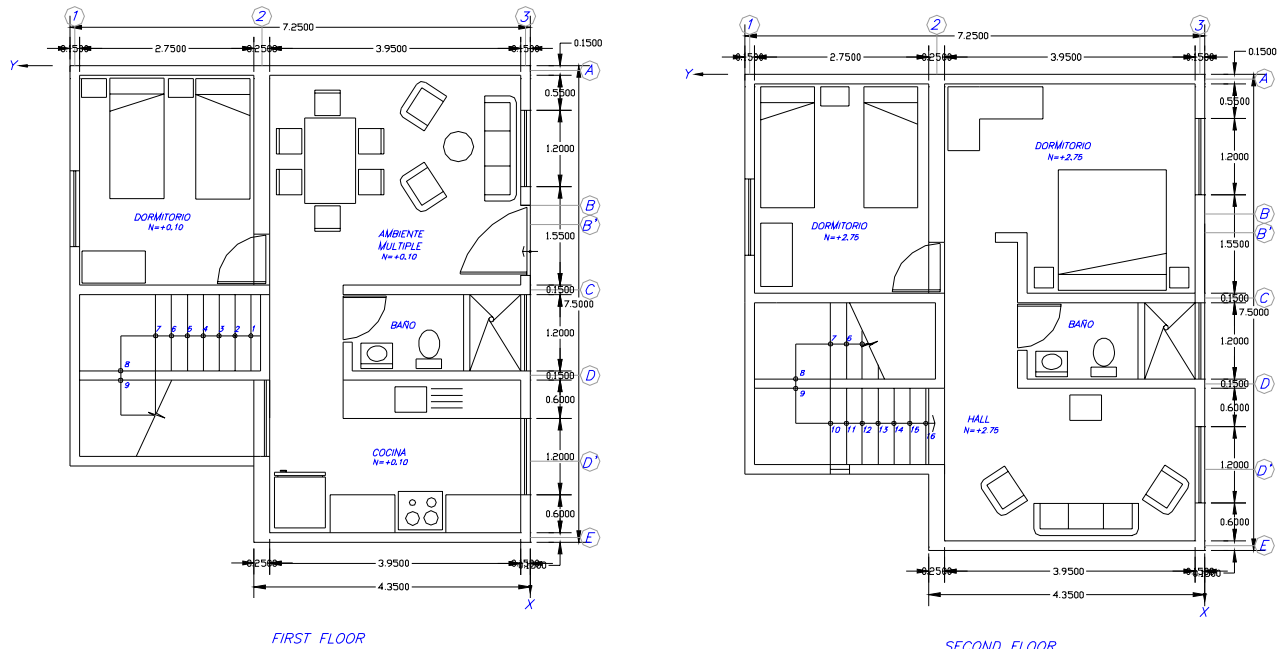
FIGURE 1: Architectural distribution of testing house (←North South→)

Figure 1 presents the architectural drawing of two stories testing building. This house represents a likely used distribution for six family members and have all facilities for living. The house was built using handmade clay bricks taken from a representative sample from common informal sellers in surroundings north Lima’s suburbs. Story height of the house is 2500 mm.. Samples of the material were taken and piles of 4 clay bricks were subjected to compression test for determine the resistance of masonry. Table 2 show the results for the used handmade bricks and also the factory bricks for comparison

The building was designed following the Peruvian earthquake design Standards NT-E030 and the masonry standards NT-E070. Under these standards Table 3 presents the computed design quake demand for the building where design quake acceleration was 267 gals. Table 3 presents the results for the demand of the quake in each of the directions of the building. Test forces application was in direction X-X, which is parallel to the longest length of the building as is presented in Figure 1.

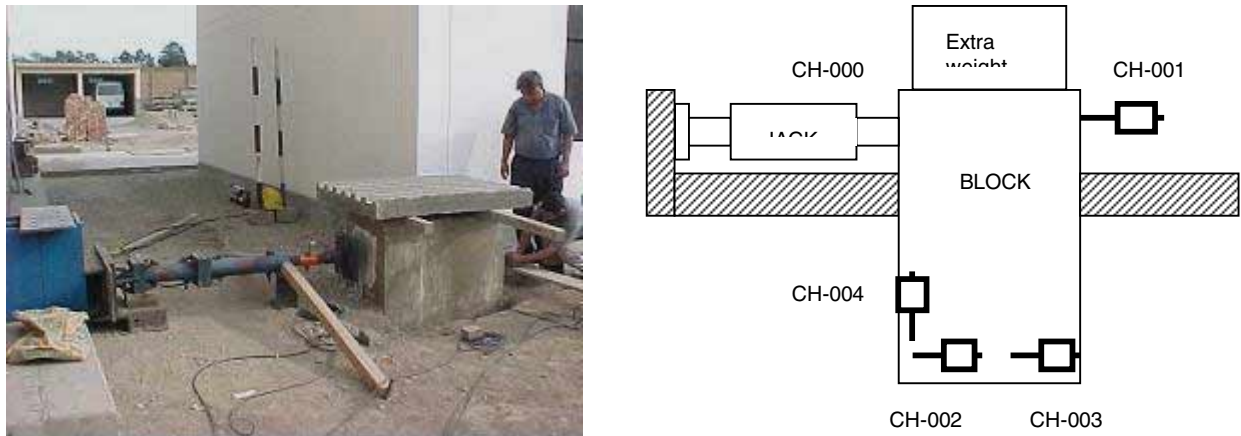
FIGURE 3: Block test

To investigate the friction coefficient between foundation and soil, a block of 100 cm length and 60 cm. width was build in a position beside the house as is presented in Figure 3. The block weight is 2500 kg. and extra weight of 350 kg. was set. The total height of the block is 170cm. which consider the top side to apply the jack.

The load was applied with a 20 t. Static Jack and 4 displacement transducers were set according with Figure 3. Ch-000 is the load channel and Ch-001 to Ch-004 corresponds to displacement channels.

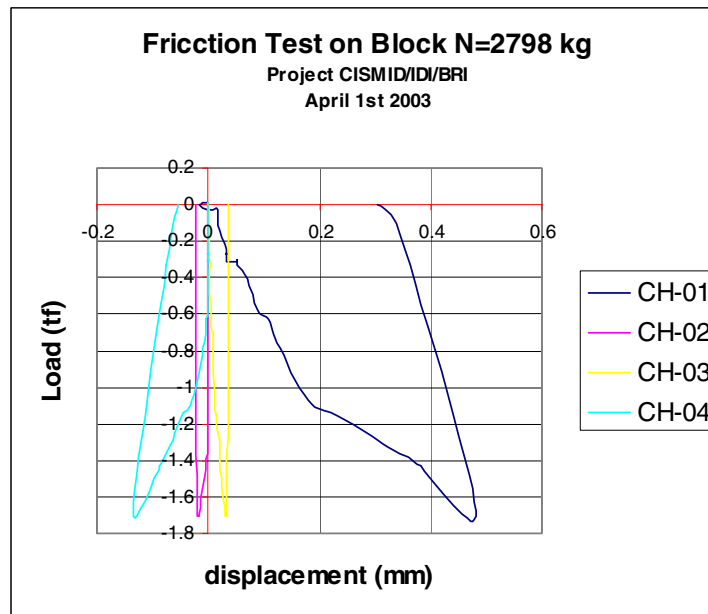
FIGURE 5: Load – displacements on block

If the behavior of channel 4 is observed, for a load of 1.073 t. the block started to move vertically as is shown in Figure 5. Therefore the static friction coefficient is computed as the ratio between the start load and the normal load. Then friction coefficient is $\mu_s = 1.073/2.798 = 0.3834$.

If the normal load of the masonry house including the footing is 175 t., the load to produce the lift of the building is $V_{max} = \mu \times 175 = 67.1$ t. as a base shear. According with the analysis presented above maximum shear load of 54.6 t. is demand for the design quake. However the resistance of the building is 61.82 t.

After the block investigation is possible to assure a threshold load of 67 t as a base shear will not produce displacement or lift on the building. After this threshold value, a correction in the lateral displacement should be performing in order to have the real behavior of the house without influence of the footing displacement.

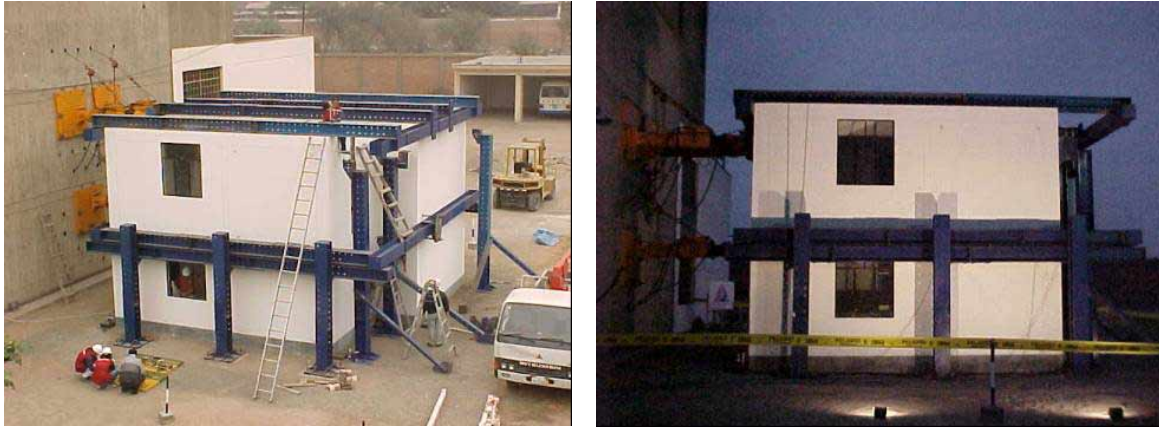
FIGURE 6: Test setup of the testing house

In order to develop a cyclic test on the full scale confined masonry house, the procedure proposed by the standard ASTM E564-00e1 Standard Practice for Static Load Test for Shear Resistance of Framed Walls for Buildings have been adapted for this experiment. Considering the possibility of torsion on the house and mitigation the problems for the loading on the experiment using an external support structure as shows in Figure 6.

To develop the test, three actuators of 25 t. of capacity were used. Two actuators on the second floor and one actuator on the first floor were in position to push and pull the full-scale specimen. The actuators were working under a mix control; this is one actuator on the second floor under displacement control (let's name it command actuator) and the others two actuators under load control using the signal from the command actuator. All the actuators work under a stroke range of 200 mm. A computer through a servopulser controlled the actuators. Signal conditioner was used for the acquisition of the signals of each sensor. A set of 45 sensors were set and two measuring systems were used: first a signal conditioner with 16 channels and UCAM 5BT static measuring system using 29 channels.

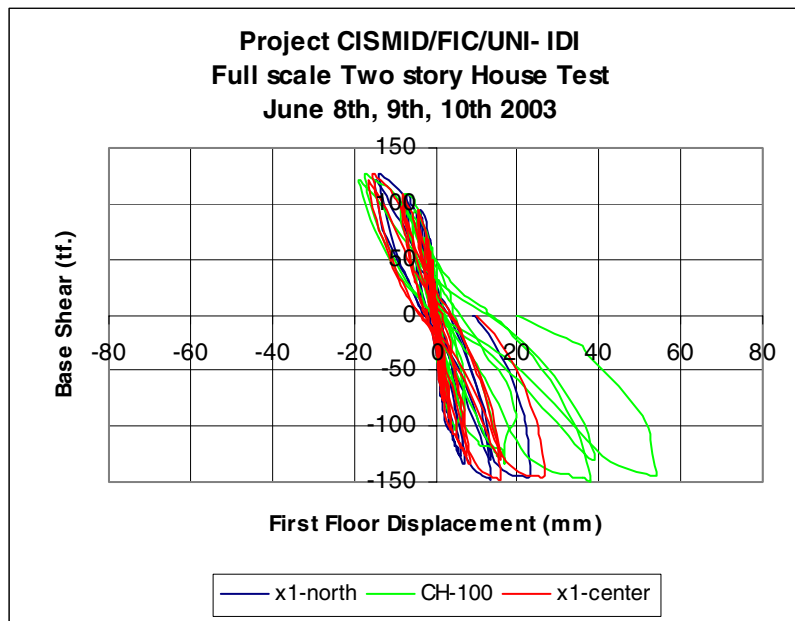
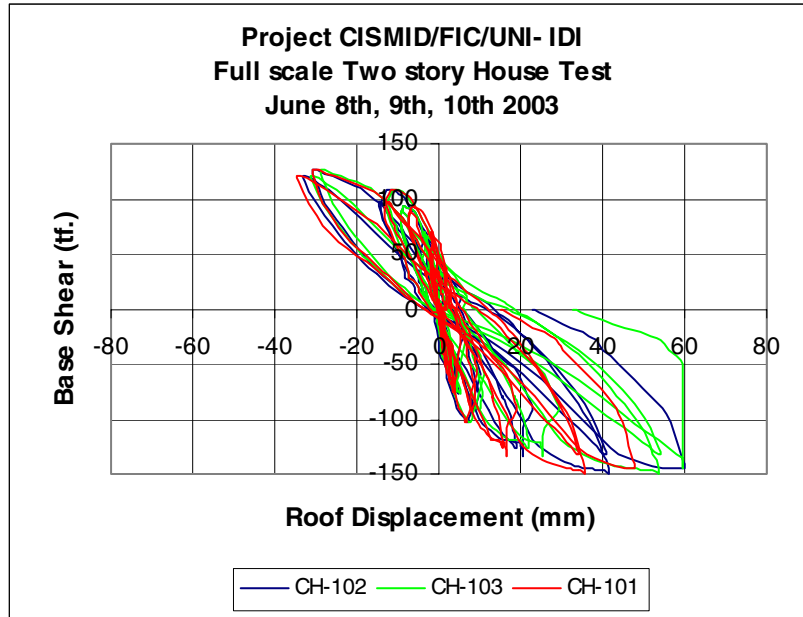
FIGURE 7: First Floor displacement versus Base shear

FIGURE 8: First floor displacement history

Figure 7 and Figure 8 shows displacement - shear relations on the first and second floors. Here each of the sensors is related with the main axis for walls in the direction of the test. It is possible to read that small torsion is induced because there are difference between each of the sensors on this direction. This is confirmed in Figure 9 where measure rotation is presented. The rotation angle on the top floor has maximum value of 0.0035 radians that was reached for the maximum drift

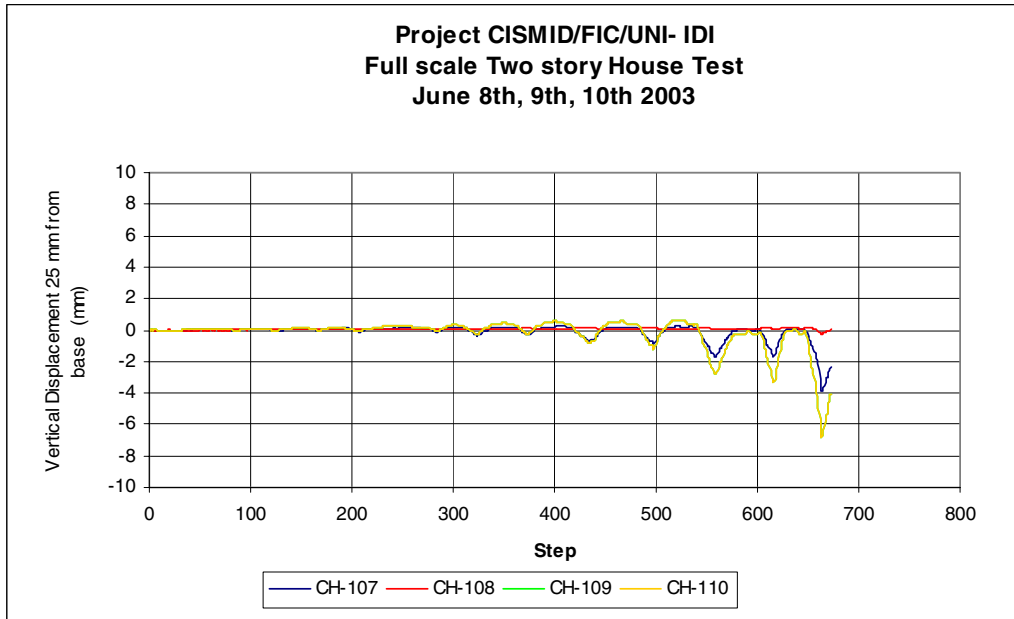
FIGURE 10: Vertical displacement at level 25 mm. from basement

Figure 10 presents the vertical displacement at level 25 mm. from basement. By observation of Figure 10 is possible to read that after step 250, the base shear of the house reach the friction resistance value and the lateral displacement will include the displacement of the basement due to resistance of soil is overpassed. Therefore, a correction on the displacement was performed on the curves presented in Figure 7 and 8. The results of the test after this correction are presented in Figure 11 and 12.

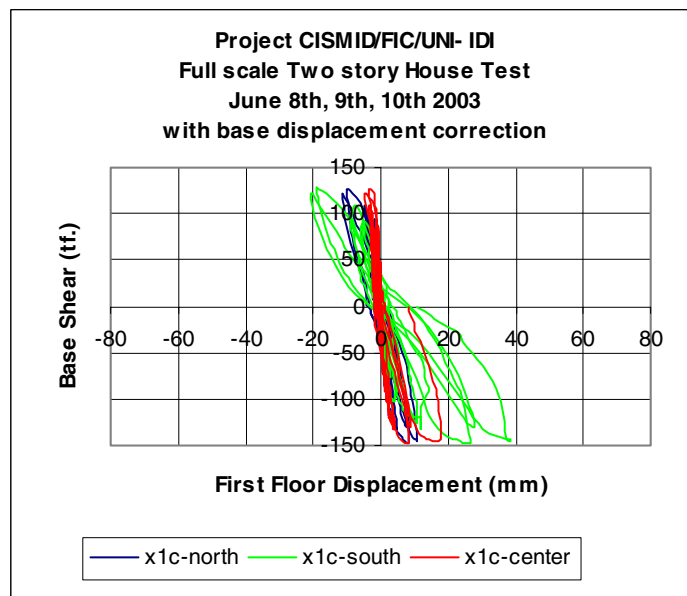
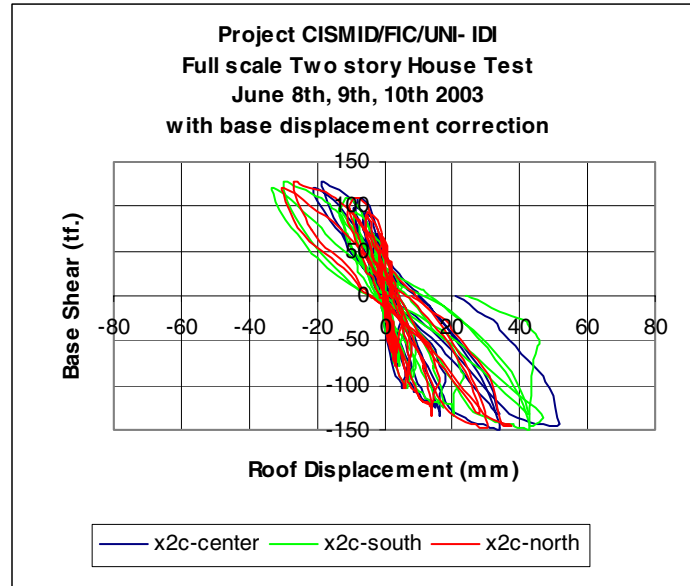
FIGURE 11: First Floor displacement versus base shear with base displacement correction

FIGURE 12: Second floor load - displacement corrected

Using the peak values for each of the applied loading cycles of Figure 11 and Figure 12, the behavior curves of each floor is built. Figure 13 and Figure 14 presents the behavior curves for first and second floor respectively. It is possible to read from Figure 13; Then, the displacement of the central part of the structure became smaller than the south and north sides. However the south side have bigger displacement because the torsion effect (irregularity in plan of the structure). Then the building has more displacement in the south side than in the north one, as is expected. A maximum drift of 1/140 in the south side was reach on the first floor and 1/250 on north side when actuator pulls the specimen. By the other side when actuator push the specimen maximum drift of 1/65 and 1/250 was reach for south and north sides

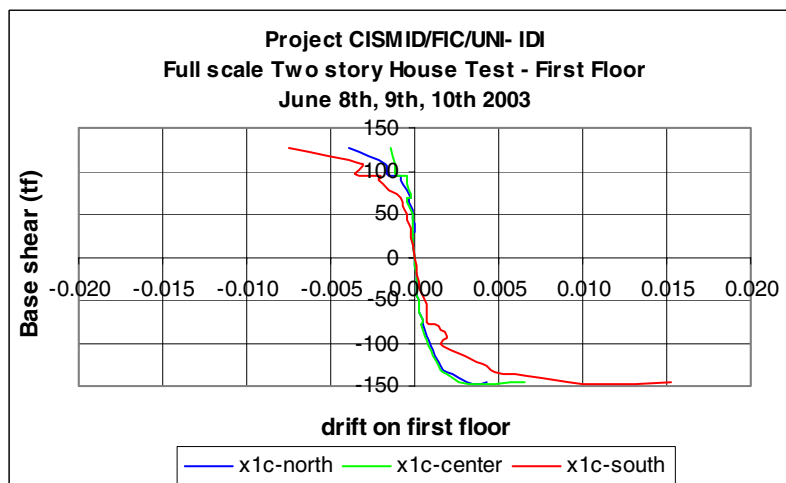
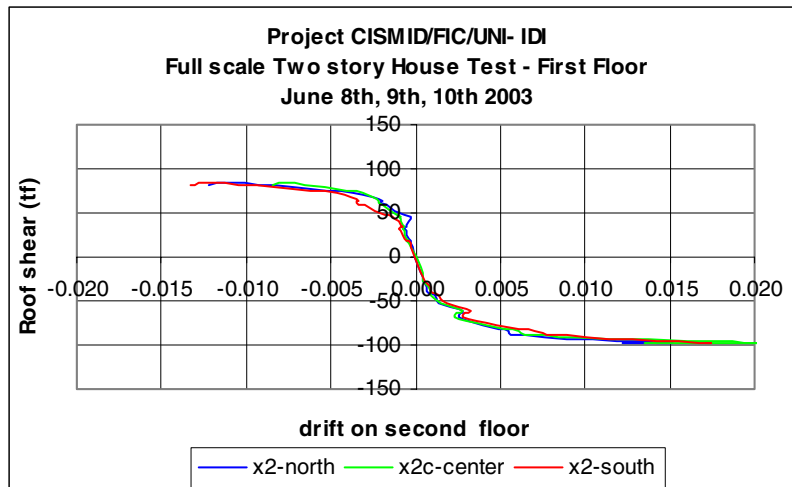
FIGURE 13: Behavior curve on first floor

FIGURE 14: Behavior curve on second floor

- Behavior curves are presented in Figure 13 and Figure 14 for first and second floor of the building. Here it is possible to read how the displacement in the south side of the specimen is bigger than the displacement of north side. Is obvious influence of the torsion effect was verified in Figure 9 where rotation on roof was reported. Then specimen rotates to the south side because north side has bigger stiffness than the south side.

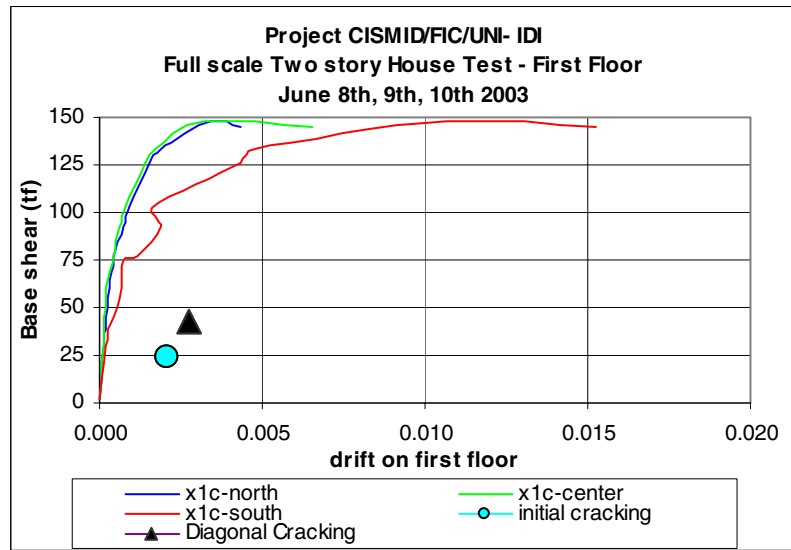
Figure 15: Design require demand points and cyclic behavior on full scale house

- Considering that the actuator pushing behavior curve represents the performance of the structural system, the required demand for severe quake and the required demand for moderate quake is

presented in Figure 15. Considering the diagnosis by capacity design values from Table 4 and 5 we found the values of the standards are in a safety range.

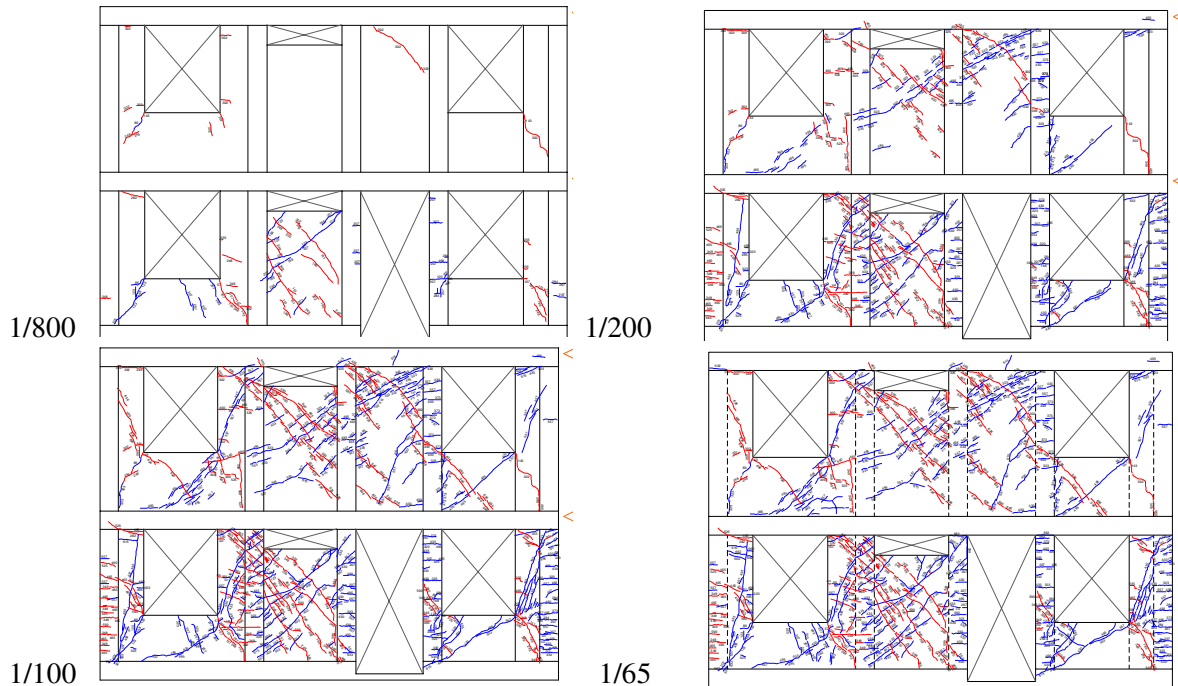
FIGURE 16: Crack Pattern during test

- Cracking pattern performed during the test is presented in [5]. Figure 16 shows some cracking patterns in south wing of the building. Here its is possible to understand the meaning of each of the drift values and verify that with 1/200 value the structure could be repair even a considerable cracking appears on walls.

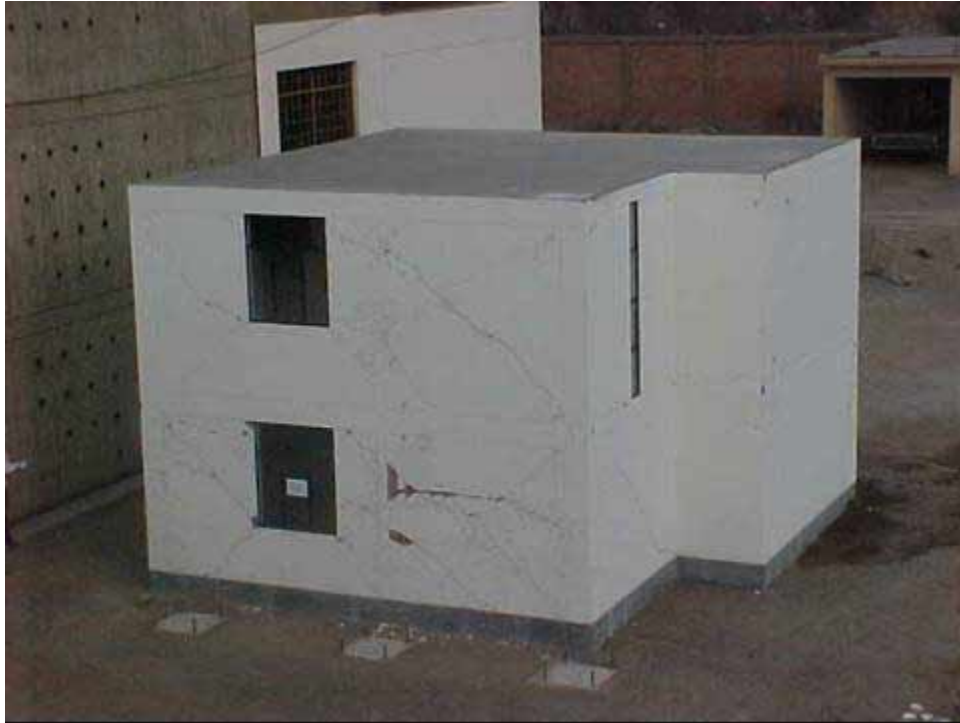
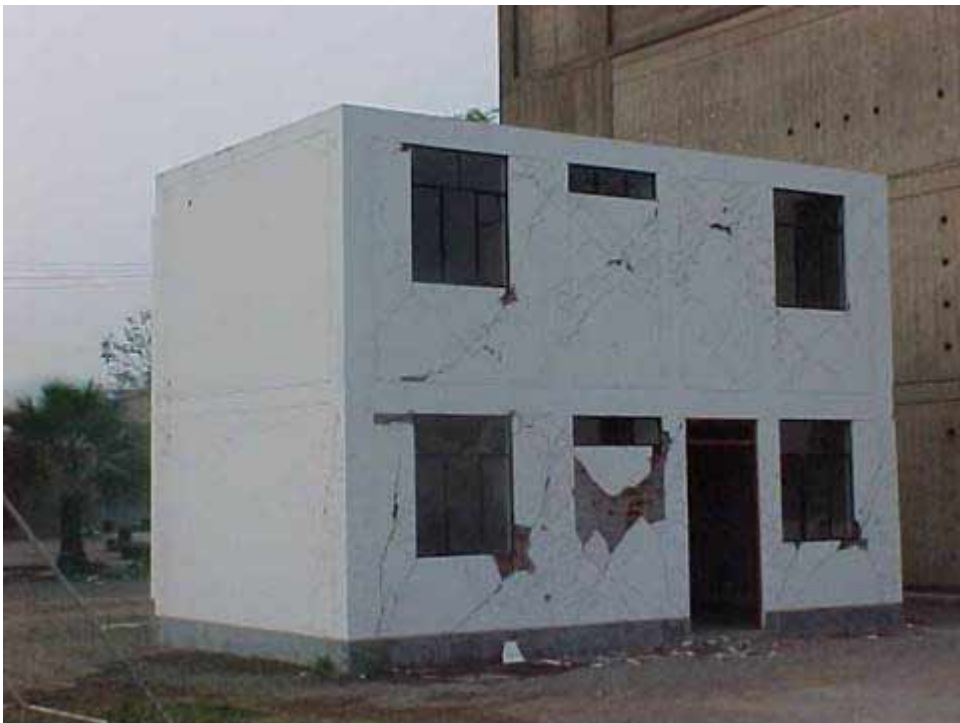
FIGURE 17: North wing of the house in final state

FIGURE 18: South wing of the house in final state

- Figure 17 and Figure 18 shows the final state of the house in north and south wings of the house. It can be seen that at final stage some parts of the covering surface falled down and cracks has been open from face to face on the falls.
