SEISMIC BEHAVIOR AND REHABILITATION ALTERNATIVES FOR ADOBE AND RAMMED EARTH BUILDINGS

Luis E. YAMIN¹, Camilo A. PHILLIPS², Juan C. REYES^{3*}, Daniel M. Ruiz²

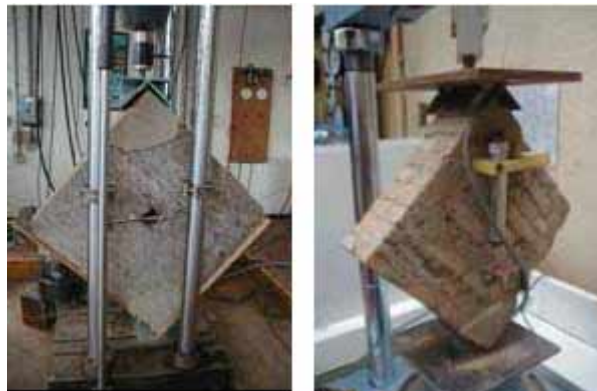
A general characterization was carried out of the mechanical properties of the materials used in earth constructions concerning weight and strength according to the different stress solicitations. In the first stage of the experimental phase characterization tests were developed (compression, diagonal tension, flexure, etc.) to determine the properties relating the mechanical behavior of adobe and rammed earth walls. In addition, reduced scale tests were made to verify that corresponding properties were similar to those resulting from real scale tests. Figure 1 shows photographs diagonal tension tests on real scale and reduced scale (1:5) wallettes.

Figure 1.
Diagonal tension test on real scale (left), and reduced scale wallettes (right).

From the results obtained in the characterization tests it was observed that the main mechanical properties of the materials do not change considerably with the scale of test, except for the cases where self weight of the sample affects the results. It is clear that in these cases the strengths measured in reduced scale models shall give larger values compared with the corresponding real scale parameters.

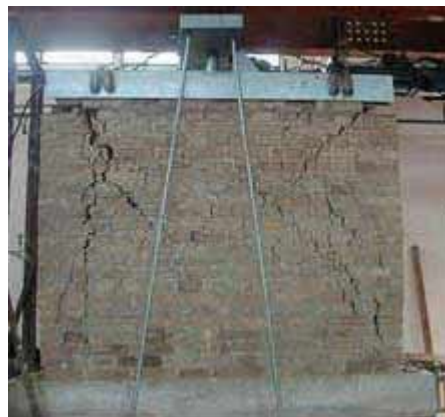
In-plane tests were developed on full scale walls applying cyclic loading on the upper part of the specimen (Figure 2). These tests allow estimating the in-plane properties of the walls under cyclic loading, such as initial rigidity and degradation of the rigidity with horizontal deformation, maximum horizontal capacity for different levels of vertical loading, ductility, residual shearing strength after first failure and an estimate of energy dissipation and damping capacities. A total of six (6) cyclical in-plane loading tests were performed on adobe and rammed earth walls with different levels of vertical loading. The vertical loads applied correspond to typical load acting on bearing walls for one and two story buildings.

Figure 2.
In-plane cyclic loading Test

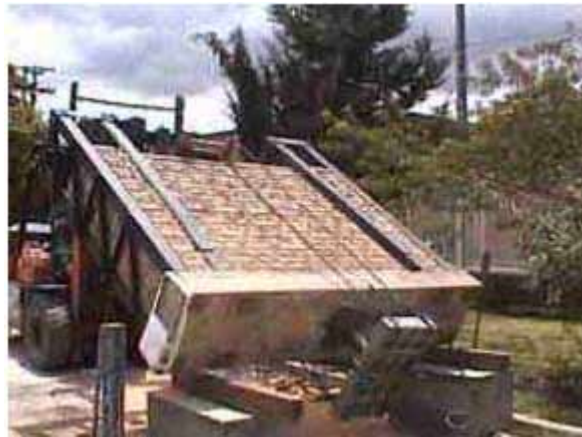
Most of the failures related to adobe and rammed earth buildings have been caused by a combination of shearing stresses in the wall plane and bending stresses perpendicular to the wall under seismic action. To determine the out-of-plane flexural capacity of real scale wall, overturning tests were developed. In those

tests an increasing load perpendicular to the wall is applied by a progressive inclination of the sample maintaining a constant vertical load over the wall. To simulate the effect generated by the walls in the orthogonal direction of the tested wall, reduced walls of the same materials were constructed on each side of the tested wall. Figure 3 shows a photograph of general setup of out-of-plane loading test.

*Figure 3.
Loading test perpendicular to the plane*

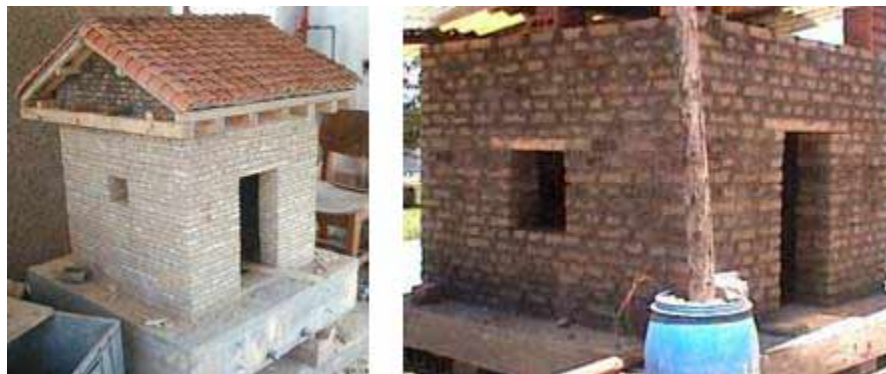
In order to study the simultaneous effect of in-plane and out-of-plane cyclic action, two adobe reduced scale modules were constructed (1:5 and 1:1.5 scales). The 1:5 scale model (Figure 4) was subjected to a shaking table test by using a seismic record characteristic of an earthquake corresponding to Colombia's central region. During the test the maximum acceleration was gradually increased until failure. In addition, the 1:1.5 scale model was tested by means of an applied cyclic load at roof level simulating inertial effects generated over the bearing walls.

*Figure 4.
1:5 scale models tested on shaking table and 1:1.5 scale models tested with applied cyclical loading*

From the results obtained in the wallettes, reduced scale and full scale wall tests it can be concluded that buildings constructed with traditional techniques present low capacity to resist stresses and deformation imposed by seismic events, and therefore these constructions are classified in general as highly vulnerable.

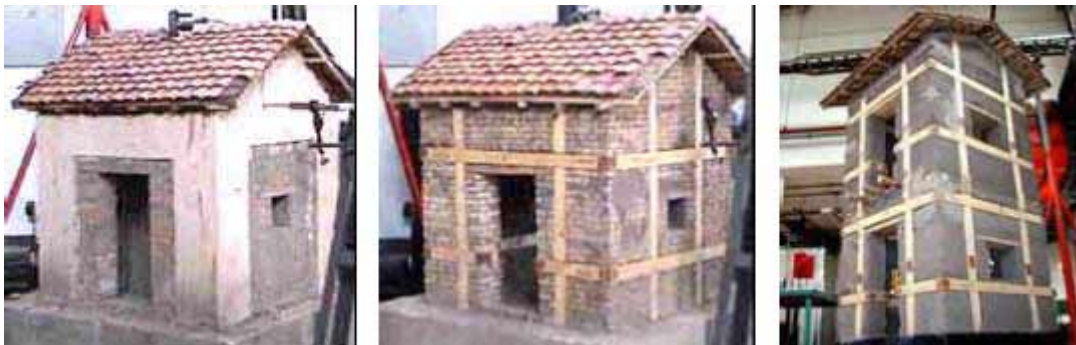
In order to study the dynamic behavior of the rehabilitation alternatives proposed, three (3) reduced scale (1:5) models were built and retrofitted to be tested in the shaking table. The first one correspond to a one story adobe model reinforced with wire mesh, the second model was built like the first one but reinforced with boundary wooden elements and the last one correspond to a two story rammed earth model reinforced with rammed earth model reinforced with boundary wooden elements. Figure 8 shows photographs of the three 1:5 scale models tested on shaking table.

*Figure 8.
Reinforced models tested on vibratory table*

For the model reinforced with wire mesh and lime mortar, although it exhibited a more ductile behavior as compared with the equivalent unreinforced model, a separation between the reinforcement elements and the original the original wall was clearly observed, generating general cracking of the walls and affecting the general stability of the structure.

On the other hand, the one and two story models reinforced with boundary wooden elements exhibited a more ductile behavior and a better resistance to the earthquake input. Although failure was attained at certain acceleration level, a much higher number of cycles of greater intensity were needed to produce collapse.

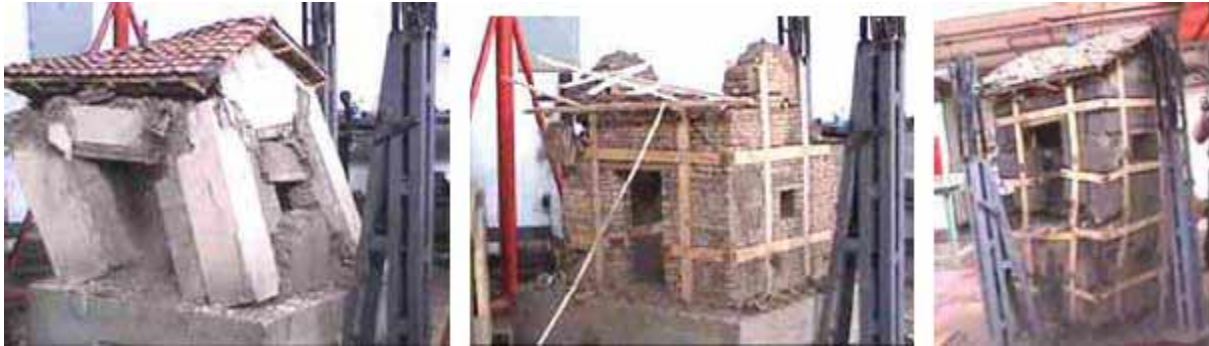
Figure 9 shows photographs of the collapse suffered by the three reinforced 1:5 scale models. In general, a better behavior of the boundary wooden elements rehabilitation alternative was observed in the scale models.

Figure 9.
Failure- mechanism for 1:5 scale models tested on
