Fire Following Earthquake – Flex Hose

Summary

This paper describes the use of Flex Hose for use by water and fire departments to address the Fire Following Earthquake issue.

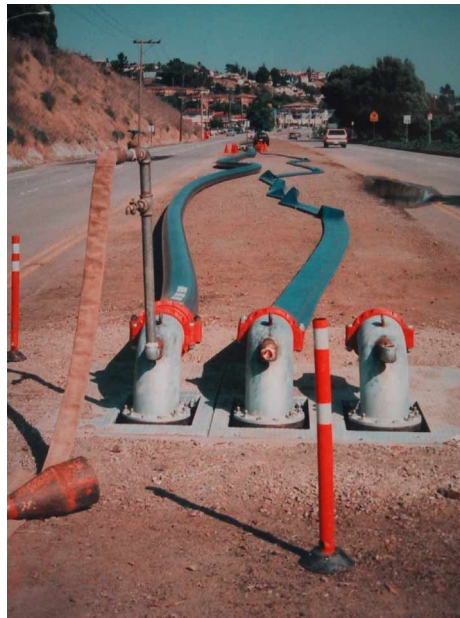
Figure 2 shows the actual deployment of above ground flexible hoses uses to bypass a 24" diameter pipeline that crosses the Hayward fault. In the foreground of this figure are three pipe elbows. Attached to the elbow on the left is a 12" diameter blue-colored "super aqueduct" hose manufactured by Angus. We call this 12" ultra large diameter hose, ULDH, in distinction to 5" large diameter hose, LDH, commonly used by fire departments. Attached to the middle elbow is another hose, but unpressurized. The third elbow is currently shown with no attached hose. The original 24" diameter steel pipeline is located in the road to the left of the hoses. The Hayward fault traverses across this street, a few hundred feet away from the elbows seen in the foreground. A similar set of three elbows is located at the other side of the fault, about 900 feet from the elbows seen in the foreground.

Figure 2. Flex Hose Deployment in EBMUD System

directly to the screwed 4.5" diameter pumper outlet fitting on the hydrant. The small pipe outlets seen in Figures 2 to 4 provide an easy way to empty water from the large diameter flex hose when it is time to roll it up; and also to flush the hose should that be necessary.

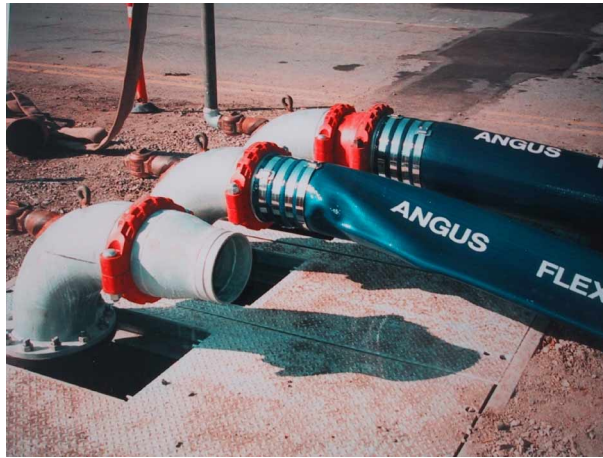
Figure 3 shows the same three elbows seen in the foreground of Figure 2, from a side view. The hose is attached to the elbows using victaulic couplings. The three elbows are in turn connected to a buried 12" diameter pipe which laterals off the main 24" diameter

transmission backbone pipe. The street repair (new pavement) seen in Figure 3 shows where the new 12" lateral has been installed.

Figure 3. Flex Hose Deployment in EBMUD System

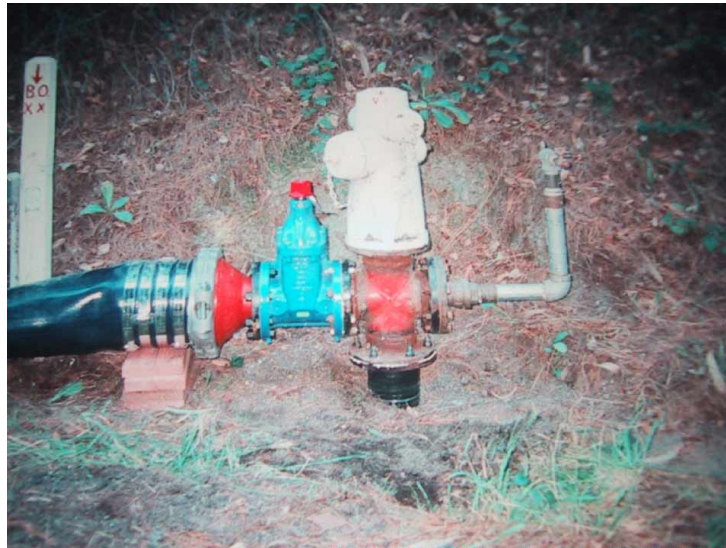
Large diameter flex hoses can also be hooked up to fire hydrants, as for example in Figure 4. The hose is attached to a special fitting placed under the hydrant, in order to accommodate the change in diameter. A different fitting could be used to attach the hose

Figure 4. Flex Hose Attachment To Fire Hydrant

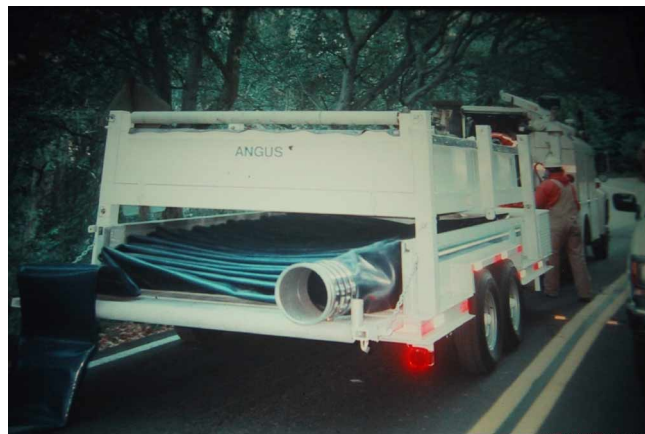
Figure 5 shows a "flaking" truck being hauled by a heavy pickup truck. The large diameter hose (up to 600 foot length) is stored in the flaking box, and then driven to the site, and then deployed. Figure 6 shows a "hose reel" as an alternative way to store and deploy large diameter hose (in practice, the storage of hose in flaking boxes, Figure 5, might be most cost effective).

Figure 5. Deployment of Flex Hose

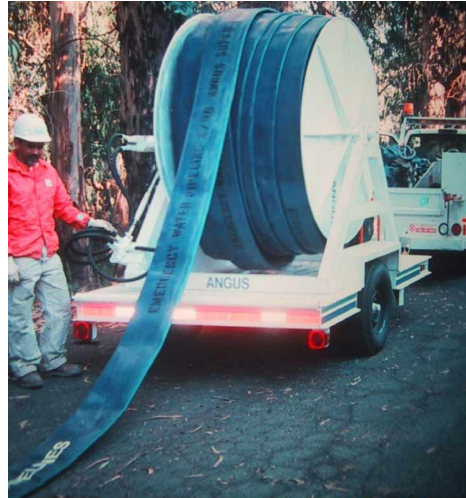
Figure 6. Alternate Deployment of Flex Hose

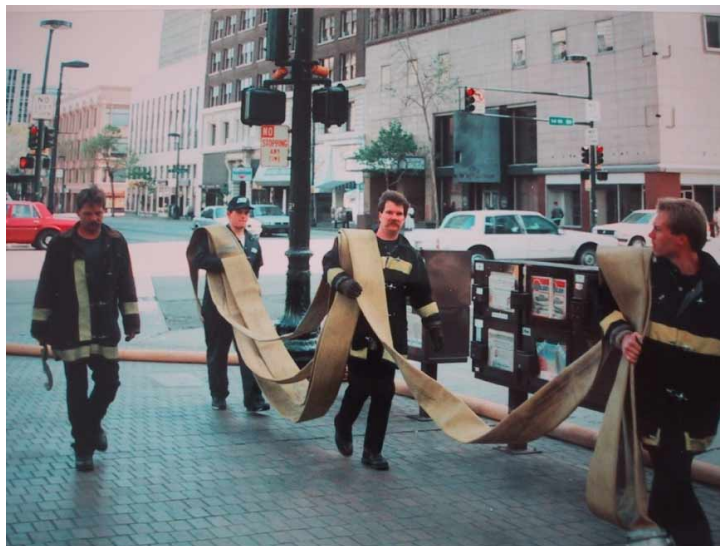
Depending upon the length of hazard to be bypassed, and the required flow rates, it will sometimes be feasible to use large diameter (5" to 6") above ground flex hose to do, more-or-less, the same function as the 12" ultra large diameter flex hose. Fire departments are well versed with the use of large diameter flex hose. Figure 7 shows just one such deployment.

Figure 7. Deployment of Large Diameter Flex Hose

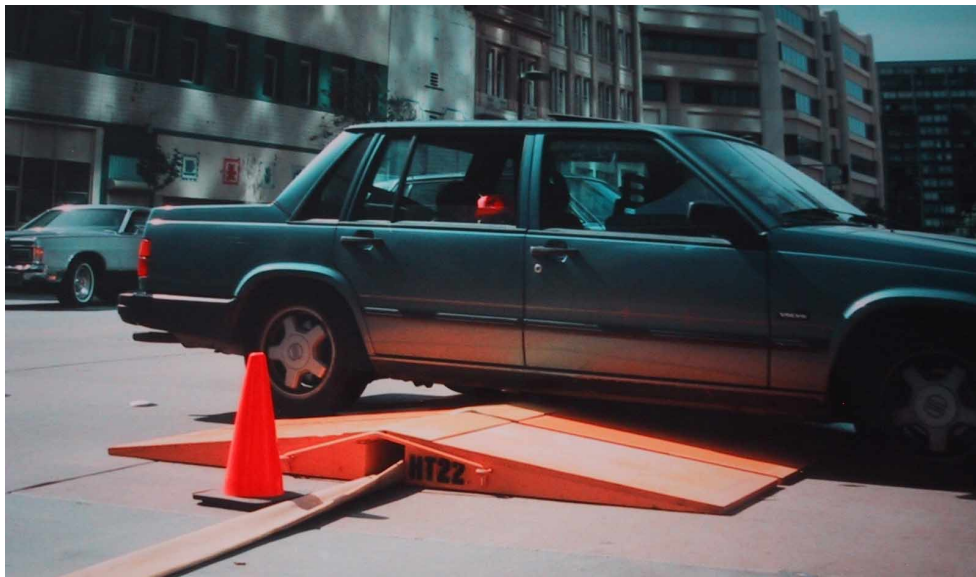
When using 5" diameter flex hose, it might be feasible to also install ramps to allow traffic to go over the hose. One such example is seen in Figure 8. These ramps will require additional time / manpower to set up the hose. Even with these ramps, there is no guarantee that vehicles will use them – as was evidenced when a taxicab got stuck on a 5" hose.

Figure 8. Use of Ramp Over A 5" Diameter Flex Hose
