EFFECTIVE SYSTEM FOR SEISMIC REINFORCEMENT OF ADOBE HOUSES

SUMMARY

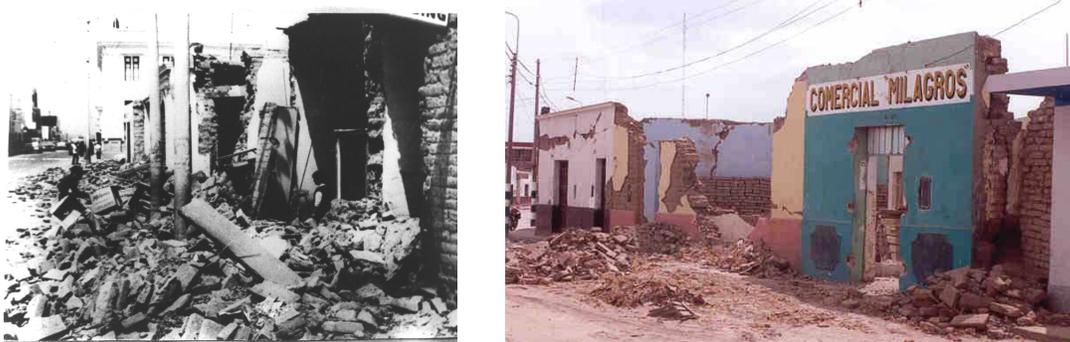
Fig.1. Collapse of traditional adobe houses due to severe earthquakes in Peru.

goal was to find a way to prevent the sudden collapse of traditional adobe houses during earthquakes, which usually cause human casualties and loss of properties (fig. 1). The main objective was to provide the adobe house with the enough seismic resistance, so that the habitants could get out before it collapsed.

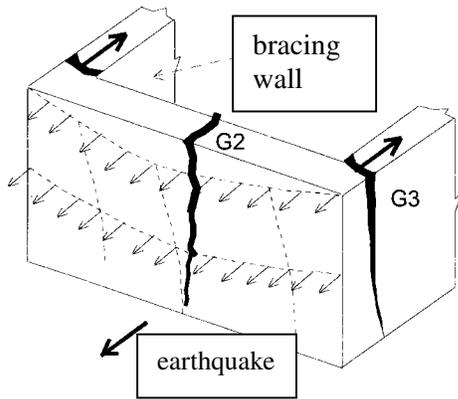
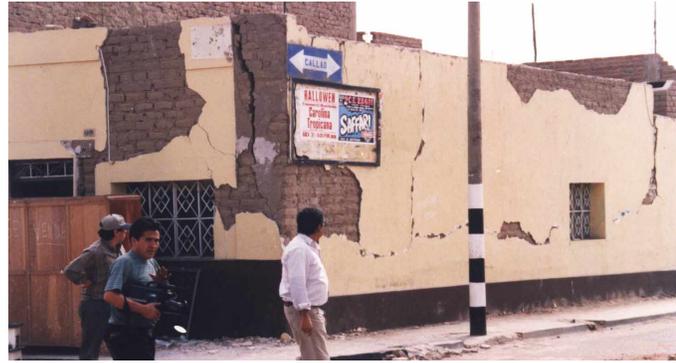
Fig. 2. Typical cracks on adobe houses due to out-of-plane seismic forces.

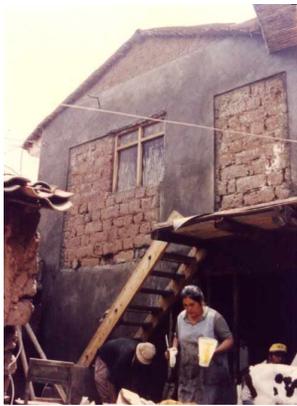
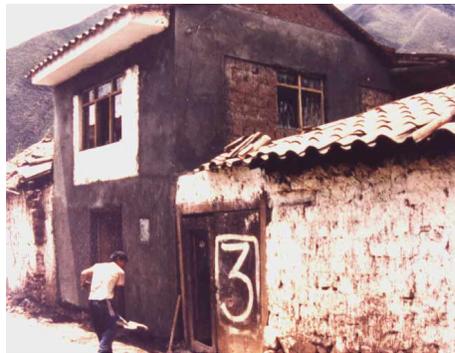
Fig. 4. Reinforcement for existing 2-story houses.

The seismic forces increase with the amount of stories, therefore, in case of two-story houses, it is necessary to put the wire mesh over the whole surface of the first-story walls, and use strips of wire mesh for the second story walls, as shown in fig. 4.

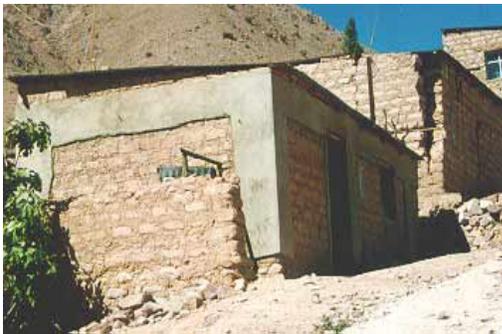
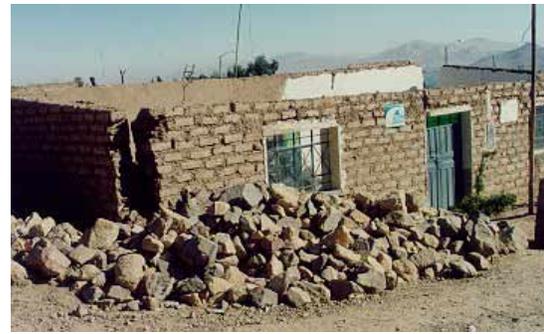
Fig.5. Reinforced house and unreinforced neighbor houses after the 2001 earthquake.

The earthquake of June 23, 2001 (Mw=8.4) caused important damages, especially at traditional adobe constructions located in the south of Peru (Arequipa, Moquegua, Tacna). However, the 6 houses that were reinforced with the system proposed in this paper: three at Moquegua, two at Tacna and one in Arica (Chile), withstand the earthquake and the aftershocks without any damage, while neighbor houses had severe damage or collapsed (fig. 5), see Zegarra *et. al.* (2002) [6].

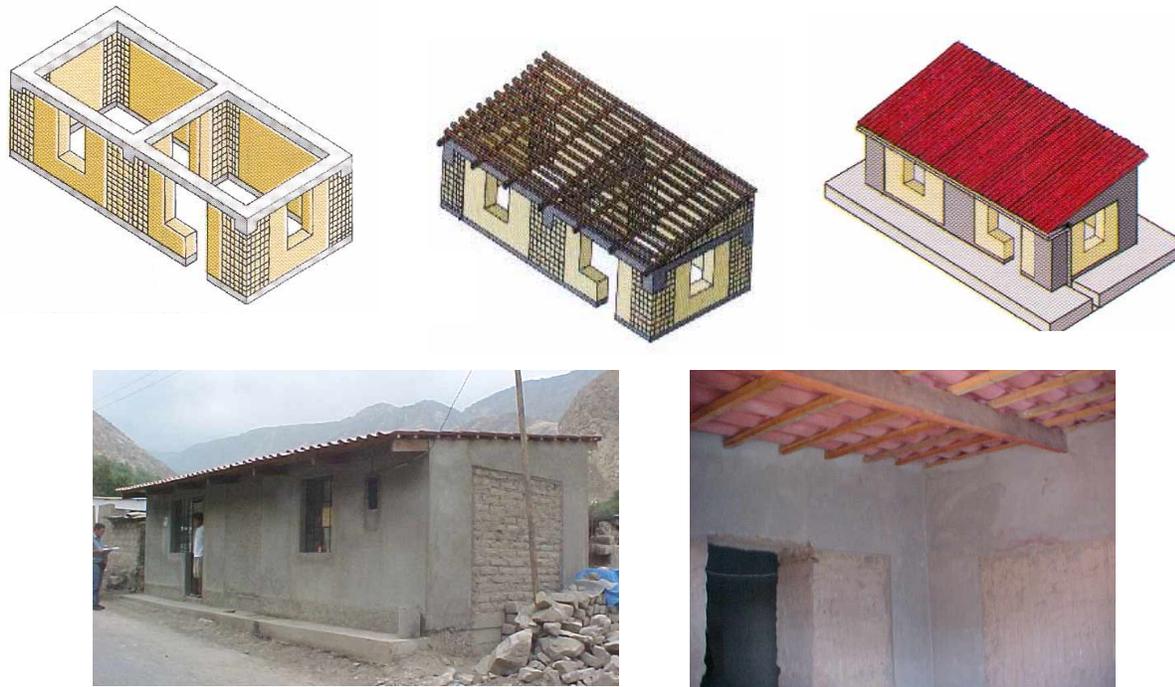
Fig. 6. Views of the new reinforced houses built in Arequipa.

The basic module architecture is shown in fig. 6, in which the vertical strips of wire mesh covered with mortar may be appreciated. The module was conceived in such a way that could be adapted to different areas and that future modules for expansion could be added by duplicating this basic module.

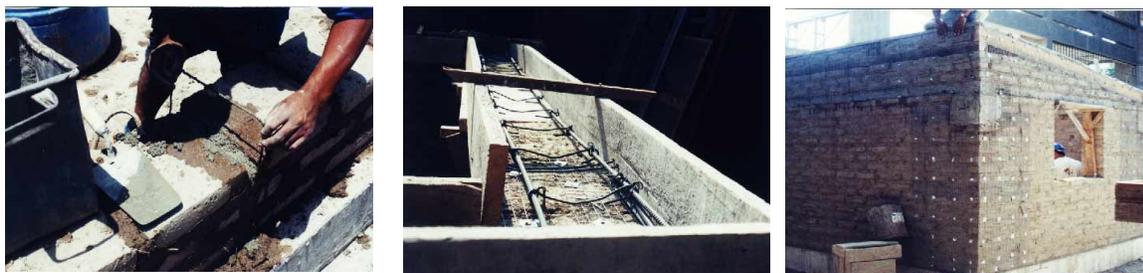
Fig. 7. Some structural improvements in the new adobe houses: wire connector in joint (left), collar beam (middle), and shear key (right).

Some of the structural improvements, designed at PUCP, are indicated in fig. 7, and include the following: 1) use of plain concrete for the foundation; 2) the construction procedure, like the wetting of the adobe units before placement, the use of a marked stick to control the 2 cm joint width, the installation of the connector at the vertical joints covered with cement mortar; and, 3) the collar beam of poor concrete ($f'_c=10$ MPa), used as lintel in doors and windows, reinforced with two #3 bars.

At the end of the collar beam, at the intersection with an orthogonal wall, a plain concrete shear key was included to avoid sliding of the beam during seismic movements. The purpose of this beam is to connect the walls, and in case the collapse of the unreinforced part of the walls occurs, this beam can still carry the roof weight, supported on the corners of the house that have wire mesh reinforcement.

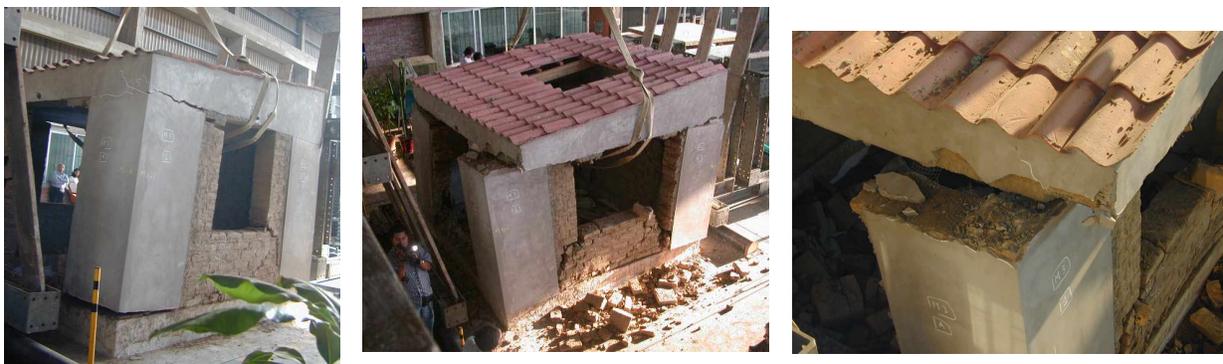
Fig. 8. Behavior of the module during the catastrophic earthquake simulation test (left), after the test (middle), and failure of the plain concrete shear key (right).

The module withstand without any damage the mild earthquake, with unimportant damage the moderate earthquake, and with moderate damage the severe earthquake. Only for the catastrophic earthquake the module nearly reached collapse, generated by the shear friction failure of the plain concrete key located at the upper corners.

A conclusion driven from this test was that the seismic behavior of the proposed system for reinforced adobe houses could be still improved, in order to withstand even catastrophic earthquakes. The new features could include vertical dowels to connect the foundation with the wire mesh strips, reducing the rocking observed, and on the other hand, reinforcing the upper key with vertical dowels, to control the shear friction failure observed (fig. 8).

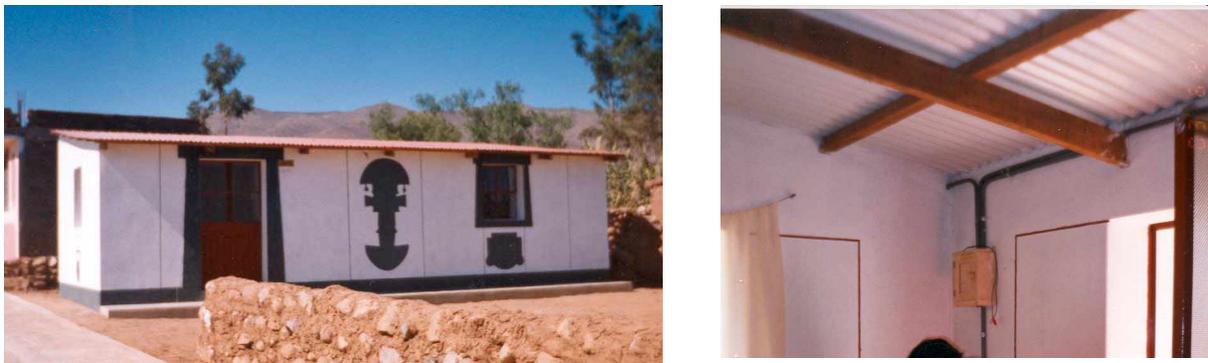
Fig. 9. New adobe house built by PNUD-SENCICO.

In this program, almost 100 adobe houses have been constructed, following the module plans initially developed by the COPASA-SENCICO-PUCP team. Most of these houses have the roof with a single slope, and only a few have a two-sloped roof. The roof cover is of metal sheets. In fig. 9 some of the houses of this project are shown, in which it can be observed the correct location of the visible electrical installations by the outer side of walls and roof, in order to keep the structure intact.
