## **COLLAPSE MECHANISMS OF MASONRY BUILDINGS DERIVED BY THE DISTINCT ELEMENT METHOD**

### **SUMMARY**

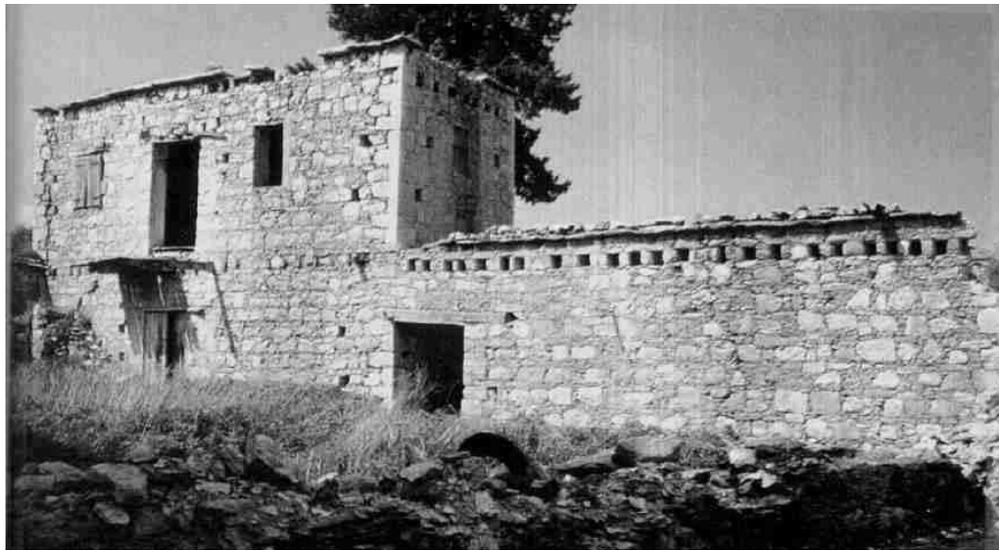
**Figure 6.** Photograph of the two-story house at 'Neo Chorio'.

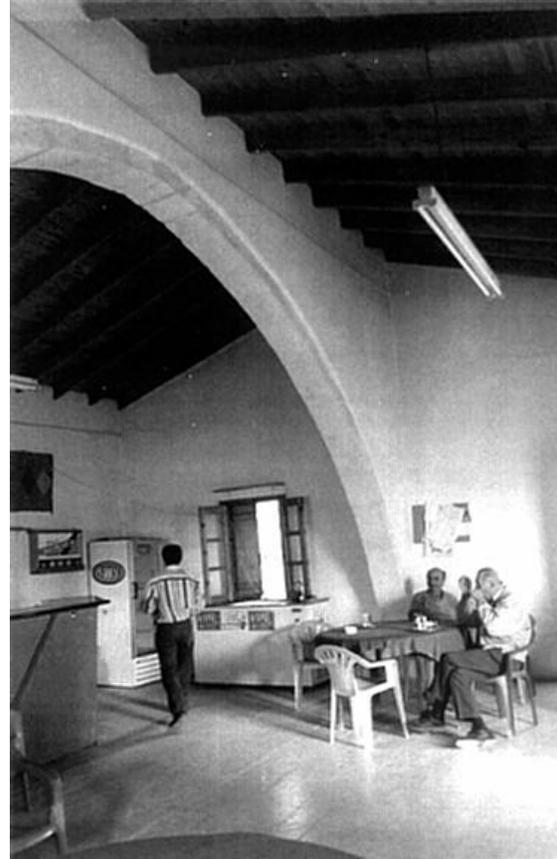
**Figure 12.** Photograph of the interior of the building. Notice the vault.

A traditional building with the typical Cypriot vault, located at the village of ‘Arodes’ of the prefecture of Paphos in Cyprus, was selected for the second set of analyses. The building is shown in figures 11 and 12. It has an almost square shape in plan ( $8.50 \times 8.50 m$ ) and it is separated in two rooms by a vaulted wall, which is also used to half the span of the wooden beams of the roof (figure 12). The building was built by
