## Seismic Evaluation of Several Hospitals in Seismic Zones 3 and 4 in Austria

### SUMMARY

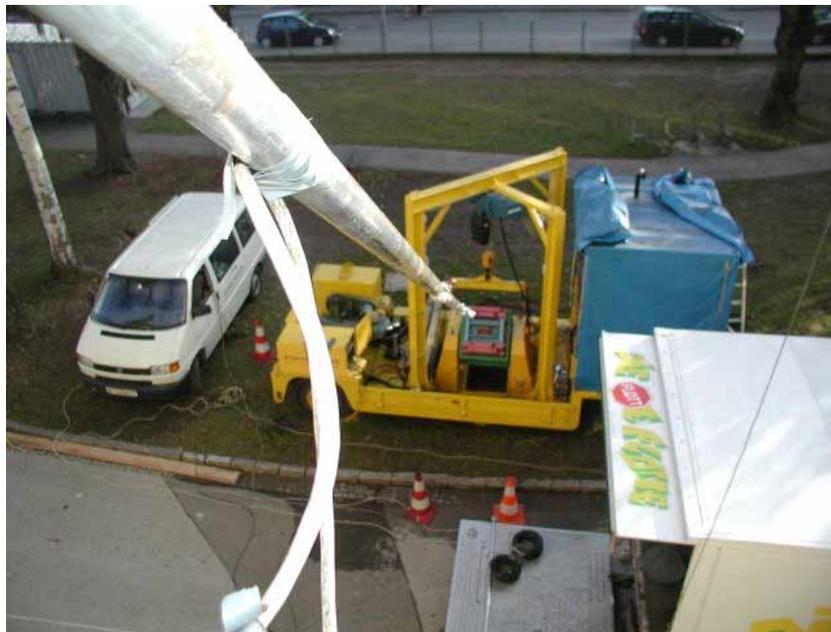
First step was to measure the natural frequencies of all the structures by ambient vibration and forced vibration using the dynamic reaction mass exciter VICTORIA of arsenal research (Figure 1.1.). Hereby, a rod-chain had to be fixed under  $45^\circ$  between the exciter and a window of the structure. This exciter works in a bandwidth between 0-80 Hz, where it is possible to execute a continuous sine-sweep with an adjustable sweep rate. The available piston elevation is max. 250 mm, the piston velocity 0.56 m/s and the piston force is 35kN. Afterwards, a sweep was brought in, which excites the whole structure and can be measured by accelerometers positioned in the building. The advantage of this method compared to the ambient measurements is that every frequency within the sweep is stimulated with high amplitudes. Even higher modes can be detected by this method.

**Figure 1.1.:** reaction mass exciter, VICTORIA with rod-chain

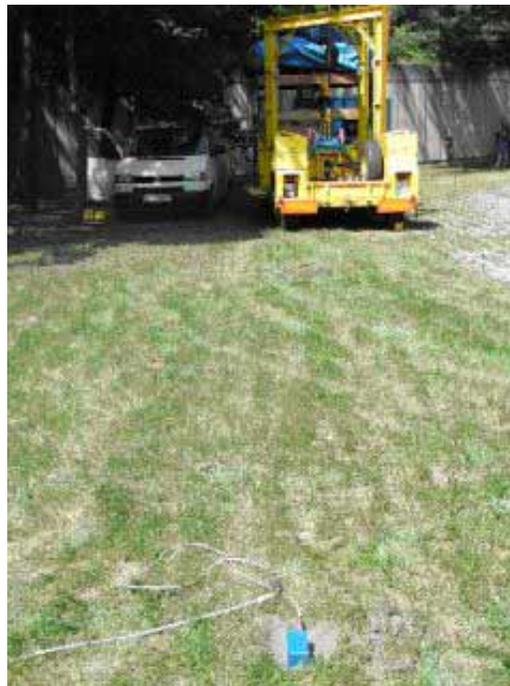
For both types of measurements the vibrations were induced by VICTORIA. The vibrations were measured up to the distance of 64 m from the exciter (Figure 3.1.).

**Figure 3.1.;** In situ soil measurement with VICTORIA

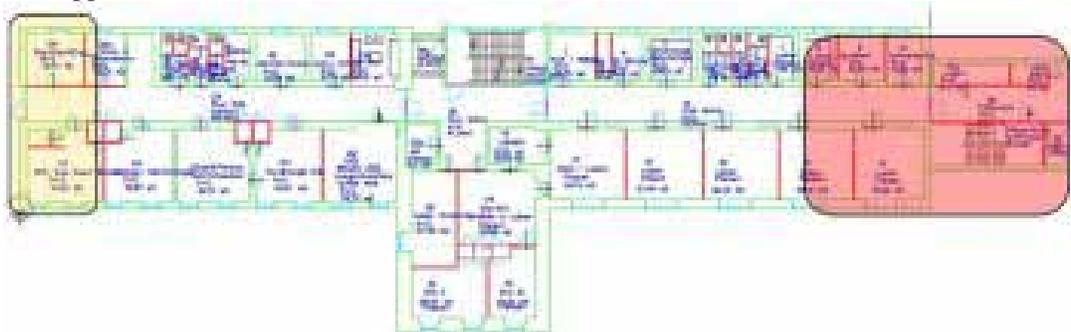
After the main risk index is determined, it is possible to point out the endangered areas on each ground plan for every storey and every building (Figure 5.2. and Table 5.2.) for example for LKH Leoben, Funtionstrakt third upper floor.

**Figure 5.1.:** Risk Mapping
