**ON RELATIONSHIP BETWEEN THE ESTIMATED STRONG MOTION
CHARACTERISTICS OF SURFACE LAYER
AND THE EARTHQUAKE DAMAGE
- CASE STUDY AT INTRAMUROS, METRO MANILA -**

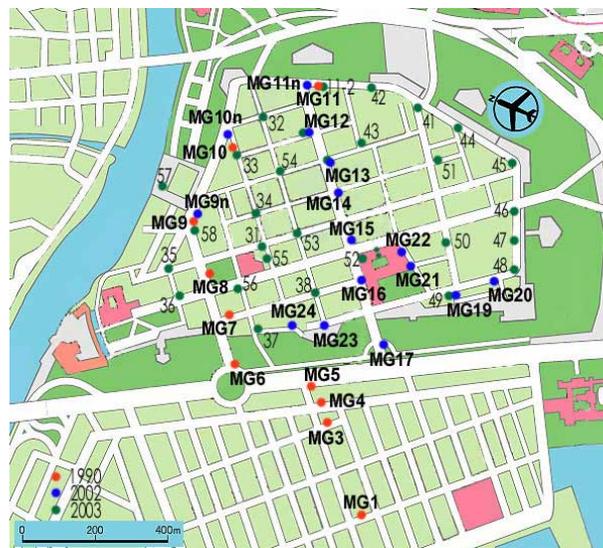
Figure 1 shows the distribution of measurement points in the study area. In and around this area, there were ten points surveyed in 1990 (shown by red circles), fourteen points in 2002 (shown by blue circles) and thirty points in 2003 (shown by green circles). Some points were resurveyed in 2002 and 2003 for the purpose of comparing results of the 1990 survey.

Figure 1 Distribution of Measurement Points.

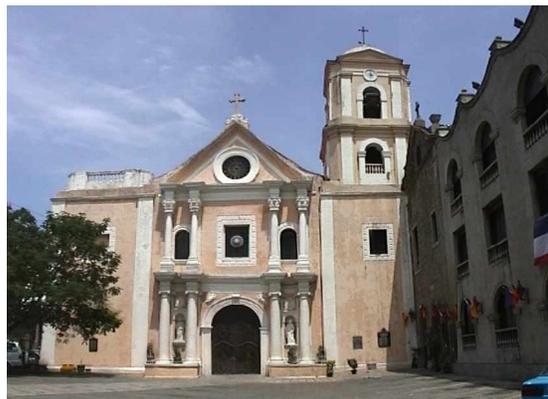
Figure 5 shows the overview and damage situation of San Agustin Church after the July 18, 1880 earthquake, located inside Intramuros and considered as one of the world heritage sites in the world. This church repeatedly suffered earthquake damage. Figure 5(b) shows its picture in 1880 after this earthquake caused one of the bell towers to fall.

(a) Present Condition

Figure 5 Overview of San Agustin Church

To grasp the dynamic characteristics in detail, microtremor measurement was also conducted inside the church., both for the main building and the bell tower shown in figure 5. Here the height of the main building and the bell tower assumed to 12 m and 8 m, respectively. Measurement points were installed on the grand floor and the top for the main building and on the bottom, middle and top of the bell tower.

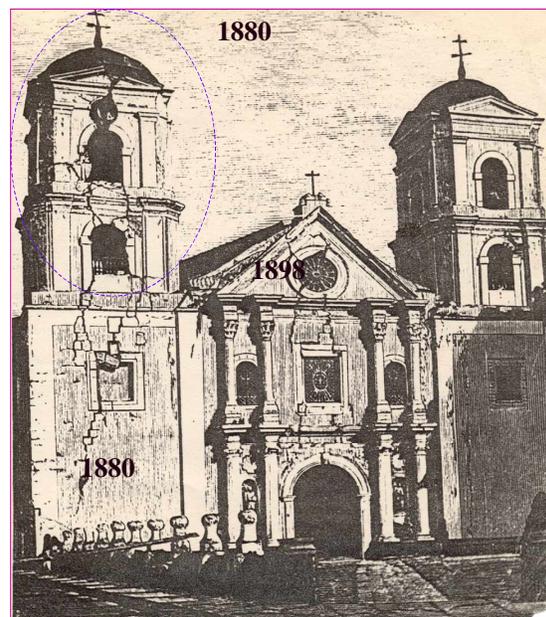
(b) Past Damage Condition
