SEISMIC ASSESSMENT OF ‘POMBALINO’ BUILDINGS

SUMMARY

‘Pombalino’ Buildings are old masonry buildings from Lisbon Downtown. These buildings were built after the 1755 Lisbon Earthquake and they include a three-dimensional timber structure enclosed in masonry walls aiming at providing seismic resistance to these structures. Seismic vulnerability of a ‘Pombalino’ building from Lisbon Downtown will be evaluated and its collapse mechanism will be identified. According to the collapse mechanism obtained, a strengthening solution will also be analysed defining the increment of building seismic capacity. Discussion will be made in terms of (i) the differences observed in seismic behavior of the building before and after strengthening, (ii) how the knowledge of the expected structural collapse mechanism allows identifying the structural elements that should be strengthened, leading to a better seismic performance of the building.

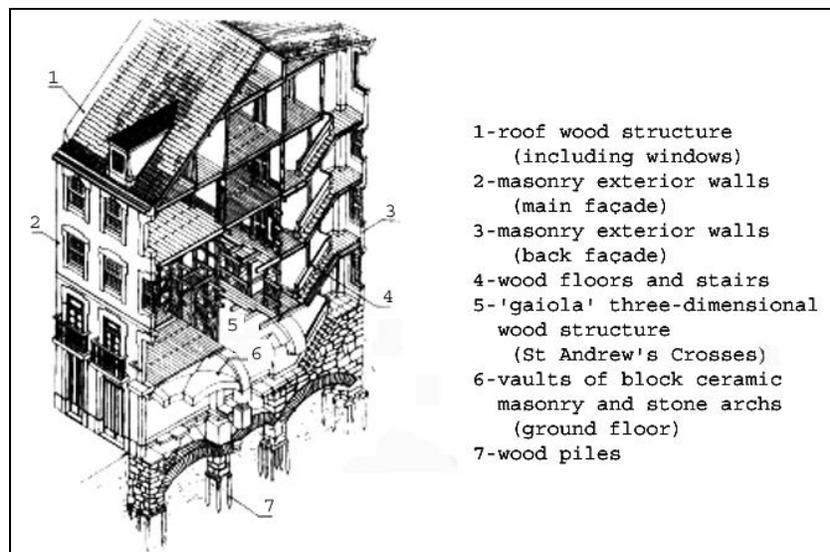
Figure 1 presents the structural details of ‘Pombalino’ buildings. The three-dimensional timber structure of ‘gaiola’ in the interior walls above the first floor can be identified in this figure, as well as other interior walls (partition walls), which are wooden panels that do not have structural functions. Façades are made of masonry without the ‘gaiola’. The openings (doors and windows) in these walls define the geometry of masonry structural elements. Roofs are made with timber truss and ceramic tiles and may include window openings. Floors are timber slabs and should be considered as flexible diaphragms. Ground floor interior walls are masonry walls supporting a system of vaults made of blocks of ceramic masonry and stone arches. Foundations include short and small diameter woodpiles connected by a timber grid.

Fig. 1 – Structural details of a ‘Pombalino’ Building (*adapted from Mascarenhas [2]*)

The timber structure of ‘gaiola’ is like a birdcage made of vertical and horizontal elements braced with diagonals. The masonry of the exterior walls is made of irregular blocks of calcareous stone and lime mortar with very poor strength capacity. Masonry infill of the ‘gaiola’ can be stone (rubble) or clay bricks. It is usual to find both type of masonry at interior walls. Most of the times, timber elements of ‘gaiola’ are notched together or connected by nails or iron ties, according to historical information regarding construction techniques. A more detailed description of ‘Pombalino’ Buildings can be found in Cardoso *et al.* [1].

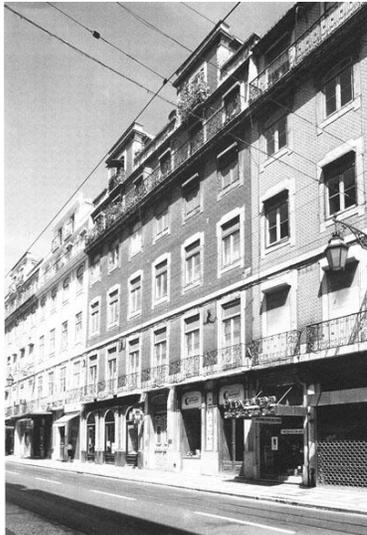
Figure 2 – Analysed Building (Prata Street, 210 to 220) (Santos [3])

Figure 2 presents the Building analysed from Lisbon Downtown (Prata Street, 210). It is a five-floor ‘Pombalino’ building and its plan, with the ‘gaiola’ walls identified, is presented in Figure 3.

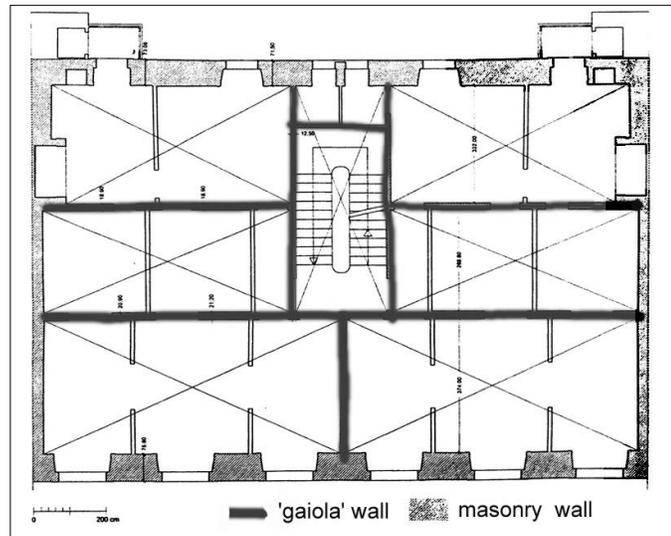
Figure 3 – Plan of a typical floor of the analyzed building (adapted from Santos [3])

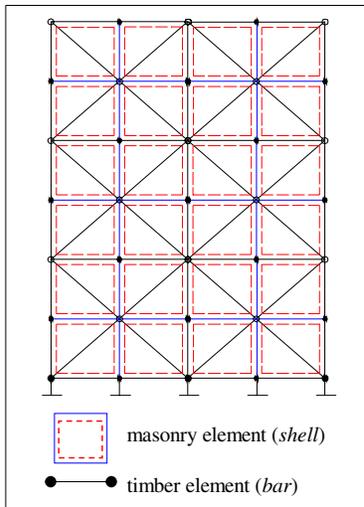
Only timber elements were considered in the model of 'gaiola' walls, excluding the masonry where this timber structure is wrapped in. This provision was adopted to simulate the stiffness of 'gaiola' panels for horizontal forces acting parallel to their plane, according to the results of a previous study (Cardoso [5]). In this study, a numerical model of a 'gaiola' wall panel, removed from a 'Pombalino' building, was defined (Figure 4) and the results obtained were compared with experimental data (Figure 5). These data were the results of cyclic tests where a horizontal force, parallel to the plane of the wall and applied on top, was applied.

Figure 4 - Numerical model of a 'gaiola' wall panel (Cardoso [5])

The stiffness obtained in both situations was compared. The experimental stiffness considered was the slope of the beginning of the first load cycle. The most relevant conclusion of the study was that the connections of diagonal timber elements could not transmit tensile forces. This conclusion is compatible with historical data regarding construction practices, the observed gaps between the different timber elements of 'gaiola', and the absence of iron elements at the connections. Therefore the contribution of the diagonal bars under tension was not considered in the numerical model.

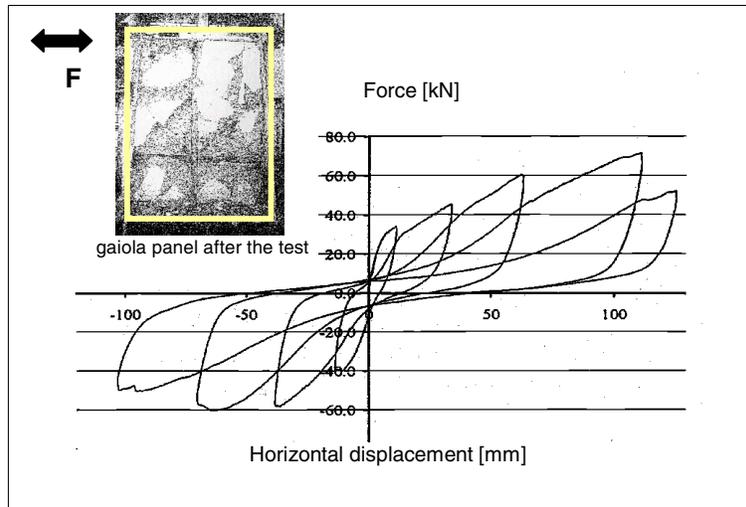
Figure 5 - Results of cyclic tests of a 'gaiola' wall panel removed from a 'Pombalino' building (Silva *et al.* [6])

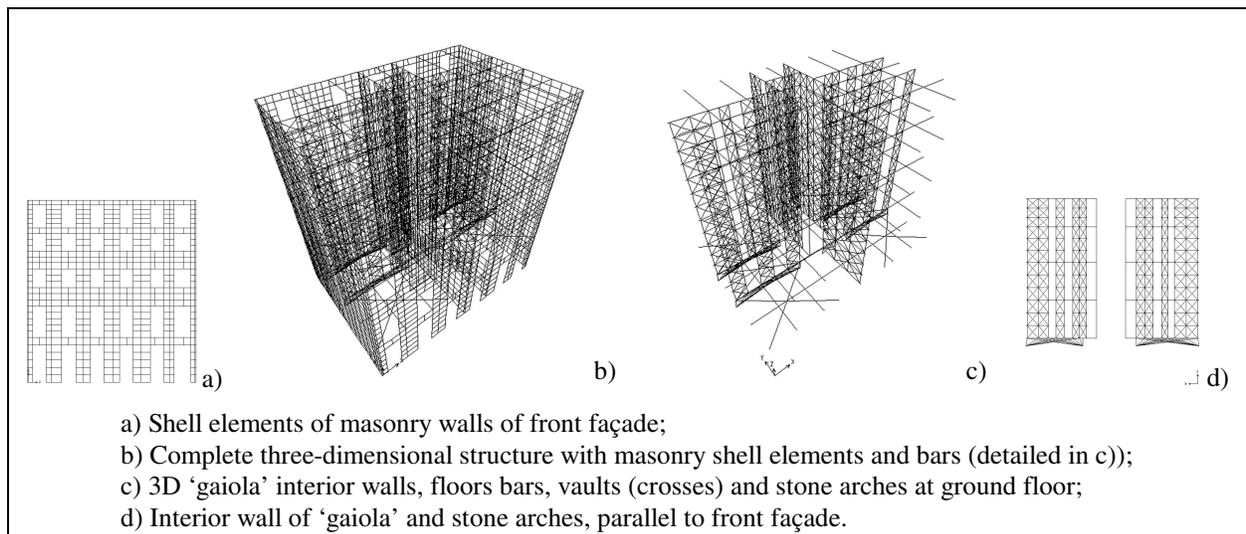
A numerical model of the building was defined (Figure 6) and a commercial program (SAP2000® [6]) was chosen to perform the structural analysis.

Figure 6 - Numerical model of the building (Cardoso [5])

The floors were modelled as truss bars with free rotations at the connections to the walls, simulating flexible diaphragms. The floor bars were orientated perpendicular to the façades, restraining the relative out-of-plan displacements of parallel masonry walls. The connections between timber elements of the 'gaiola' and perpendicular masonry walls were simulated considering timber bars that only resist to axial forces. In spite of the information about old construction techniques, that indicate connections between timber elements of the floors and 'gaiola' and masonry walls are done with iron elements, no iron elements were considered at these connections due to the uncertainties about their real existence in the buildings.

The masonry vaults of the ground floor were simulated by two crossed rigid diagonal bars with fixed displacements and free rotations in their connections to masonry walls. A triangular truss of rigid bars modeled the stone arches of ground floor. The connections between these bars allow relative rotations transmitting compression forces simulating the arch effect. These arches were connected to the interior ‘gaiola’ walls of the first floor parallels to the main façade and were supported by ground floor masonry walls. The self-weight of the roof structure was included in the nodes of the *shell* elements at the top of the building. The foundations were simulated by built-in connections.

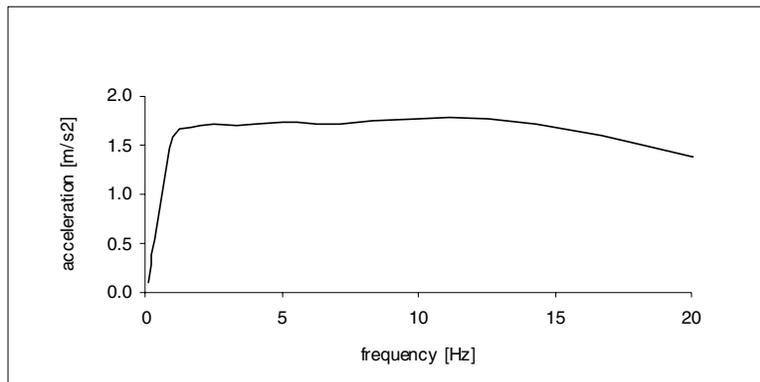
Figure 7 – Response spectrum of accelerations (RSA [8]) (Seismic Action n. 2, Soil type III (soft soil))

It was intended to develop a methodology that could be useful in current Strengthening Design of old masonry buildings, by using a commercial program (SAP2000® [7]). An iterative procedure was adopted, which allows simulating in an approximately manner the main sources of non-linear behavior of masonry buildings. Linear dynamic analyses by response spectrum were performed. The acceleration response spectrum used is presented in Figure 7.

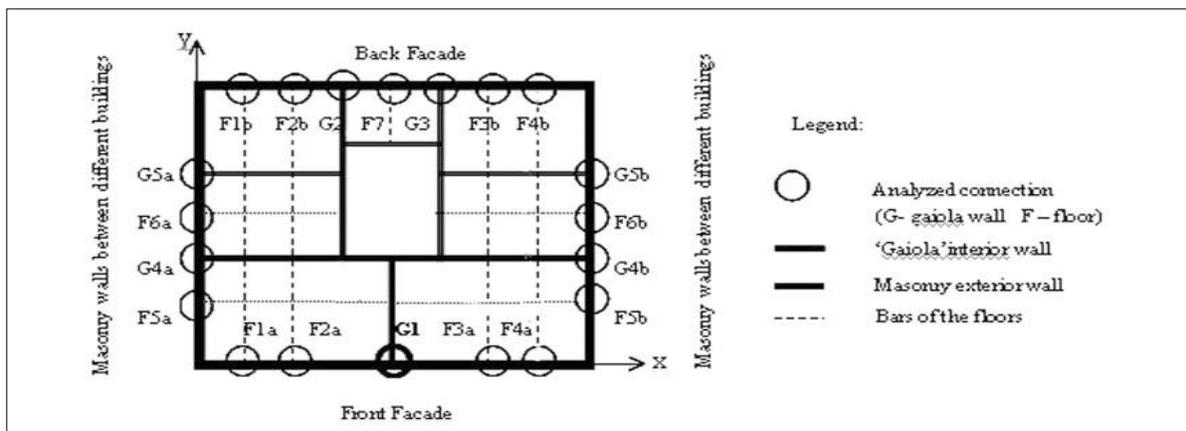
Figure 8 – Plan of the numerical model of the building identifying the different walls, the bars simulating the floors and the connections between the timber elements and the masonry walls

(Figure 8), between the front façade and the perpendicular ‘gaiola’ wall, and the damages in the masonry wall.

in connection G1 (Figure 8). The displacements presented are the difference of the displacements at the connection G1 and the displacements in the left corner of the front façade.

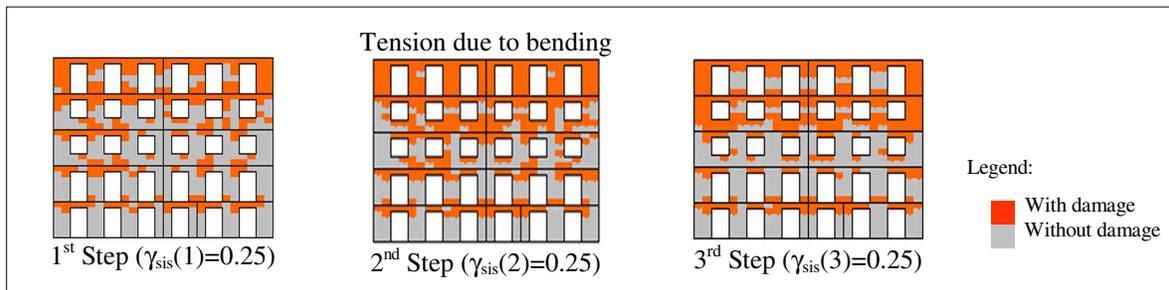
The collapse mechanism obtained was the bending of the front façade out of its plane. Three iterations were necessary to identify this mechanism. The corresponding seismic intensities were $\gamma_{sis}(1)=\gamma_{sis}(2)=\gamma_{sis}(3)=0.25$, therefore $\gamma_{sis}^{max}=0.25$. Figure 9 presents the evolution of the tension-damaged masonry from the front façade due to bending. These damages allow predicting masonry cracks similar to those presented in Figure 10.

Figure 9 - Damage levels in masonry elements from main façade in iterative calculation

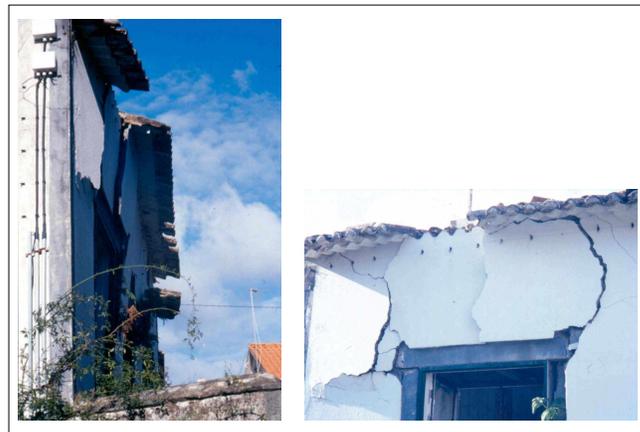
Figure 10 – Damages due to 1998 Azores Earthquake, similar to those obtained in the analysis

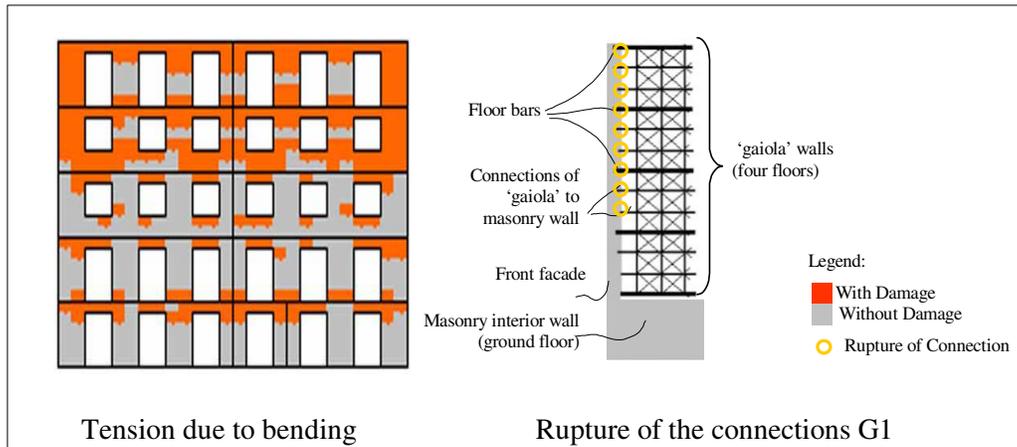
Figure 11 presents the damages at the end of the iterative process, which allow to identify the out-of-plane bending of the front façade as the building collapse mechanism. Since masonry walls can fall only after the rupture of their connections to the perpendicular 'gaiola' walls that support them, the described collapse mechanism was identified by considering simultaneously the rupture of the connections G1

Figure 11 - Masonry damages and the rupture of connections at the end of the iterative process that allowed identifying the bending of the front façade collapse mechanism

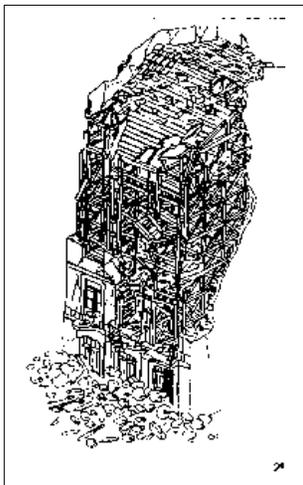
The collapse mechanism obtained eventually corresponds to the original designers conception presented in Figure 12 (Mascarenhas [2]) that intended to preserve the inner wood structure of the buildings aiming at the safekeeping of human life. This conception may be efficient for one or two floor buildings as it shown in Figure 13 that represents a building whose exterior walls have fallen out-of-plane in the 1998 Azores earthquake. However, there are some uncertainties regarding its efficiency in buildings with more than two floors because the out-of-plane fall of the façades may bring down other parts of the building.

Figure 12 - Collapse mechanism according to original conception

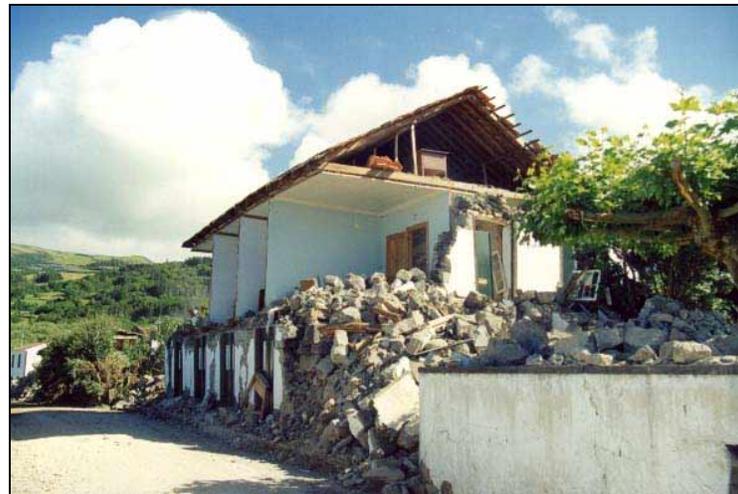
Figure 13 - Fall out the plane of exterior walls without complete collapse (1998 Azores earthquake)

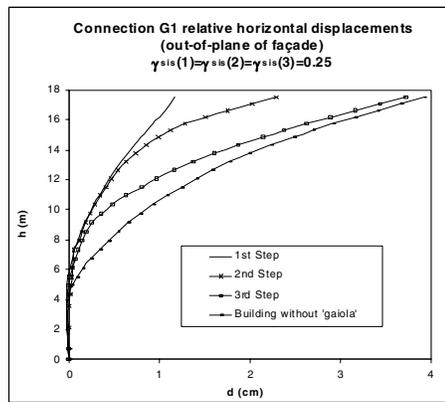
The collapse mechanism can also be identified by the out-of-plane horizontal displacements of the main façade presented in Figure 14. For better understanding the real out-of-plane deformed configuration of the wall, the displacements presented are the difference between the horizontal displacements observed in the connection G1 (Figure 8) and those observed in the left corner of the front façade of the building. The maximum values were observed at the top of the building and are presented in Table 3 for each step of the

Figure 14 and Table 3 also include the displacements observed in the numeric model of the same building without the ‘gaiola’. It can be observed that displacements measured at the end of the previous iterative calculation were 0.2cm (5%) smaller than the displacements measured in the same building without the ‘gaiola’ (Table 3). The difference in these values allows understanding the contribution of the remaining active connections after the collapse of the building (step 3) to its stiffness, as the displacements obtained are smaller than those measured in the same building without the ‘gaiola’ structure.

Figure 14- Horizontal displacements out-of-plane of the façade along the connection G1, relative to the corner of the building.

The displacements observed (Table 3) at the end of the iterative calculation (2.50cm - step 3) were increased 217% above the value observed in the first iteration. The displacements obtained in the first step are the displacements that would be obtained in linear analyses, indicating that the iterative calculation can lead to a more realistic evaluation of the displacements.

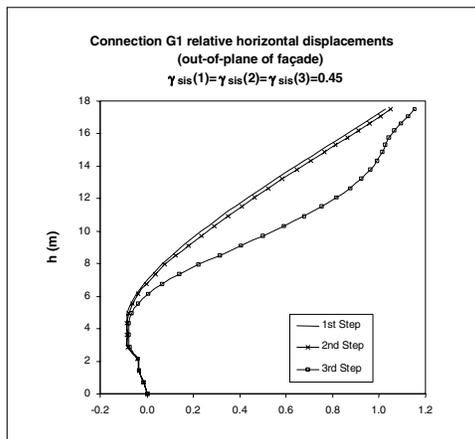
Figure 18 indicates that the collapse mechanism after strengthening is still the out-of-plane fall of the façade, triggered by the collapse of the connections with the ‘gaiola’ wall. However the sequence of collapse starts by the connections at third floor level and not at the top. Figure 18 shows the difference in the displacement pattern along the high as compared to the structure before strengthening (Figure 13). The obtained collapse mechanism may indicate that the introduction of a concrete beam, or of a metallic tie, in all the floors of the building connecting the façade to the floors and to the ‘gaiola’ walls at these levels, as presented in Figure 19, will be an efficient solution to increase the seismic capacity even further.

Figure 18 – Horizontal displacements out-of-plane of the façade after strengthening

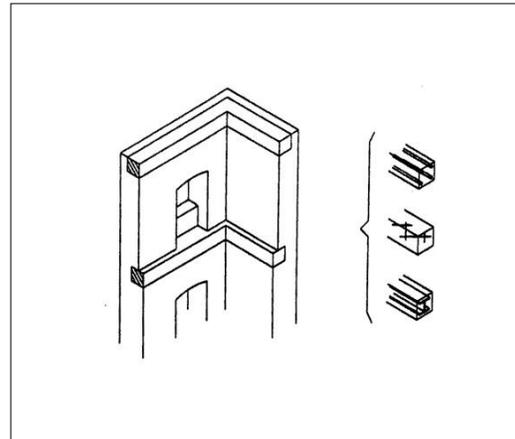
Figure 19 – More adequate strengthening solution (Croci [10])

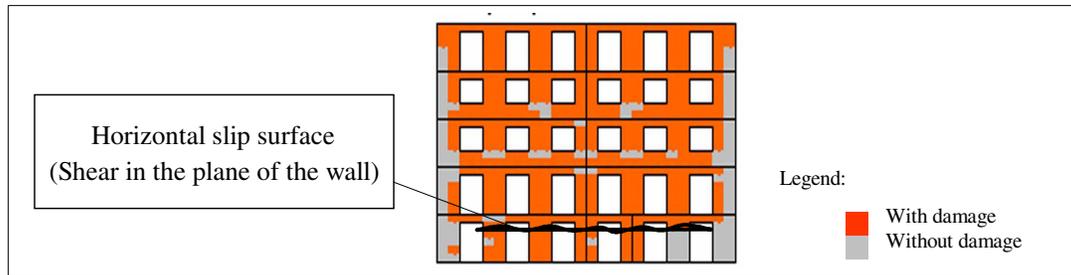
The global base shear mechanism was also analyzed. Damage state corresponding to this mechanism is considered to occur when the damaged masonry elements define a continuous horizontal slip surface. For the building before strengthening, this mechanism was reached for the value $\gamma_{sis}=0.70$. The first masonry elements showing the complete slip surface due to shear collapse were the vertical elements of the façades (masonry between the doors of ground floor), as presented in Figure 20. This result was expected because the shear resistance of the masonry walls of the façades, due to the doors and windows openings, is smaller than the resistance of masonry walls without openings, like the walls between adjoining buildings.

Figure 20 – Masonry shear damages identifying the shear base collapse mechanism ($\gamma_{sis}=0.70$)

The shear base collapse mechanism was also analyzed for the strengthened building and a similar value $\gamma_{sis}=0.70$, only slightly inferior, was obtained. The values of the global shear base reactions presented in Table 4 allow understanding the small difference observed in the γ_{sis} for shear base collapse mechanism for the building before and after strengthening. According to the values presented in Table 4, the increment of the global shear base reaction parallel to the front façade due to strengthening is 9%, which is a reduced difference, justifying the similarity of the values of results obtained for both situations.

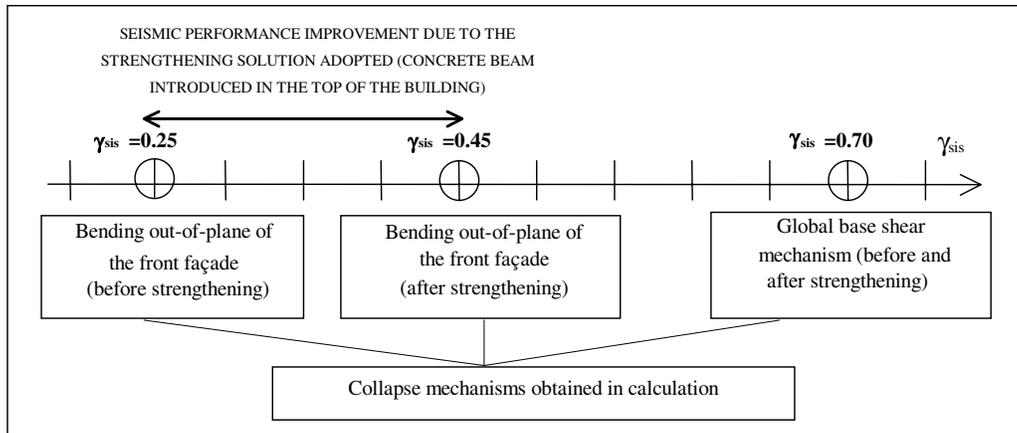
The values of γ_{sis}^{max} obtained in this study give information about seismic vulnerability of old buildings and seismic resistance improvement after strengthening. The results obtained from seismic assessment of the building before and after strengthening are presented in Figure 21.

The main conclusions regarding the results of the analyses performed (Figure 21) are: (i) the expected collapse mechanism of the ‘Pombalino’ building is the bending out-of-plane of the front façade, corresponding to $\gamma_{sis}=0.25$; (ii) the strengthening solution adopted increases the seismic resistance of the building to $\gamma_{sis}=0.45$; (iii) after strengthening, the collapse mechanism is still the bending out-of-plane of the front façade but at an inferior level (third floor instead of fourth floor, which is the top floor of the building), therefore the most efficient strengthening solution would be the inclusion of a concrete beam or metallic tie in all the floor of the building; (iv) global base shear mechanism occurs for $\gamma_{sis}=0.70$ but the bending out-of-plane of the front façade mechanism occurs first in both analyzed buildings because the expected collapse mechanism for the building is the one corresponding to the lowest γ_{sis} .

Figure 21 - Results from seismic assessment of the ‘Pombalino’ building analyzed
