BUCKLING OF PILES DURING EARTHQUAKE LIQUEFACTION

Subhamoy Bhattacharya¹ and Malcolm Bolton²

SUMMARY

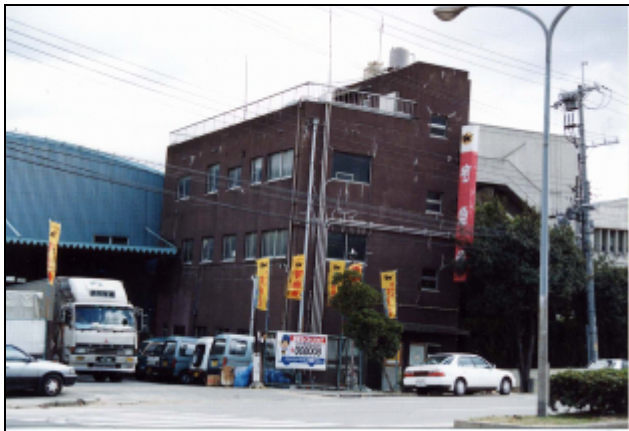
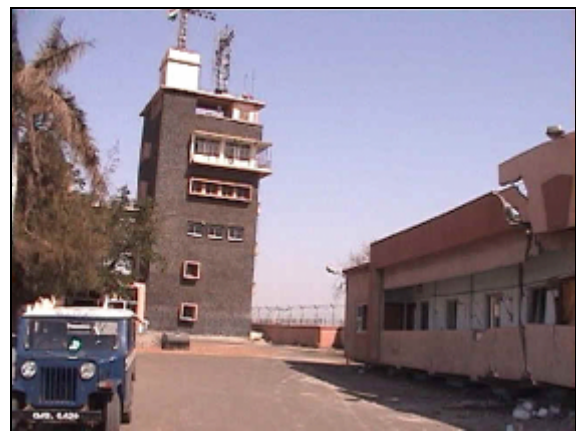
Figure 2(a): Failure of pile foundation in level grounds, after the 1995 Kobe earthquake, Tokimatsu [19]; (b): Collapse of piled Kandla Tower in laterally spreading ground after the 2001 Bhuj Earthquake, Madabhushi et al [20].

Figure 2(a) shows the failure of a piled foundation in a level ground and Figure 2(b) shows the failure of a piled foundation in a laterally spreading ground. Both the foundations tilted in the direction of the

asymmetrical mass i.e. in the direction of the eccentricity of vertical loading. It is surprising that a piled foundation collapses in a similar way in level ground i.e. in absence of lateral spreading and in laterally spreading grounds i.e. in the presence of lateral spreading. If lateral spreading is the main cause of failure, Hamada [12]; it is most unlikely that a piled foundation will collapse in level grounds. It must also be noted that most of PHC piles which had a high bending strength also failed.

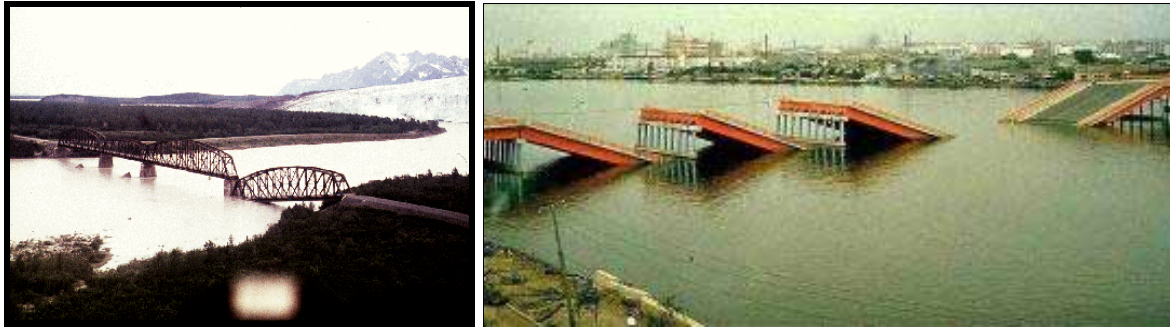
Figure 3: Failure of bridges during earthquakes; (a): Million Dollar Bridge during the 1964 Alaska earthquake (b): Failure of the Showa Bridge after the 1964 Niigata Earthquake. Photo courtesy [21].

It is a common observation in seismic bridge failure that piers collapse while abutments remain stable, for example Figures 3(a&b). Figure 3(a) shows the collapse of one of the piers of the Million Dollar Bridge leading to bridge failure. Similar failures were also observed of the Showa Bridge during the 1964 Niigata earthquake (see Figure 3(b)). Bhattacharya and Bolton [5] notes that in a bridge design, the number of piles required to support an abutment is governed by lateral load due to the fact that the abutment, as well as carrying the dead load of the deck, has to retain earth and fills of the approach roads to the bridge (see Figure 4). On the other hand, the bridge piers (intermediate supports) predominantly support the axial load of the deck. The lateral load acting on the pier during an earthquake is primarily the inertial force. The lateral capacity of a pile is typically 10 to 20% of the axial load capacity. Thus, for a multiple-span bridge having similar span lengths, the number of piles supporting an abutment will be more than that of a pier. It is worthwhile to note that in these examples only bridge piers collapsed while the abutments remained stable. This hints that the failure of bridge pier foundations may be influenced by axial load. In contrast, the current design methods only concentrate on lateral loads.

The example of the failure of the Showa Bridge (see Figure 3(b)) is extensively used to illustrate the effects of lateral spreading loads to piled foundations, see for example Hamada [8], Ishihara [22]. Figure 5 shows the schematic representation of the failure of the bridge. As can be seen from Figure 5, piles under pier no. P₅ deformed towards the left and the piles of pier P₆ deformed towards the right Takata et al [23], Fukuoka [24]. Had the cause of pile failure been lateral spreading, the piers should have deformed identically in the direction of the slope. Furthermore, the piers close to the riverbanks did not fail, whereas the lateral spread is seen to be most severe at these places. Bhattacharya et al [25], Bhattacharya [4] has

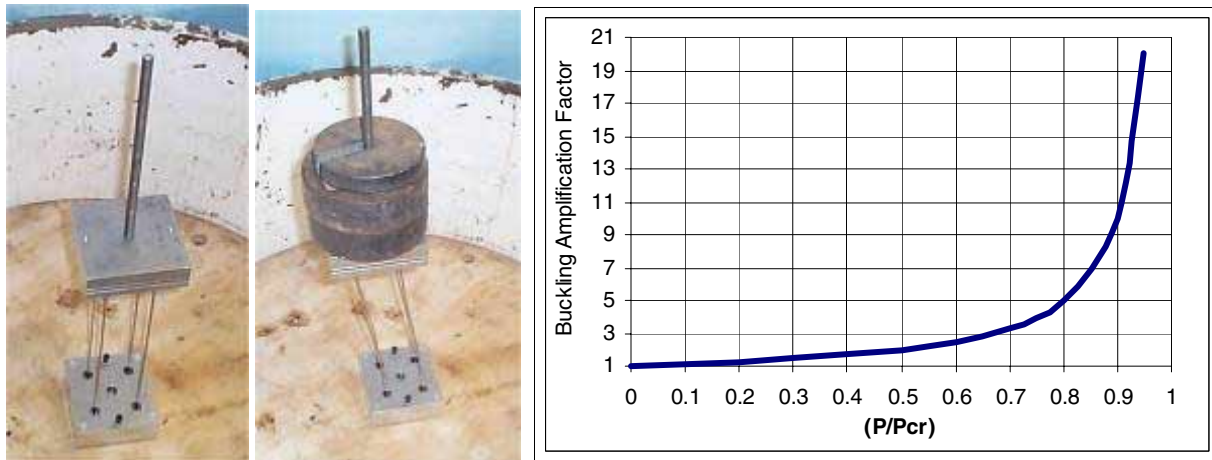
Figure 6(a): Failure of frame supported on long columns. (b): Buckling amplification factor.

Bond (1989) showed through the collation of data of tubular piles used in different projects around the world that the length to diameter of the pile ranges from 25 to 100. Figure 6(a) shows the failure pattern of structures resting on slender columns (length to diameter ratio of 93) which would represent a piled building or a bridge in absence of soil but may not necessarily mean in the absence of soil support. Thus in the absence of soil, we would expect a pile-supported structure to fail in a similar pattern but it remains to be seen if liquefied soil behaves like the "absence of soil". It must be remembered that the failures shown in Figure 6(a) is due to axial load alone. Example of failure of slender columns in a single row as in Showa Bridge (Figure 3(b)) can be seen in Bhattacharya et al [3].

The failure shown in Figure 6(a) is only due to the effect of static axial load. In the presence of static lateral loads, the critical load would come down i.e. the frame will become unstable at much lower load typically at 50% of the elastic critical load. In presence of dynamic loads, i.e. if the entire set up shown in Figure 6(a) is shaken as in an earthquake, the frame would become unstable at a much lower load. Stability analysis of elastic columns, see Timoshenko and Gere, [28], shows that the lateral deflections caused by lateral loads gets amplified in the presence of axial loads. If δ_0 is the deflection due to lateral loads alone, the final deflection δ gets amplified in the presence of axial loads. The term (δ/δ_0) can be termed as the "Buckling amplification factor (BAF)" given by equation 2.

This form of expression, sketched in Figure 6 (b), can be used with good accuracy (less than 2% error) for all beam-columns having (P/P_{cr}) less than 0.6, Timoshenko and Gere [28]. Beyond the ratio of 0.6 the induced plastic strains cause a deterioration of elastic bending stiffness leading to a reduction in the critical buckling load P_{cr} , and to premature collapse.

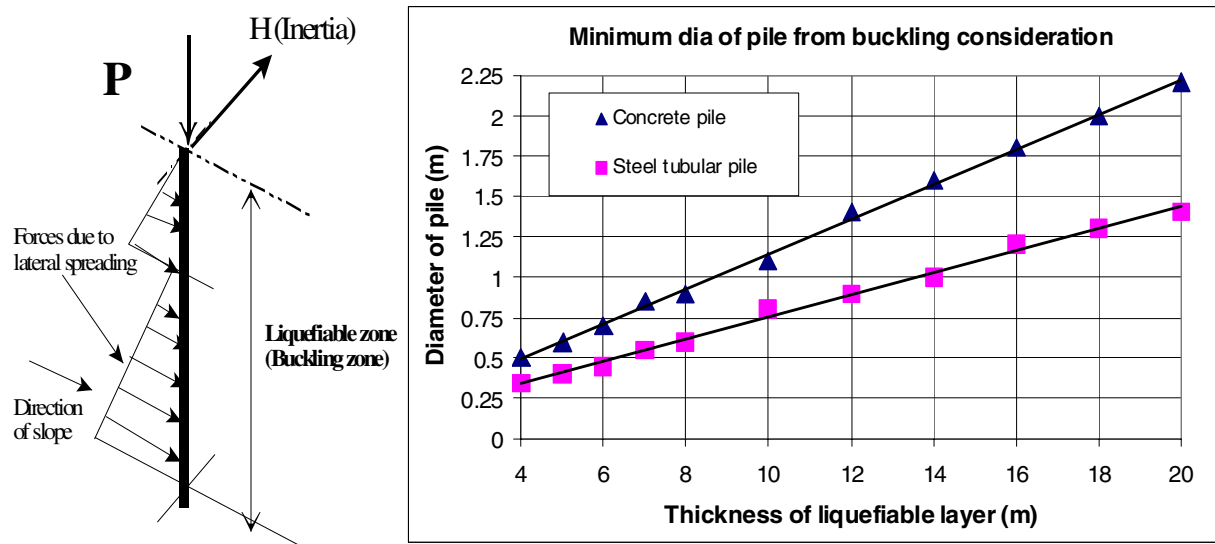
Figure 11: (a): Free body diagram showing the generalized loading acting on a pile; (b): Design chart to avoid buckling after Bhattacharya and Tokimatsu [33].

As can be seen in Figure 11(a), lateral spreading loads and inertia loads may act in two different planes. Thus the pile not only has axial stress but also may have bending stresses in two axes. The pile represents a most general form of a "beam-column" (column carrying lateral loads) element with bi-axial bending. If the section of the pile is a "long column", analysis would become extremely complex and explicit closed-form solution does not exist. The solution of such a problem demand an understanding of the way in which the various structural actions interact with each other i.e. how the axial load influences the amplification of lateral deflection produced by the lateral loads. In the simplest cases i.e. when the section is "short column", superposition principle can be applied i.e. direct summation of the load effects.

Figure 11(b) shows a typical graph showing the minimum diameter of pile necessary to avoid buckling depending on the thickness of liquefiable soil. The slenderness ratio is kept around 50. The main assumptions are that the piles are solid concrete section having E (Young's modulus) of 22.5×10^3 MPa and for steel E of 210GPa. The piles are not in a single row and at least in 2×2 matrix form. The thickness of the steel pile is based on API [35] code (American Petroleum Code) i.e. the minimum thickness is $6.35\text{mm} + (\text{diameter of the pile}/100)$. Details of the design chart can be seen in Bhattacharya (2003).
