Site Characteristics Based on Microtremors and Borehole Data in the Epicentral Area of the Central Java Earthquake of 2006

ABSTRACT :

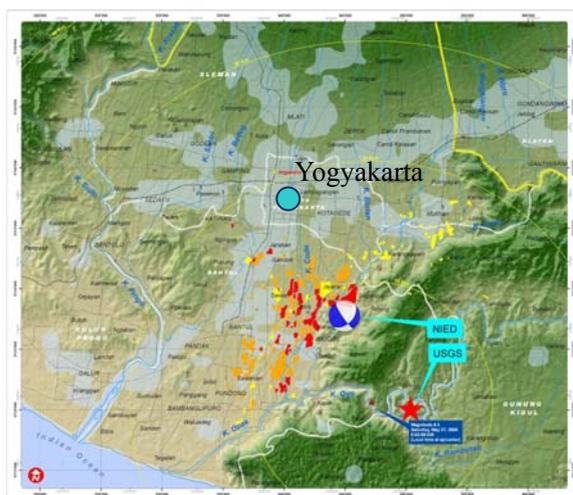
Fig.1 Damage distribution obtained by UNOSAT and the location of the epicenter (star) by USGS and the mechanism and location of the moment centroid by Nakano et al. (2007).

First we surveyed briefly the general condition of heavily damaged areas in the epicentral region, namely, Desa Pleret (Pleret village), Kecamatan Jetis (Jetis county), and Imogiri City. When we moved along a southbound highway from Jetis to Imogiri we found that the damage levels are changed strongly. This sudden change of damage levels corresponds to the difference of damage levels determined by UNOSAT from satellite photos (Fig.1). Therefore, the UNOSAT figure shows more or less precise damage distribution in the epicentral region.

This village lies in the area not mentioned in a damage distribution map of UNOSAT (Fig.1), considerably far in the eastern side from the center of Pleret. However, damage in this village is as severe as the others; school buildings as well as a mosque are totally destroyed. Probably more than 60% of houses are heavily damaged. Since this site is close to the hill zone, we should not expect high amplification due to soft soil, and therefore strong ground motions at this site may reflect strength of the earthquake source. It is guessed that strong ground acceleration produced at this site may not exceed 200 Gals (20% of g) because a store building survived with only a slight damage and a small steel tower in the village center do not suffer any damage.

damage concentrated areas as seen in Fig.1 may be the results of both source rupture pattern along the fault as well as the local soil conditions, which may strongly amplify ground motions impinged from the source to the surface.

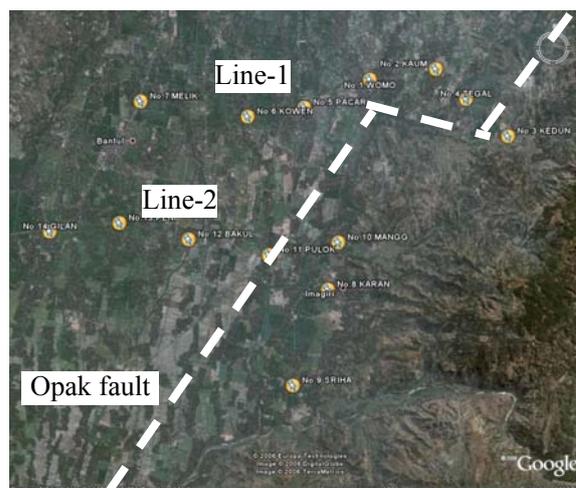
Fig.2 Two survey lines and the Opak fault in the heavily damaged areas.

Then we started detailed investigation along a east-west line of about 10km, Line-1, which is crossing the Opak fault through Pleret (See Fig.2). We investigated the damage of each village using an elementary school or a local village office which is usually located in the center of each village. We also conducted questionnaire survey to evaluate the levels of strong ground motions in each village.

In the same way we continued to investigate damage at 7 sites along the east-west line across the Opak fault through Imogiri City center, Line-2 as shown in Fig.2. The averaged damage ratios are not as high as those in Line-1.

We started microtremor measurement along a east-west line of about 10km, Line-1, which is crossing the Opak fault through Pleret (See Fig.2). We measured microtremors in each village using a playground or courtyard of an elementary school or a local village office which is usually located in the center of each village. In total seven sites are investigated. We also conducted. We also measured microtremors in the two school structures with two stories.

In the same way we continued to perform microtremor measurements at 7 sites along the east-west line across the Opak fault through Imogiri City center, Line-2 as shown in Fig.2.

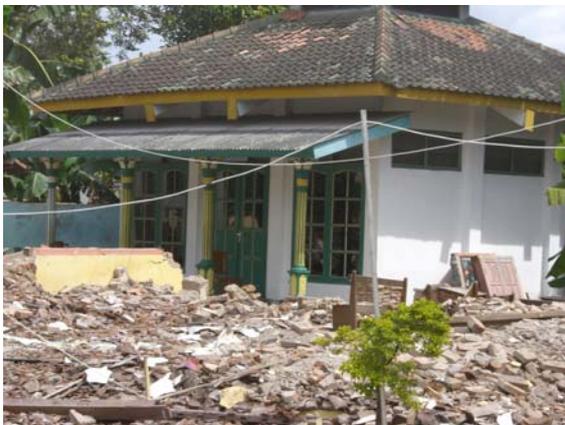
Photo 1 Debris of a totally collapsed elementary school and a survived mosque at No.2 survey site, Kauman in Pleret.

The main building of the elementary school was totally collapsed during the earthquake (Photo 1), while the other classroom has only walls stand still. A library building and a stockyard building had survived as well as two adjacent mosques (as shown in this photo) and a one-storied building of the local government office. Statistical data obtained from this local office yields damage ratio of about 75%. However, there existed several houses completely survived in this village as shown in Photo 2.

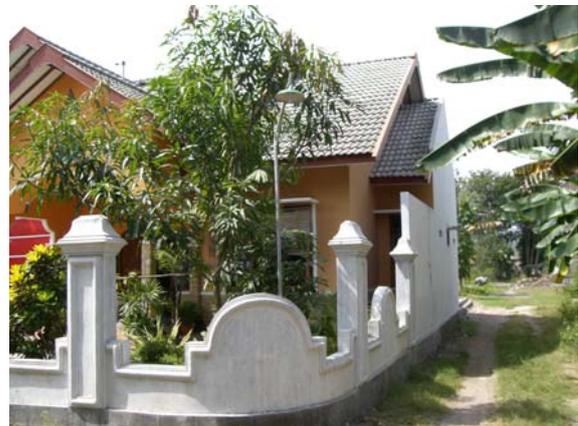
Photo 2 A beautifully survived house near No.2 survey site, Kauman in Pleret.

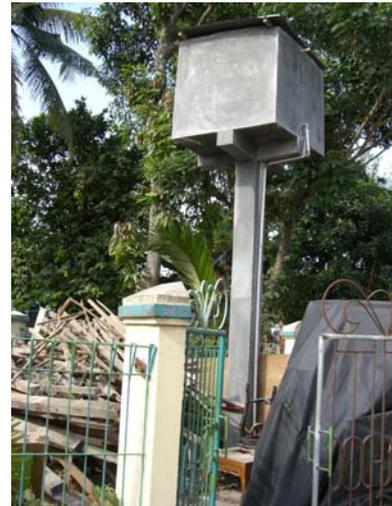
Photo 3 A beautifully survived water tank near No.3 survey site, Tegalrejo in Pleret.

These are brief description of the survey results along the line-1. It is not easy to estimate strong motion levels in the epicentral region from observation of the above- mentioned damage. However, it is not considered to be the case that the shaking level in terms of the JMA seismic intensity exceeds 6-, which corresponds to VIII for MMI intensity scale, in terms of peak ground acceleration (PGA) level, 400Gals, or peak ground velocity (PGV) level, 20 ~ 40cm/s, because at least we see a few examples of survived structures such as water tanks or steel towers which does not seem to have enough earthquake resistance.

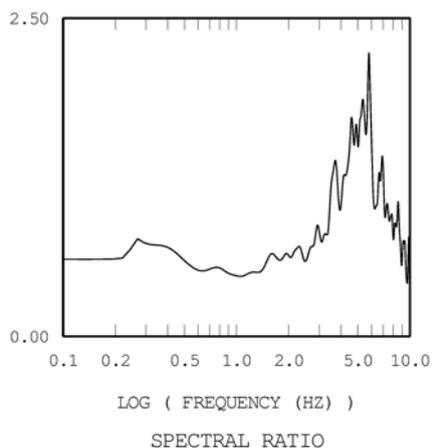
Figure 3 H/V spectral ratios at No.3 site in line-1 (KEDUN) .

In Fig.3 we show H/V spectral ratios at No.3 site, KEDUN, the easternmost site. This figure suggests that the thickness of the surface sediments must be very small (shallow) because the peak frequency is as high as 6Hz. If we assume the averaged S-wave velocity of surface sediment to be 250m/sec and if we assume the peak frequency of H/V ratio may close to the S-wave amplification peak frequency, then the thickness at this site is estimated to be 10m. However, peak frequencies for different time segments show different values and their amplification level is not so high that the S-wave at this site may be increasing as we go downward.

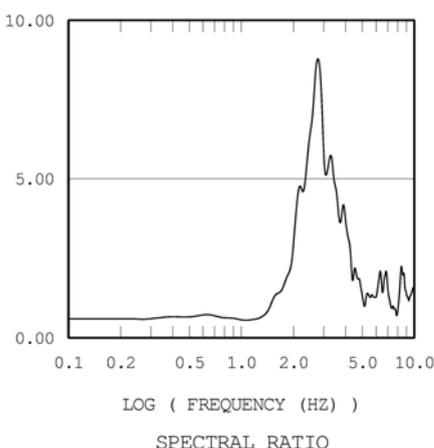
Figure 4 H/V spectral ratios at No.4 site in line-1 (TEGAL) .

Fig.4 shows H/V ratios at No.4 site TEGAL. The peak frequency becomes lower to 2.5Hz and its amplitude becomes higher, close to 10 times. This suggests high impedance contrast between bedrock and shallow Quaternary sediments. Peak frequencies for different time windows do not change much, which also suggests high impedance contrast. If the average S-wave velocity of sediments is assumed to be 200m/sec, then their thickness may be 20m and the S-wave velocity below may be 1,000m/sec.

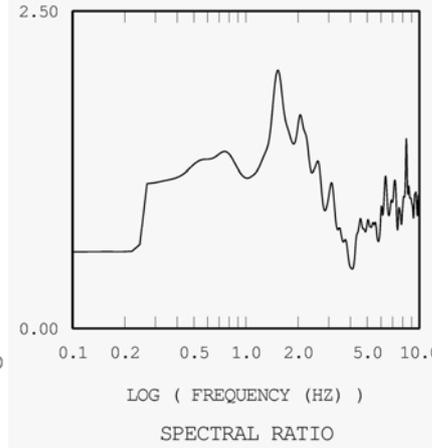
Figure 5 H/V spectral ratios at No.2 site in line-1 (KAUMAN) .

When we look at next station, No.2 site KAUM in Fig.5, the peak frequency of the H/V ratio is lowest, 1.5 Hz, which suggests the thickest sediments at this site along the Pleret line. However, its peak level is only two so we cannot expect high impedance contrast here. At the next western station No.1 site Wonokromo, the peak frequency becomes 3.0Hz as seen in Fig.6. This means after KAUM the thickness of the sediments tend to be larger as we go to the west. If we assume the S-wave velocity of sediments to be 200m/sec, the peak frequency of 1.5Hz suggests the thickness of 33m, while it is 3.0Hz, the thickness of 17m. If we assume 300m/sec of S-wave velocity, then thickness could be 50m and 25m, respectively.

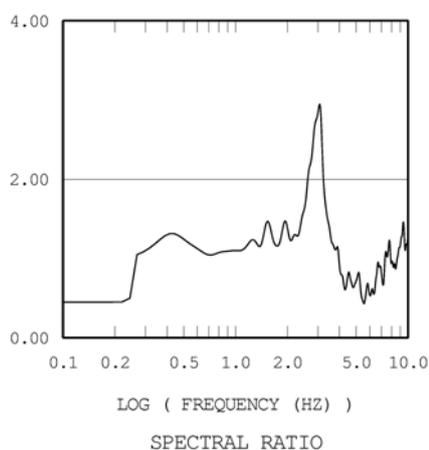
Figure 6 H/V spectral ratios at No.1 site in line-1 (WONOKROMO) .

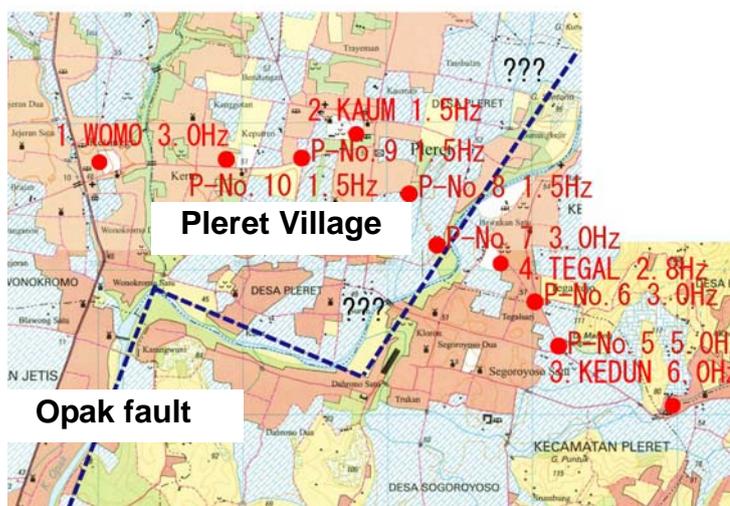
Figure 7 Peak frequency distribution in Pleret district based on microtremor H/V spectral ratios.

In Fig.7 we show results of detailed investigation from No.3 site (KEDUN) to No.1 site (WONOKROMO), peak frequency distribution of H/V spectral ratios. As we move from the east bank of Opak river to the west peak frequency is varying from 6Hz to 1.5Hz. This suggests that the Opak fault may be running near the Opak river.

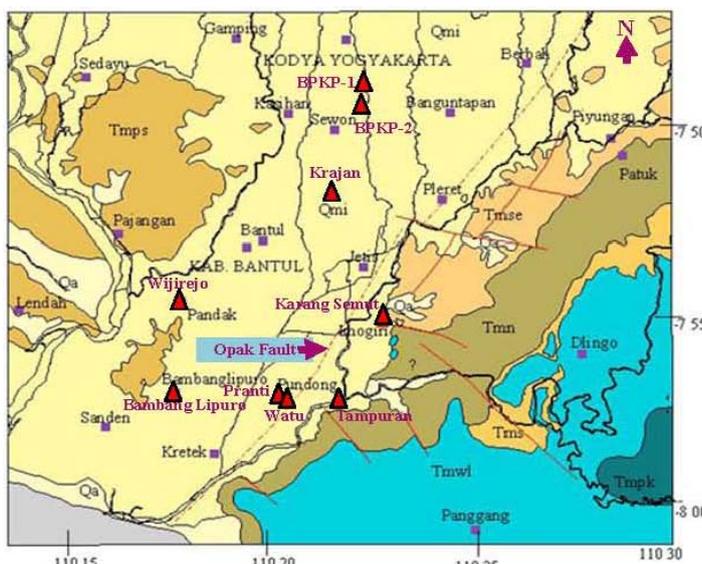
Figure 8 Borehole locations in the Yogyakarta Basin

Line – I: Boring was firstly carried out in the southern part of Yogyakarta basin as Line – I, passing through Opak fault as shown in Figure 8. It consists of Wijirejo, Bambang Lipuro, Pranti, Watu, and Tampuran sites. The depths of boreholes are varying from 26 m to 50 m.

Line – II: Four boreholes were drilled in Line – II, starting from BPKP-1 which is located in Jl. Parangtritis, Yogyakarta City and then BPKP-2, Krajan. It finally crossed Opak fault and ended at Karang Semut site as shown in Figure 8.

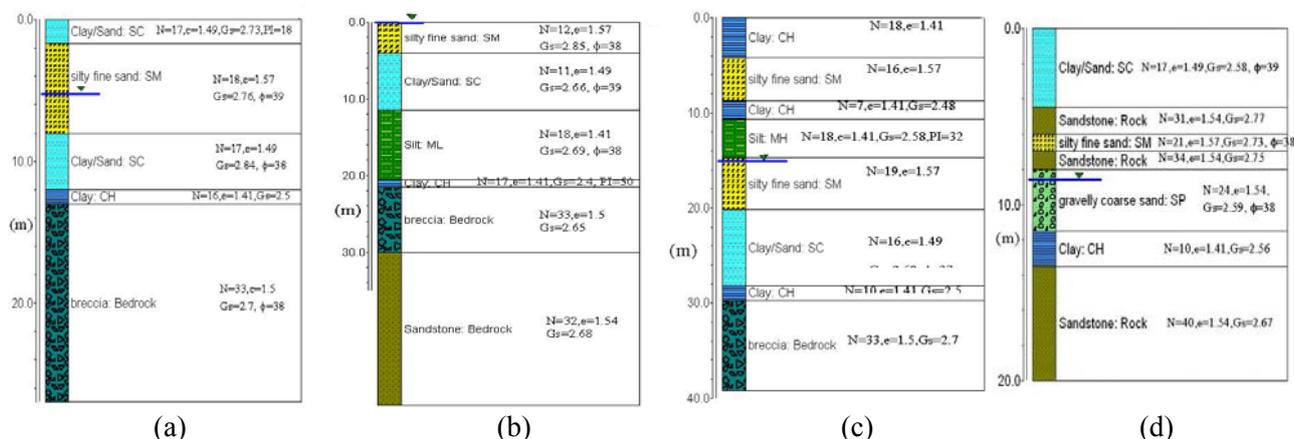
Figure 9 Subsurface soil profiles and geotechnical parameters of (a) Tampuran, (b) Watu, (c) Pranti, and (d) Karang Semut Sites

The subsurface soil profile and geotechnical parameters of each soil layer at Tampuran site are shown in Figure 9(a). That borehole is located near Opak River. It was drilled just up to 26 m since bedrock had been encountered starting at 13 m. The water table in this area is very shallow and observed at 2.5 m depth. Fine to medium uniform sand had been observed up to 12 m. This zone is very loose ($N \leq 18$) and so the high amplification can be expected in this zone. This zone is underlain by 1 m thick clay layer. The bedrock, breccia, was encountered starting from 13 m.

Figure 9(b) shows the soil condition and related properties of Watu site, up to 35 m depth. The water table was at surface. Medium to gravelly coarse sand are mainly observed in upper 1 m and silt to fine sand are dominant from 1 m to 20 m depth. This portion ($N \leq 18$) will be a major zone for the consideration of ground motion and amplification. This zone is underlain by 1 m thick clay layer. The bedrock, breccia, is encountered starting from 22 m to 30 m. Blackish brown, fine-grained, hard sandstone is observed after 30 m depth.

In Figure 9(c), the subsurface soil condition of Pranti site is shown. It was drilled up to 40 m depth and the water table was encountered at the depth of 14.6 m. It is an area of thick sand deposit. Bedrock is encountered after 30 m depth and which is overlain by sand deposit of different layers. This is an area of thick unconsolidated sediment ($N \leq 19$), and so high amplification and strong ground motion during an earthquake can be expected in this area. Although Watu and Pranti sites are very close to each other, their soil conditions are quite difference. This can be due to the proximity of the Opak river and the Opak fault. It is quite clear that we need to consider nonlinear behavior at these sites in their dynamic response analyses.

We show the soil condition and geotechnical information of Karang Semut site in Figure 9(d). It was in Imogiri, Bantul and drilled up to only 20 m depth as bedrock, where sandstone is emerged at 14 m. The water table was observed at 8.5 m depth. The upper 4 m is mainly composed of fine to medium sand and two sandstone layers are observed at depth 4.5 m and 7.5 m. A thin clay layer is found at 12 m depth, which is overlying on sandstone bedrock. The different impedance ratio between sandstone and soft soil layers will cause trapping most of seismic waves in soil layers and more cycles of dynamic loading can be expected.
