THE SEISMICITY OF CENTRAL GREECE IN THE LATE 19TH – EARLY 20TH CENTURY AS ENGRAVED ON VARIOUS HISTORICAL BUILDINGS

KEYWORDS: monumental buildings, macroseismic intensity, Central Greece

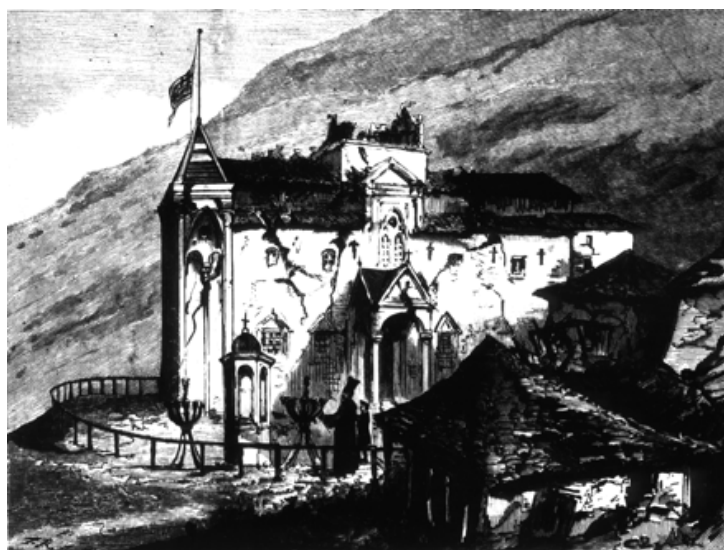
Figure 2. Main church damaged at Atalanti due to the 1894 events, drawn from a sketch by W. C. Bourchier (Albini & Pantosti 2004)

Identifying the historical buildings from the amount of buildings quoted within the earthquake reports is sometimes a rather subjective procedure, taking into account that the variety of earthquake accounts does not allow for a homogenous listing of those affected by the earthquakes. Detailed professional reports (compiled by geologists appointed by the ministry, local historians, local earthquake observers appointed by the National Observatory, etc.) on damage to specific buildings exist only from a small number of strong earthquakes of late 19th century, e.g. the 1861 Aigion or the 1894 Atalanti events. In these reports, the effects of the earthquake to the important buildings of the area are described in detail and in some cases it is stressed which building did not suffer any damage at all. In very few cases photographic material or engravings are available (figure 2).

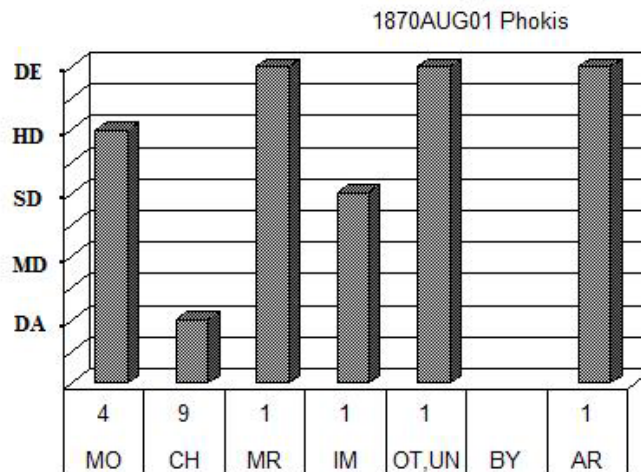
Figure 4. Severity of damage vs various types of historical buildings of table 1 for the earthquake of 1870 (DA: damage, MD: moderate damage, SD: substantial damage, HD: heavy damage, DE: partial or total destruction)

Figure 4 presents an example of distribution of grades of damage to the different types of historical buildings, for the earthquake of 1870 in Phokis, near Delfi. Archaeological sites present a variety of damage, probably due to the fact that they have suffered repeatedly from earthquakes in the past, and therefore they are the most vulnerable. The same stands for the Venetian, Turkish and recent monuments. In this earthquake, a considerable number of buildings that were not identified, together with other historical buildings, also present a variety of damage grades. However, the identified churches and the other important buildings of the area show lower grades of damage, a fact proving that in the local communities of the time, special care was given during the construction of their churches, schools and other public buildings, as the earthquakes in these areas are not a rare phenomenon.

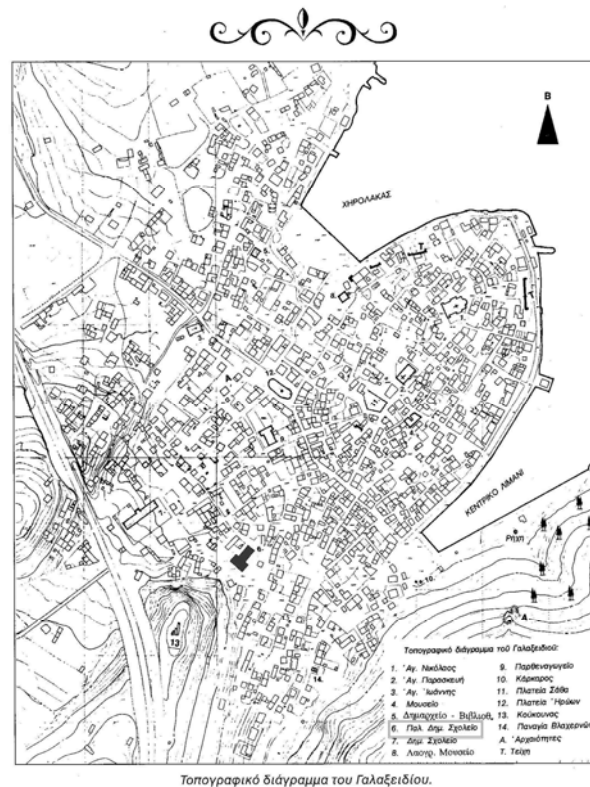
Figure 5. Topographic diagram of Galaxeidi, showing the location of the primary school damaged during the 1861 event

Skiadas (1999), in his historical compilation on Galaxeidi, lists the various important buildings of the town through its history, amongst others, the old primary school. The topographic diagram of figure 5 gives the position of the building.
