Influence of external steel plates on the characteristics of existing RC columns under near field ground motion

A. Mortezaei¹, A. Kheyroddin², G. Ghodrati Amiri³

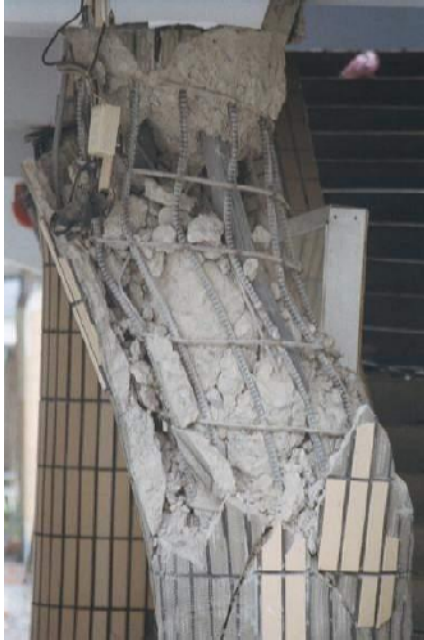
Fig. 1. Failure of a reinforced concrete column caused by inadequate flexural ductility

Flexural failures in plastic hinge regions occur mainly in columns with continuous longitudinal reinforcement. Such failures occur because the concrete core is not sufficiently confined by the transverse reinforcement to allow the column to reach the inelastic displacement demand imposed by the near field ground motion. Failure of a plastic hinge is preceded by the occurrence of horizontal cracking, spalling of the concrete core in compression, failure of transverse reinforcement, and buckling of longitudinal reinforcement, as shown in Figure 1.

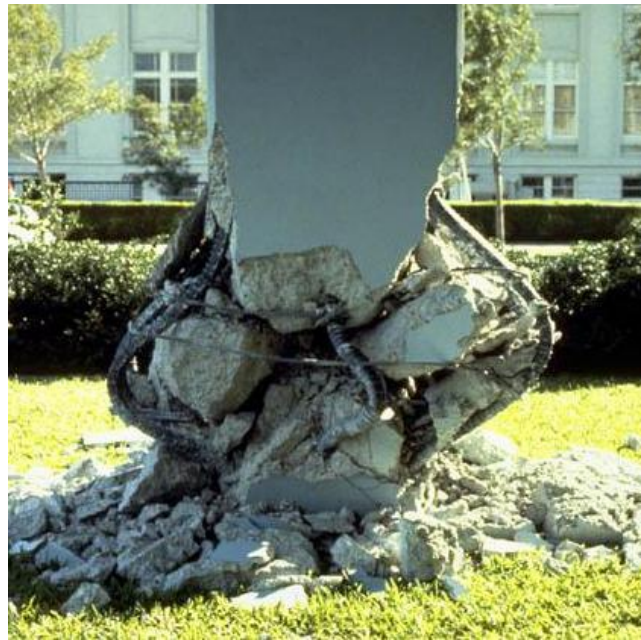
Fig. 2. Shear failure and migration of plastic hinge region

Shear failures can take various forms depending on the cross section of a column. A pure shear failure is associated with major diagonal cracking along the complete height of the column before any yielding of the reinforcement. A combined shear–flexure failure can also occur and can be accompanied by a migration of the plastic hinge region. A plastic hinge can migrate to a section where the ratio of the confining pressure to the applied bending moment is a minimum. A shear failure can also occur away from plastic hinge regions if the spacing of the transverse reinforcement is not uniform over the height of the column, as shown in Figure 2. Shear failure is more dangerous than flexural failure. For that reason RC columns must be designed to develop their full flexural capacity and assure a ductile flexural failure mode under extreme loading. However, many RC structures encounter shear problems for various reasons, such as mistakes in design calculations, improper detailing of the shear reinforcement, construction errors or poor construction practices, changing the function of a structure from a lower service load to a higher service load, and reduction of the shear reinforcement steel area due to corrosion in service environments.
