## SHEAR RESPONSE OF MASONRY WALLS WITH EXTERNAL CFRP REINFORCEMENT

P. Alcaíno<sup>1</sup> and H. Santa-María<sup>2</sup>

### ABSTRACT :

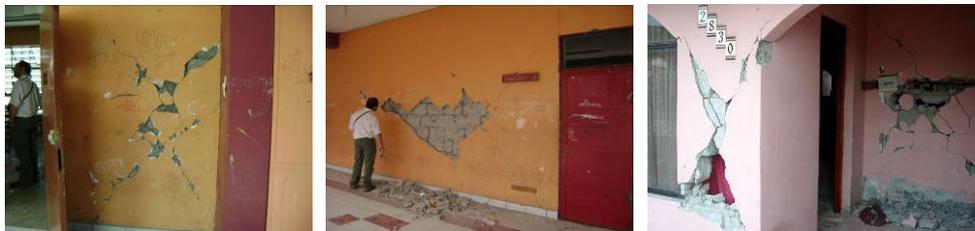
Figure 1 Damages due to in-plane shear action in Chilean masonry buildings, Tocopilla earthquake ( $M_w=7.7$ ), 2007.

Masonry has been typically used in low income and historic buildings, which have suffered large damage due to in-plane shear actions during recent earthquakes, in Chile (Figure 1), USA and Mexico (Klingner 2004), Iran (Fallahi et al. 2003), among others, showing the need for the structural retrofit of this type of buildings.

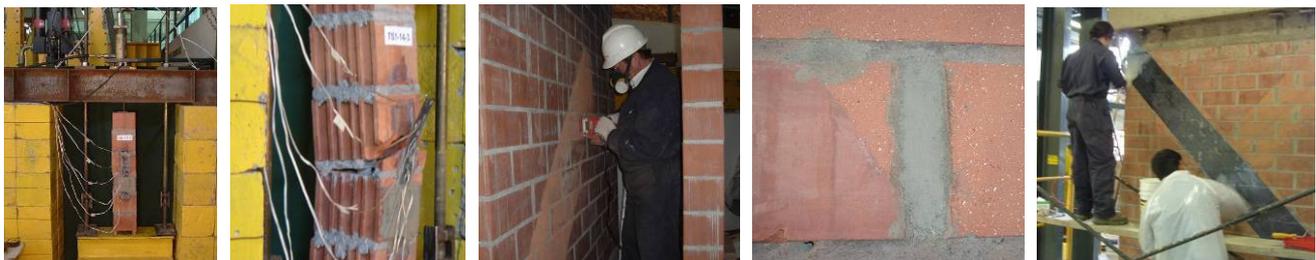
Figure 2 Bond test, surface preparation and CFRP bonding.

Previous bond tests showed that to achieve the maximum strength it was necessary to bond the CFRP to the substrate of the clay bricks. The surface of the walls was polished with a common sander machine, and then the mortar joints were filled with mortar to level the wall surface, obtaining a maximum bond strength of 0.24kN per

millimeter of width of the CFRP strip (Alcaíno and Santa María, 2008). The adherence test, surface preparation and CFRP bonding procedures are shown in Figure 2.

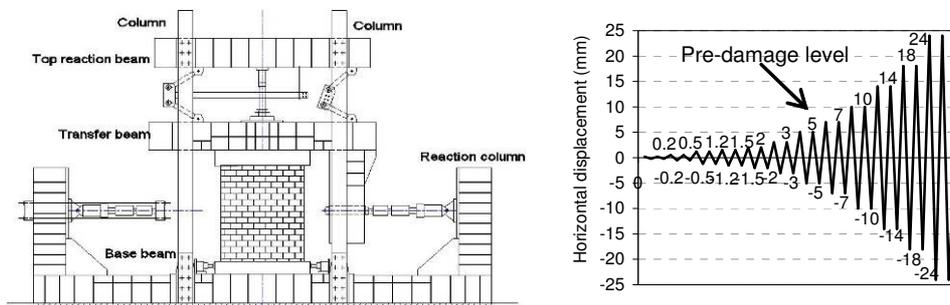
Figure 3 Reaction frame and horizontal displacement program for the cyclic shear tests.

The in-plane cyclic load and a simultaneous constant vertical load were applied by means of hydraulic rams attached to the reaction frame (Figure 3). The horizontal displacement-controlled loading consisted of two cycles at each displacement level, starting at 0.2mm and increasing up to 24mm, if failure did not occur before (see the loading program in Figure 3). The nominal vertical load was 98kN, approximately equivalent to the load of a first floor wall in a three story building with concrete slabs and a light roof. The walls were fixed to the floor and free to rotate at the top with the load applied 1700mm from the top of the bottom transfer beam (aspect ratio

$M/Vd \approx 0.86$ ). The horizontal displacement was measured at the top transfer beam with a horizontal transducer. More details can be found in Alcaíno (2007).

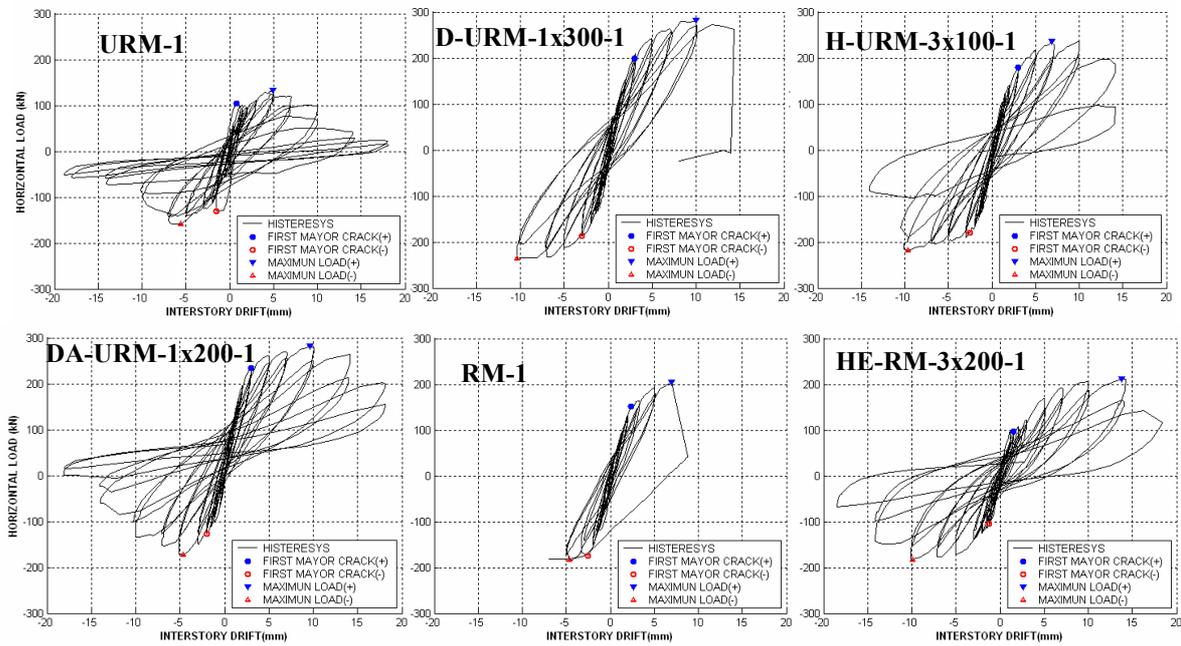
Figure 4. Hysteretic response of walls with different retrofitted configuration.

In Figure 4 are shown typical hysteretic response curves of the different retrofitted configurations. It can be seen that the behavior of the walls was approximately linear until the first major crack occurred. After cracking the walls had non-linear behavior: the shape of the loops of the retrofitted walls is similar to the non-retrofitted walls, showing narrow loops and a degradation of the stiffness as the deformation increase. After the walls reached the maximum shear strength, the load capacity began to decrease until failure occurred. It was observed that there was less decrease of load capacity as the CFRP strips were more distributed. Also, the decrease of load capacity after peak strength was reached was smaller in the horizontally retrofitted walls. The anchorage details were very effective in improving the deformation capacity of the walls and changed the failure mode to a less brittle mode.

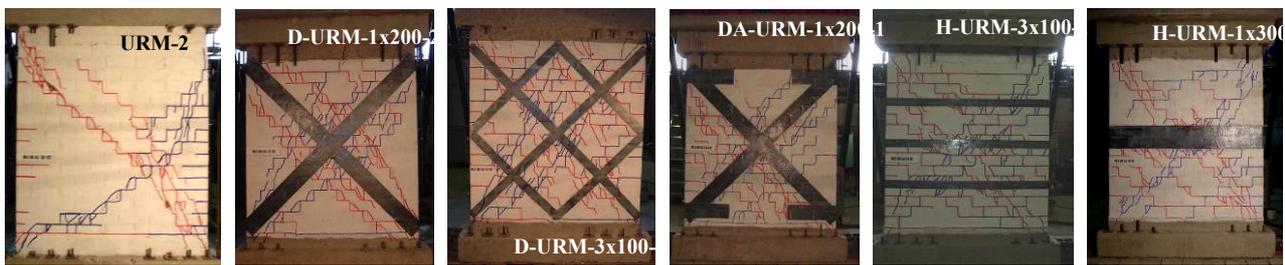
Figure 5. Cracking pattern of walls with different retrofitted configuration at displacement of 7mm

In Figure 5 is shown the cracking pattern at 7mm of displacement, which in most cases is very close to the maximum strength level. The URM walls had one large crack in each main diagonal. The walls with CFRP strips presented several cracks, increasing the number of cracks and decreasing their width as the number of strips increased.

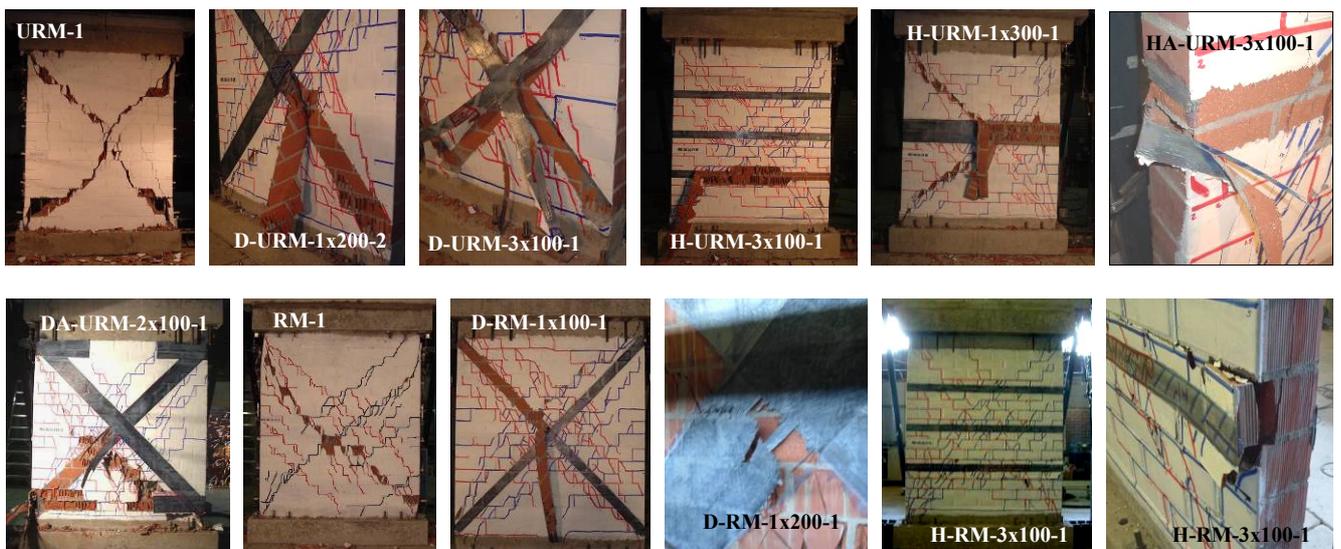
Figure 6. Failure modes of walls with different retrofitted configuration.

The failure modes are listed in Table 2 and shown in Figure 6. The walls with no CFRP strips had a brittle failure, with two main wide diagonal cracks.

The walls diagonally retrofitted with one strip per diagonal had a brittle failure with a large sudden loss of strength. The most common failure mechanism in this walls was as follows: the bricks at the ends of the walls were damaged due to high compressive stresses produced by in-plane bending of the walls; failure occurred when peeling stresses at the end of a strip broke the previously damaged bricks, the fabric delaminated along 50% of its length on one face of the wall and then the strength dropped sharply. Failure occurred between 10 and 14mm of horizontal displacement, generally during the first 14mm displacement cycle. Failure of the walls with three diagonal strips per direction and with anchorage details occurred at a larger horizontal displacement, close to 18mm, but with a similar maximum strength. The repaired walls (DR-URM-1x200 and DR-RM-1x200) reached a maximum strength similar to that of the corresponding retrofitted walls (D-URM-1x200 and D-RM-1x200).

In the horizontally retrofitted walls with three strips failure started as the bottom strip began to delaminate in important form, generally during the first 14mm cycle, producing a decrease of stiffness and strength of the wall compared to the previous displacement level cycle. As the test went on to the second 14mm cycle the strip continued delaminating and the strength of the walls decreased by more than 50%. After unloading, more than 80% of the strip had delaminated, the stiffness of the wall was very small, and the masonry below the second strip was highly damaged retrofitted with the walls of the bricks buckled outwards. There was no sudden loss of strength. The horizontally retrofitted wall with one strip (H-URM-1x300-1) showed a similar de-bonding mechanism, but in this case failure included a 100% of the CFRP reinforcement strips (Figure 6), which produced a sudden loss of strength. On other hand, the horizontal retrofitted wall with anchorage detail, the total delamination was limited by the anchorage details, reached major displacement capacity. The horizontally
