## NEW APPROACH TO REDUCING THE RISK OF NATURAL DISASTERS

Julio Kuroiwa<sup>1</sup>

### ABSTRACT

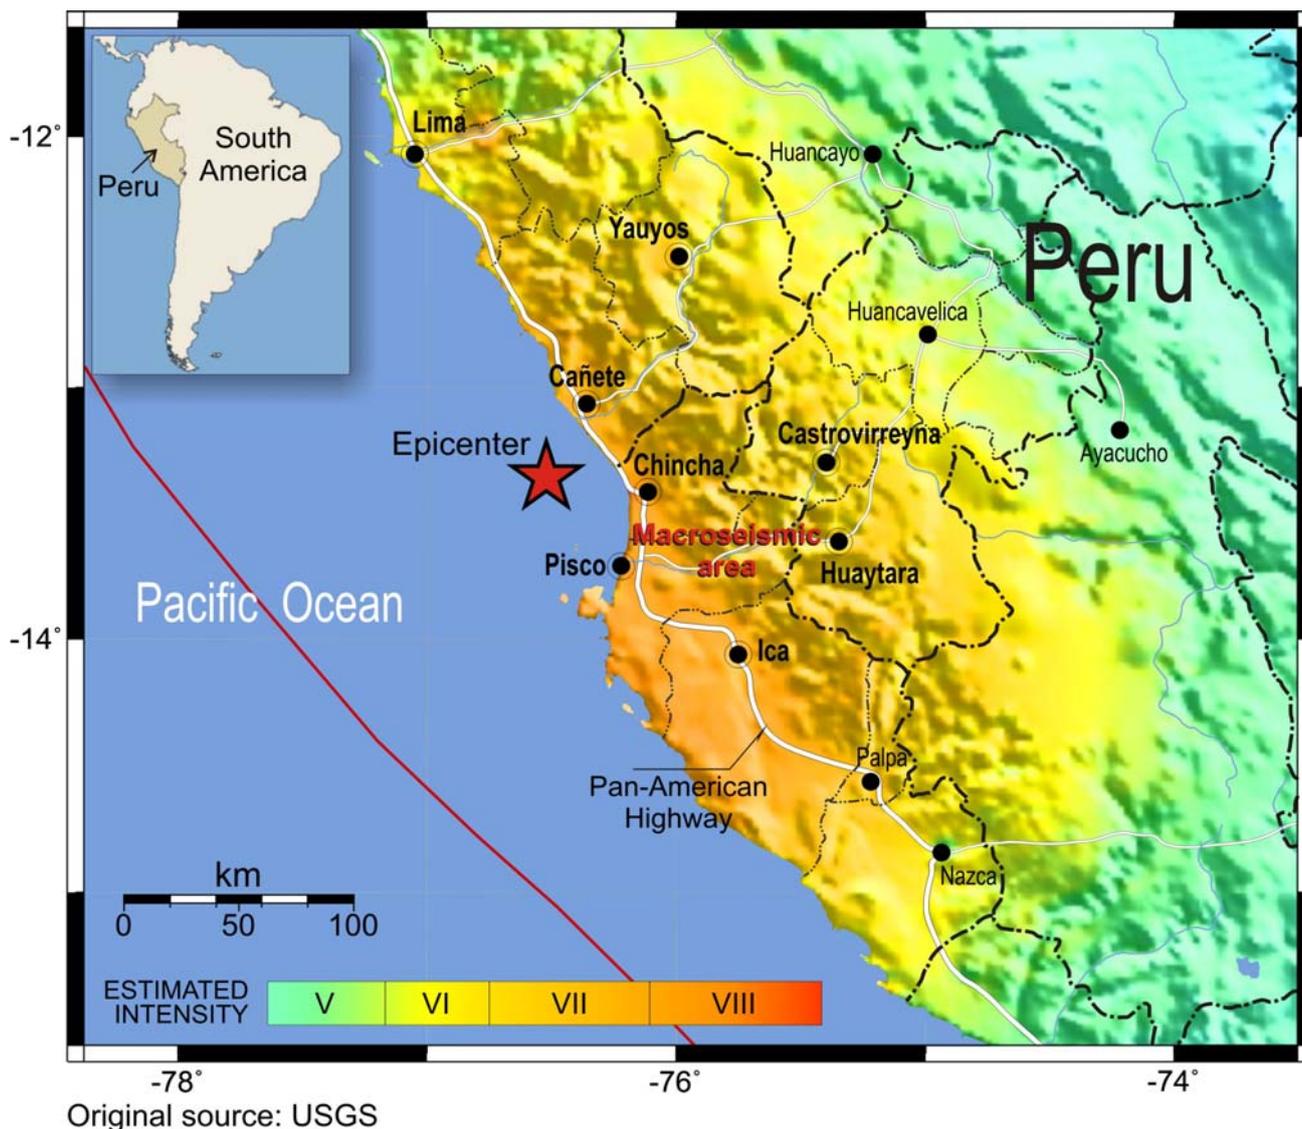
Fig. 1- Macroseismic area of the Ica region or Pisco earthquake, Peru, of August 15, 2007

The macroseismic area included three provinces of the Ica region: Ica, Pisco and Chincha, with Pisco, the capital city of the province of the same name, being the most affected. It also included the provinces of Cañete and Yauyos in the Lima region; and the provinces of Castrovirreyna and Huaytara in Huancavelica (in bold letters in Fig. 1). The death toll was close to 600 people, and approximately 1500 were injured. Some 40.000 houses collapsed, most of them of adobe, and nearly 42,000 dwellings were damaged in different degrees, that need to be retrofitted.

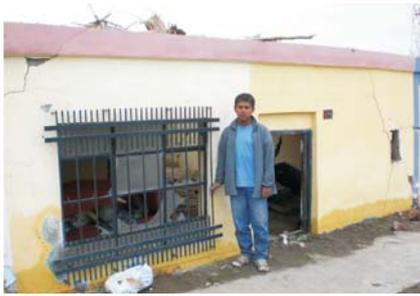
Fig. 2- One-story brick masonry house settled some 0.70 m

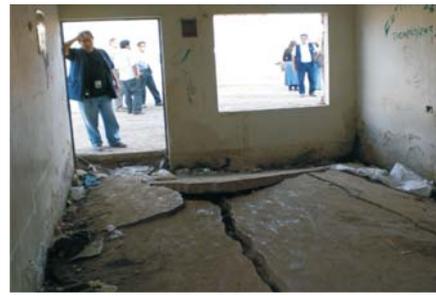
Fig. 3- Notice that the walls have sunk some 0.40 m, and the floor 0.20 m

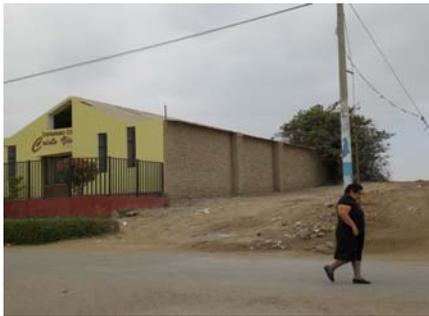
Fig. 4- Adobe walled church, on firm soil, with no damage.

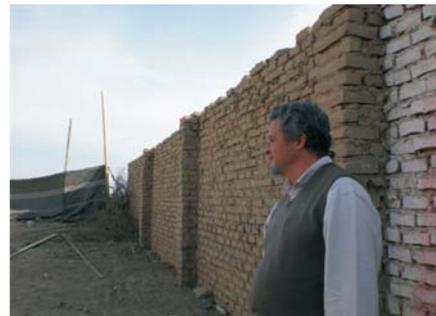
Fig. 5- An adobe fence, 15 m south of the church and 200 m east from the Tambo de Mora main square, undamaged.

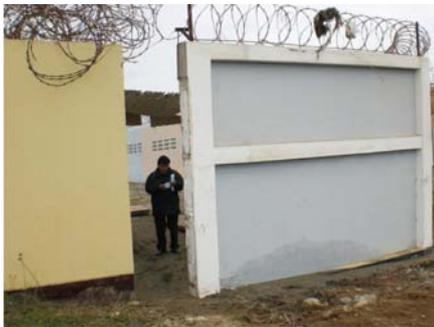
Fig. 6- These two portions of wall were aligned, separated by only 2 cm. An employee of the town hall is seen through “the door opened” by lateral spread.

Arriving from Sunampe to Tambo de Mora, large and numerous cracks were observed at the east side of Tambo de Mora, at the foot of the terrace -where Chinchá Alta and Sunampe are located – indicating that extensive soil liquefaction had occurred there, as expected from the 2001-2002 investigations. At the Calle Nueva street, very close to Tambo de Mora's main square, at both sides of the street along some 300 m., brick masonry one-story dwellings had settled 0.50 to 0.90 m. (Fig. 2). The walls sunk as they transmitted their own weight and that of the reinforced concrete roof to the soil, while the houses' floors remained almost at their original level, but were severely cracked (Fig. 3). About 250 m east of the main square, an adobe evangelical church (Fig. 4) and an adobe fence (Fig. 5), did not suffer any damage, in spite of their obvious vulnerability. They are built on a cut of a small hill, on a dry, firm soil. It is also a case of clear microzonation effect. At the Provincial Jail of Chinchá, located in Tambo de Mora, extensive soil liquefaction occurred and most of the buildings settled from 0.30 to 0.90 m. Lateral spread occurred there. It was clearly observed as walls moved laterally. For example, in a continuous wall, initially separated only by 2 cm -a construction joint- "a door was opened", as a portion of the wall moved laterally and then forward. (Fig. 6).

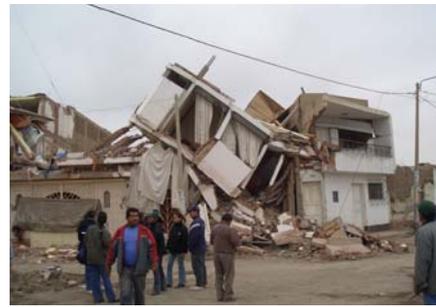
Fig. 7- Collapse of a reinforced concrete building in downtown Pisco.

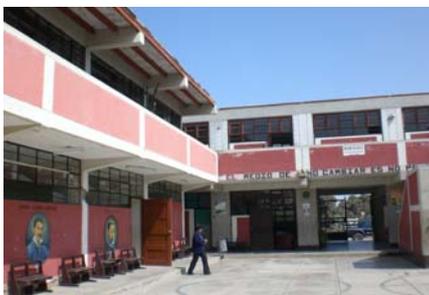
Fig. 8- The school building on the left, designed with the 1977 Seismic Code suffered short-column failure. The one on the right, designed with the 1997 SC was undamaged.

In Ica the most critical threat is flooding, as it was severely inundated during El Niño 1997-98. But in August 2007 only an earthquake occurred, so it was not possible to compare the event's effects with the envelope of the geologic-climatic hazard map. However the area worst affected by the earthquake was the part indicated by the seismic microzonation studies, as on a stepped hill covered by aeolian sand. In San José de los Molinos, located north of the city of Ica, a school was surveyed (Fig. 8). The different seismic behavior of those two buildings was noted. The first, designed with the 1977 Seismic Code, suffered severe damage, while the other building designed with the new 1997 Seismic Code, did not suffer any damage; this is true of all the school facilities designed with that code during the 2001 Arequipa and the Ica 2007 earthquakes. Only two small changes were introduced to Peru's 1977 Seismic Code. The permitted lateral drift was reduced by approximately 30%, and the use coefficient was increased from 1.3 for important buildings, to 1.5 for essential facilities. These two changes were crucial to eliminate the short column defect from Peruvian school buildings. But this was not only a problem found in Peru. During the Philippines 1990 and the Chi-Chi Taiwan, 1999 earthquakes, about half of the buildings that collapsed or were severely damaged were school buildings due to the short column structural defect.

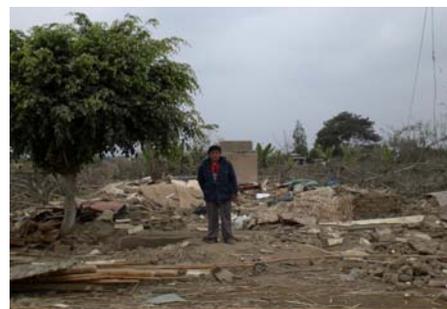
Fig. 9- Over 40,000 adobe houses collapsed mostly in rural areas irrigated by inundation. Entire blocks of houses collapsed in Sunampe, Chinchá and in Hualcara, Cañete.

On August 17, 2007, the rural area, west of Chinchá Alta, was surveyed along the way to Tambo de Mora. In Sunampe, entire blocks of adobe houses collapsed due to their close location to the earthquake source, and the soil humidity as this rural area is irrigated by inundation. Electric transformer posts, and electrical illumination posts, which are standard in shape and size in the macroseismic area, were also taken as a reference to deduce the seismic effects on the sites. For example in Sunampe, the pole of an electric transformer remained vertical, but the oil container, located some 4 m. high, fell and was found 1 – 2 m from the pole, indicating the violence of the vibration. In Tambo de Mora, Pisco and near the Huamani Bridge close to the Pisco River, where soil liquefaction occurred, some poles collapsed and others were inclined at different angles.
