"PARSANT": A "NON DESTRUCTIVE" METHOD FOR ANTI-SEISMIC STRENGTHENING OF EXISTING BUILDINGS

The method refers to the anti-seismic strengthening of existing buildings with a framing system made of concrete, using additional strong exterior bracing panels, pin connected to the existing framing system. The panels are truss type plane systems made of steel composite members and have their own foundations. The pin connection is achieved using steel connectors (tie rods), which go through existing and additional beam members, bolted at both sides. With this method the construction damages to the existing buildings are minimized, without interruption of their use, and with minimum cost and construction time. Due to great rigidity and strength of the additional panels, the overall behavior of the buildings can comply with the recent antiseismic Codes. This paper describes briefly the method and presents the design of strengthening of an existing office building.

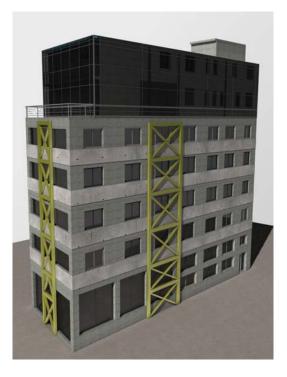
Figure 8: Building after strengthening

Figure 8 represents the exterior of the building after the installation of the additional walls and *Figure* 9 after their covering with perforated steel panels.

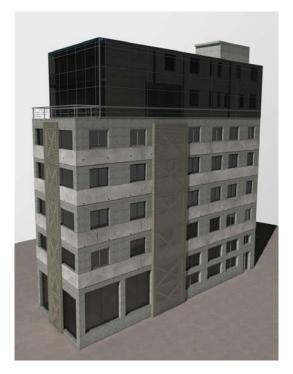
Figure 9: Building after covering of the strengthening

The additional walls are covered by perforated decorative steel panels, which allow the light to access the building.
