LOW-COST REINFORCEMENT OF EARTHEN HOUSES IN SEISMIC AREAS

M. Blondet¹, J. Vargas² and N. Tarque³

ABSTRACT:

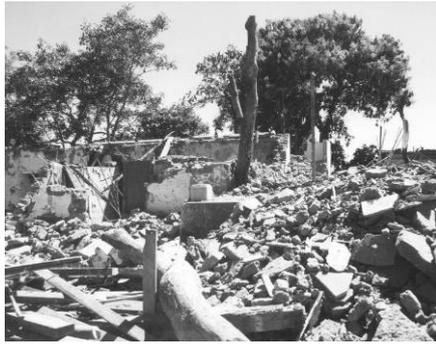
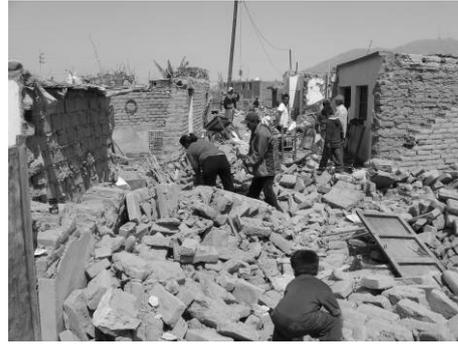
Figure 1 Destruction of adobe houses in El Salvador (2001) and Pisco (2007)

The high seismic vulnerability of earthen buildings is due to a perverse combination of the mechanical properties of their walls: earthen walls are dense and heavy, have extremely low tensile strength and they fail in a brittle fashion, without any warning. As a consequence, every significant earthquake that has occurred in regions where earthen construction is common has produced tragic loss of life and considerable material damage (Fig. 1).

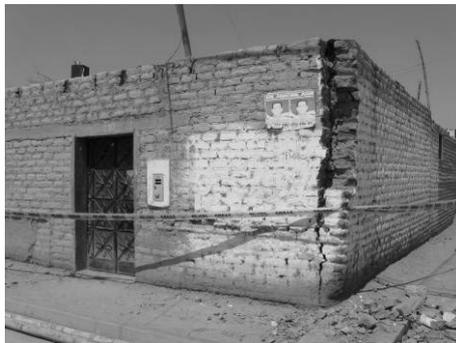
Vertical crack at corner of front wall

Figure 2 Seismic cracks in adobe houses (Pisco earthquake 2007)

During earthquakes the ground shakes in all directions and generates inertia forces that the construction material should be able to withstand. Since the tensile strength of adobe masonry is very low (and much lower than its compressive strength), significant cracking starts in the regions subjected to tension. Seismic forces perpendicular to the walls produce out-of-plane bending, and vertical cracking starts at the lateral corners of the walls, where the tensile stresses are higher. Large vertical cracks that separate the walls from one another are thus produced (Fig. 2, left). Front walls are usually the first to collapse in an earthquake, overturning onto the adjacent street. Lateral seismic forces acting within the plane of the walls generate shear forces that produce diagonal cracks, which usually follow stepped patterns along the mortar joints. The diagonal cracks often start at the corners of doors and windows, due to the stress concentration at these locations (Fig. 2, right). If the seismic movement continues after the adobe walls have cracked, the wall breaks in separate pieces, which may collapse independently.

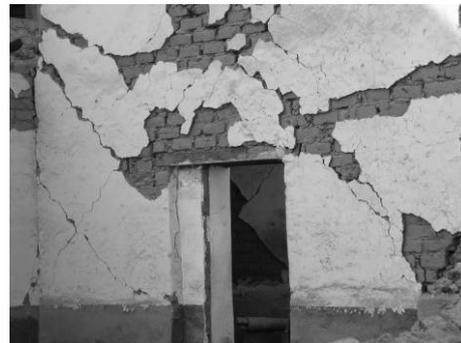
Diagonal cracks

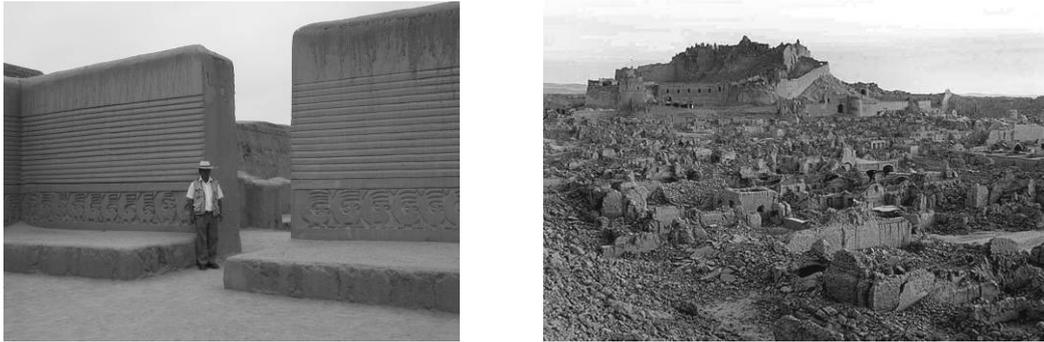
(Photo at right: Cultural Heritage News.)
Figure 3 Ancient earthen citadels of Chan-Chan and Arg-e Bam

In Peru, many historical earthen constructions have been able to withstand severe earthquakes because of their massiveness and regular configuration. For example, the Chan-Chan archeological site (1200 CE), located on the coast of Peru, is considered to be one of the world's largest mud citadels, and has survived many severe earthquakes during the past 600 years. Decorated boundary earthen walls, some of them up to 9 m tall and 3 m wide at the base, can be found in the citadel. Many long and slender walls without buttresses are still standing (Fig. 3, left). On the other hand, the 2003 Bam earthquake in Iran has destroyed not only several thousands of poorly made adobe houses, but also important ancient historical monuments such as the earthen citadel of Arg-e Bam (500 BCE; Fig. 3, right). This seriously undermines the argument of massiveness as a guarantee for earthquake endurance. The architectural design of the Bam citadel and surroundings includes upper thin walls standing over thick base walls, irregular plan configurations, and high wall densities. It seems that slender walls have collapsed, impacting adjacent walls and constructions, causing total destruction of the site, in spite of its massiveness.

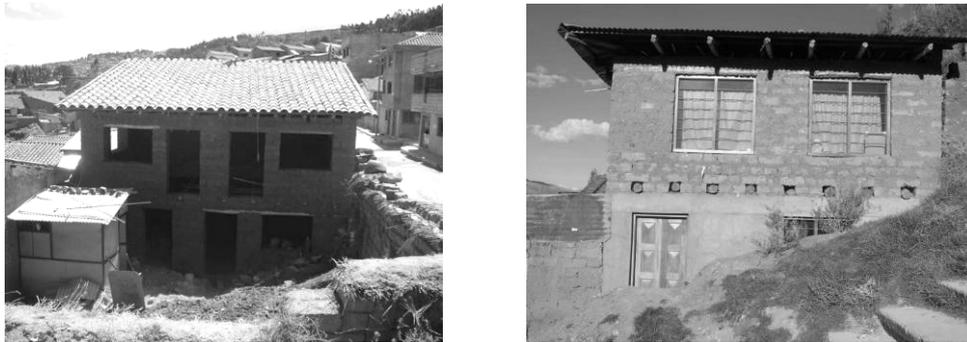
Figure 4 Contemporary adobe houses in Cusco, Peru

Most vernacular earthen houses are built without any professional intervention, and thus with poor construction quality. Furthermore, they tend to imitate the architectural features of clay masonry houses. Therefore, most present-day earthen houses are built without any structural reinforcement, with several stories, thin walls, large window and door openings and irregular plan and elevation configurations (Fig. 4). These buildings are extremely vulnerable and suffer significant damage or collapse during earthquakes.

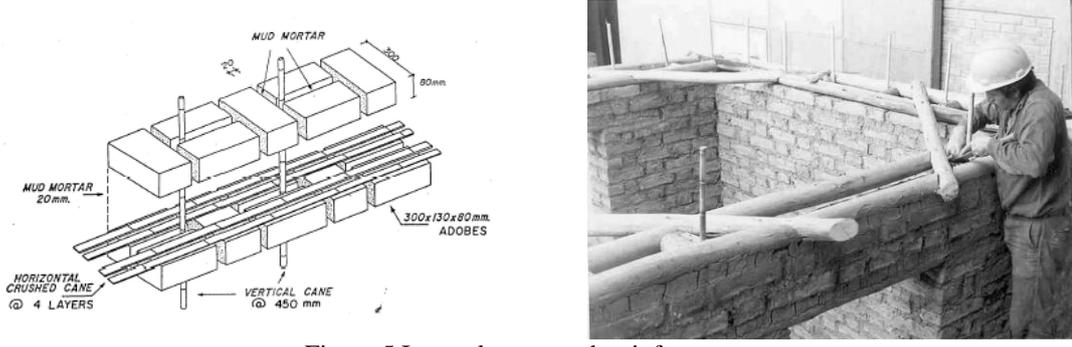
Figure 5 Internal cane mesh reinforcement

The reinforcement consists of vertical cane rods anchored to a concrete foundation and placed inside the adobe walls. The adobe block layout defines the distance between the vertical cane rods at 1,5 times the thickness of the wall. Horizontal layers of crushed canes are placed every few adobe rows and tied to the vertical cane reinforcement (Fig. 5, left). Finally, this internal cane mesh reinforcement is tied to a wooden crown beam (Fig. 5, right).

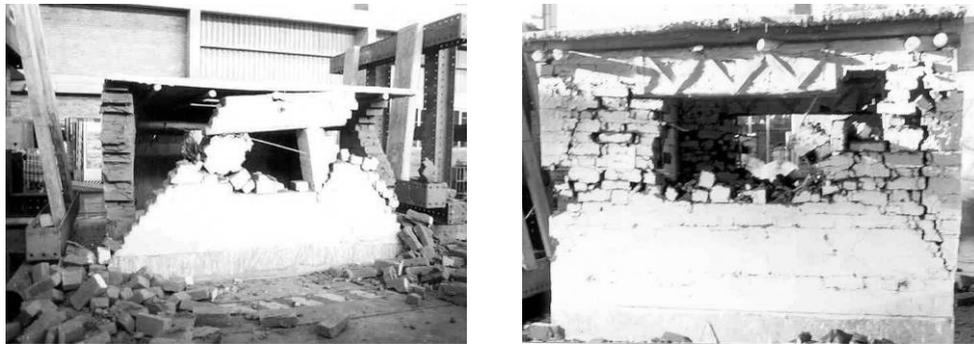
Figure 6 Adobe models after seismic tests. L: Unreinforced. R: Reinforced with cane

This reinforcement system has demonstrated excellent response in full-scale shaking table tests (Blondet et al. 1988). Figure 6 shows the collapse of a full scale adobe house model subjected to simulated seismic motion (left). During a similar test, the model reinforced with an internal cane mesh suffered significant damage, but did not collapse.

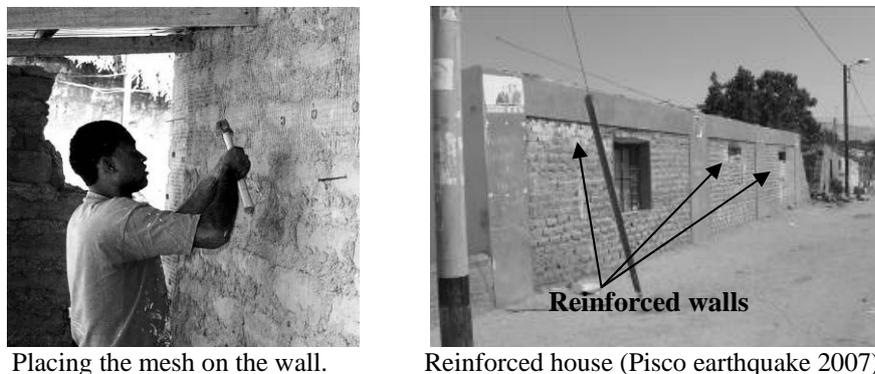
Placing the mesh on the wall. Reinforced house (Pisco earthquake 2007)
 Figure 7 External wire mesh reinforcement

This technique consists of nailing wire mesh bands against the adobe walls and then covering them with cement mortar. The mesh is placed in horizontal and vertical strips, following a layout similar to that of beams and columns (Fig. 7).

failure was brittle during a strong test (Fig. 8, left). During a moderate earthquake in Peru, while surrounding houses were severely damaged or destroyed, houses reinforced with this system did not suffer any damage and were used as shelters (Zegarra et al.1997 and 2001) as shown in Fig. 7 and 8, right.

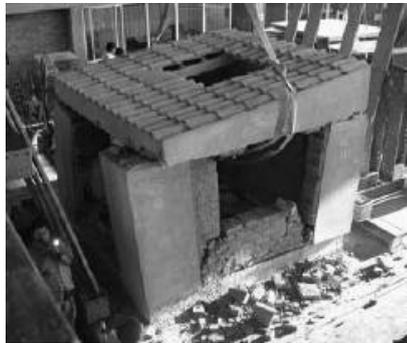
Reinforced model after seismic test

Figure 8 Adobe buildings with external wire mesh reinforcement

This reinforcement system provided significant additional strength to adobe models under earthquake simulation tests. The performance of the model was adequate during moderate and severe shaking. However, the mode of

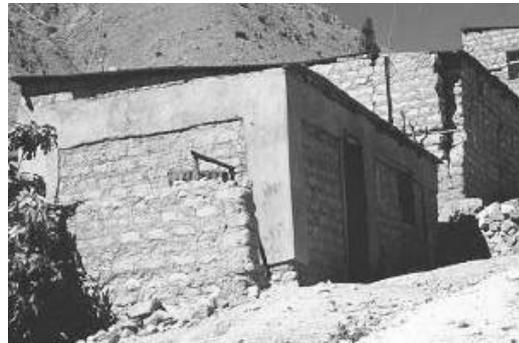
Reinforced house (Arequipa earthquake 2001)

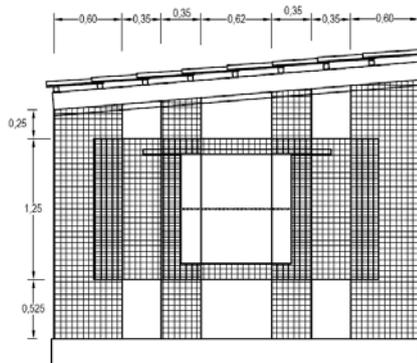
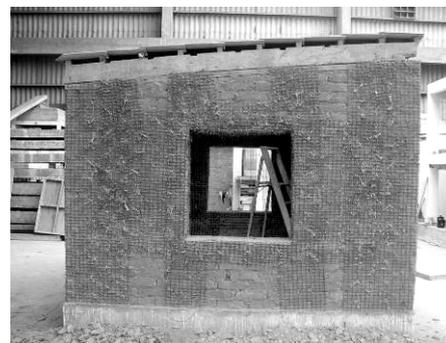
Figure 9 External geogrid mesh reinforcement (75% of walls covered)

A recent study has been performed at PUCP to evaluate the possibility of using polymer mesh to reinforce earthen buildings (Blondet et al. 2006). Several similar full-scale adobe housing models with different amounts and types of polymer mesh were tested on the PUCP unidirectional shaking table. The reinforcement provided consisted of bands of polymer mesh tied to both sides of the walls with plastic string threaded through the walls (Fig. 9).

The first models were reinforced with different amounts of geomesh and they showed good dynamic response during the earthquake simulation tests: although the adobe walls suffered some damage, collapse was avoided even during very strong shaking. As expected, however, the amount and spread of damage on the adobe walls increased as the quantity of polymer mesh reinforcement decreased.

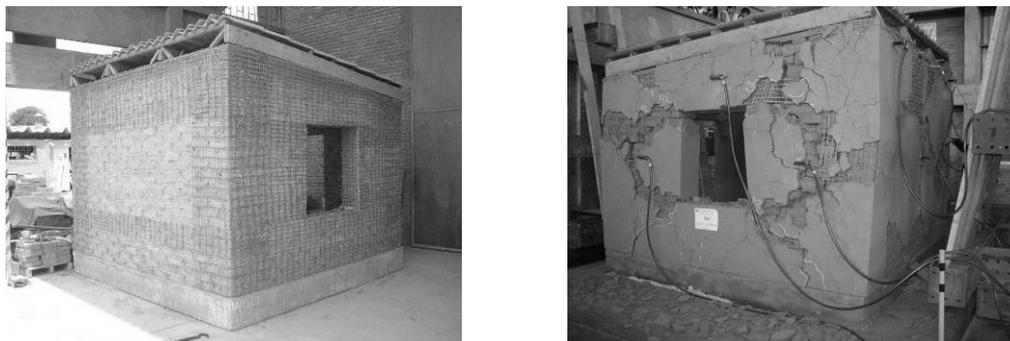
Figure 10 Adobe model reinforced with plastic mesh

Since geogrid polymer mesh is quite expensive in Peru, it was decided to study the use of a cheaper plastic mesh, usually employed as a soft safety fence in construction sites. The adobe model shown in Fig. 10 was reinforced with bands of plastic mesh located in the regions where most damage was expected on the adobe walls. The plastic mesh bands were tied to the walls with plastic string placed across the walls during construction. After a strong shaking test, the adobe walls were broken into several large pieces, which were held together by the plastic mesh. The mesh was deformed and broken in several places, indicating that the amount provided was barely adequate. It is clear, however, that although the building suffered significant damage, collapse was
