## DETERMINATION OF BUILDING DAMAGE DUE TO EARTHQUAKES USING AERIAL TELEVISION IMAGES

### SUMMARY

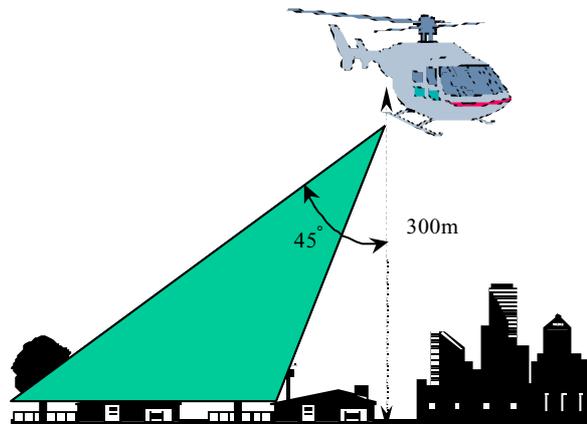
Figure 1: Schematic figure of helicopter loading the HDTV recording system by NHK

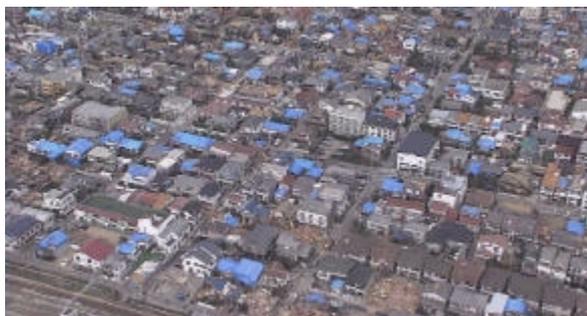
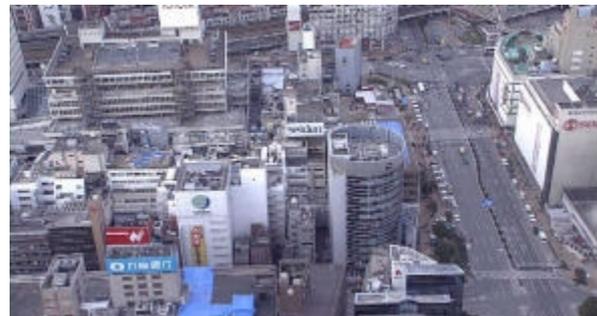
(a) Area 1 in Nishinomiya

(b) Area 2 in Kobe

Figure 2: Example of the aerial HDTV images taken by NHK

The aerial recording for all the damaged areas due to the Kobe earthquake was started shortly after the event by Japan Broadcasting Corporation (NHK). In this study, some of these images of Nishinomiya City and Kobe City were used. These images were taken at an angle inclined 30-45 degrees from the vertical direction, from a height of about 300m (Figure 1). Because these images were taken using NHK's high-definition television (HDTV) cameras and are of much higher quality compared with conventional television images, detailed damage information could be obtained. The HDTV images were converted to the data format (bitmap file of 1035×1920pixel) on a personal computer, and building damage was interpreted visually on the computer display. An example of the aerial HDTV images is shown in Figure 2.

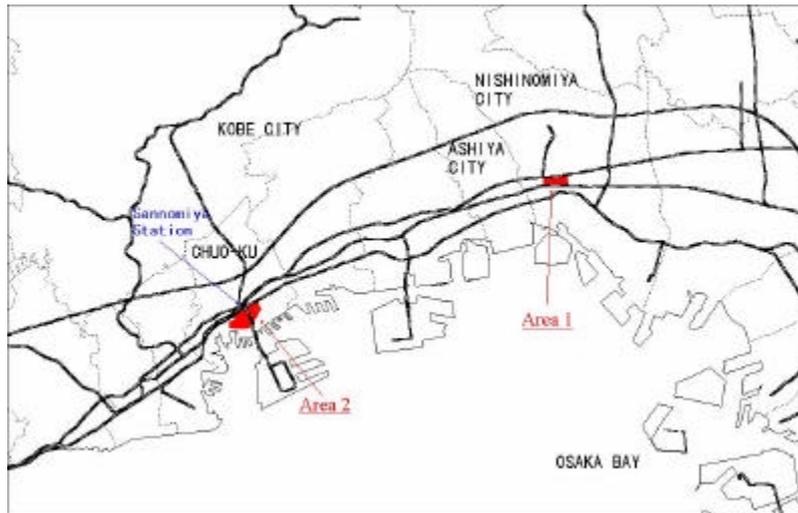
Figure 3: Residential area (Area 1) and commercial area (Area 2) selected in this study

The areas of this study were 7 blocks (about 0.37km<sup>2</sup>) in Nishinomiya City and 18 blocks (about 0.97km<sup>2</sup>) in Chuo-ku, Kobe City, as shown in Figure 3. The study area (Area 1) of Nishinomiya City is mainly residential and most of the buildings are wooden. In the area, many buildings suffered severe damage due to the earthquake as shown in Figure 4 (a). On the other hand, the study area (Area 2) of Kobe City is in a commercial zone located on the south side of Sannomiya Station, and most of the buildings are nonwooden (steel, reinforced concrete etc.) mid- to high-rise buildings. The classification of building damage due to the earthquake in this area is shown in Figure 4 (b). In this study, the damage to wooden buildings was extracted for Area 1 and that to nonwooden buildings was extracted for Area 2.

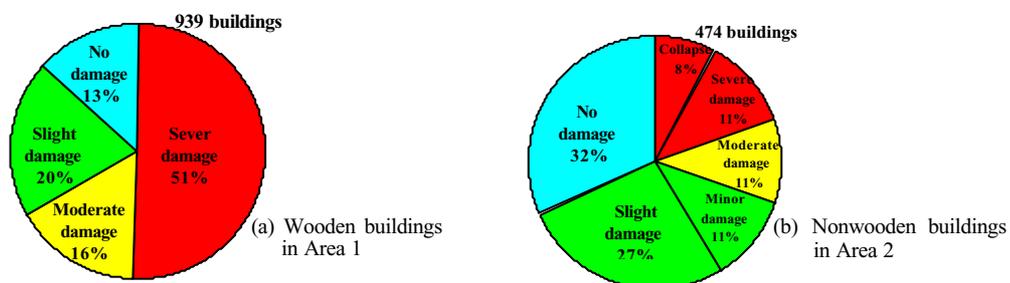
Figure 4: Damage levels based on the ground surveys: wooden buildings in Area 1 [AIJ and CPIJ , 1995] and nonwooden buildings in Area 2 [AIJ, 1995]

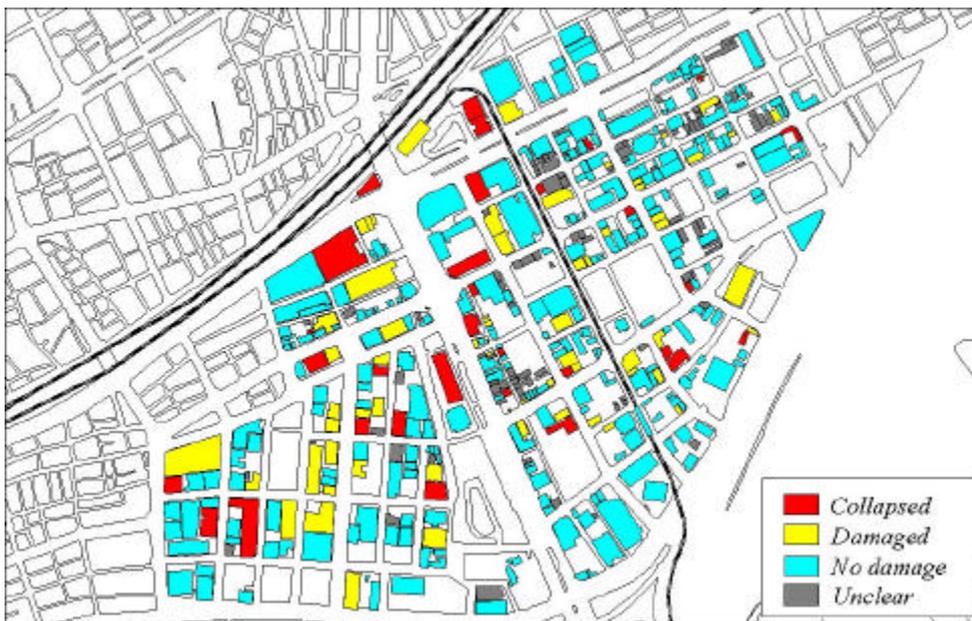
**Figure 6: Distribution of building damage in Area 2 interpreted from the aerial HDTV images**

In the study areas, the number of buildings whose degree of damage was evaluated from the ground surveys is 939 wooden buildings in Area 1 and 474 nonwooden buildings in Area 2. The distribution of building damage in Area 1 from the aerial HDTV images is shown in Figure 5 and that in Area 2 is shown in Figure 6. The result for the wooden buildings in Area 1 was given as the average of the results obtained by the five people, who engaged in the damage extraction. Interpretation of damage to most buildings was possible for Area 1 (97%). But the rate in Area 2 was lower (79%) than Area 1. The reason for this is that we used aerial images taken from an oblique angle in this study, and thus more buildings were blocked from view in Area 2 than in Area 1. Therefore, the extraction results for the both areas were evaluated without including the buildings for which damage extraction using the aerial images was impossible.

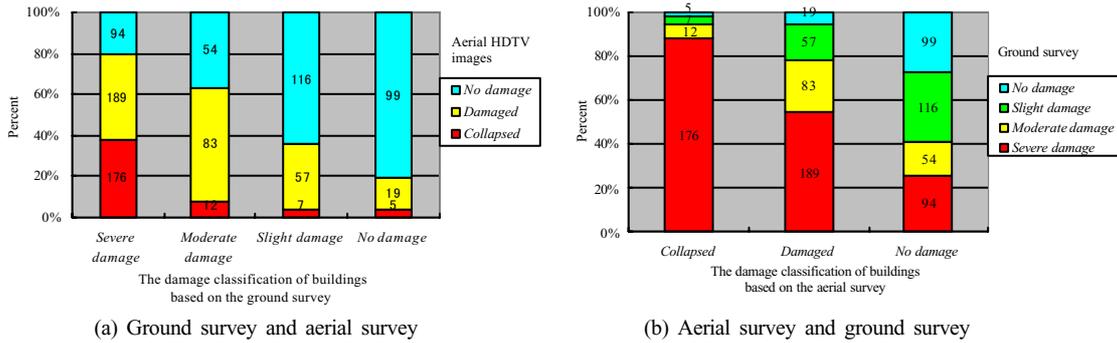
Figure 7: Relationship between the damage classifications for wooden buildings in Area 1 by two surveys

For the wooden buildings in Area 1, the relationship between the damage classifications in the ground survey and in the aerial HDTV image interpretation is shown in Figure 7 (a). In this figure, the result for the aerial survey is the average of the results obtained by the five people. The damage classification *burned* (2 buildings) in the ground survey was included in the *severe damage* classification. It is observed that 80 percent of *severely damaged* buildings in the ground survey corresponded to *collapsed* or *damaged* buildings in the aerial HDTV images. Furthermore, the 64 percent of *moderately damaged* buildings in the ground survey corresponded to *collapsed* or *damaged* buildings in the aerial HDTV images.

A similar plot by changing the reference from the ground survey to the aerial HDTV images is shown in Figure 7 (b). In this figure, 54 percent of *damaged* buildings based on the aerial HDTV images corresponded to *severe damage* by the ground survey, and 23 percent of *damaged* buildings based on the aerial HDTV images corresponded to *moderate damage* by the ground survey. *No damage* based on the aerial HDTV images almost corresponded to *slight damage* or *no damage* by the ground survey. It is pointed out that *slight damage* by the ground survey could not be interpreted using the aerial HDTV images due to the resolution.

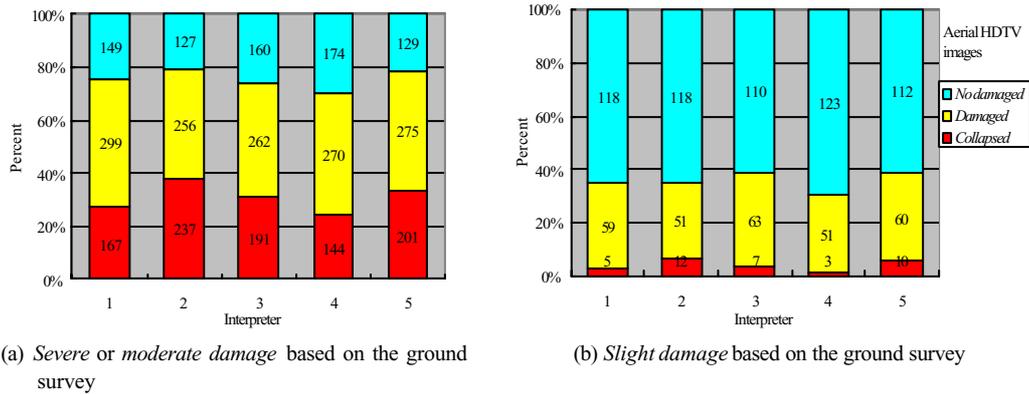
Figure 8: Difference in the results of five interpreters of the aerial HDTV images for (a) severe and moderate damage and (b) slight damage in the ground survey

The difference in the damage interpretation results between individual interpreters was examined. The relationship between the result of each person interpreting the aerial HDTV images and that by the ground survey is shown in Figure 8. It is found that *severely* or *moderately damaged* buildings could mostly be interpreted using the aerial HDTV images by all the interpreters while *slightly damaged* buildings could not be identified well.

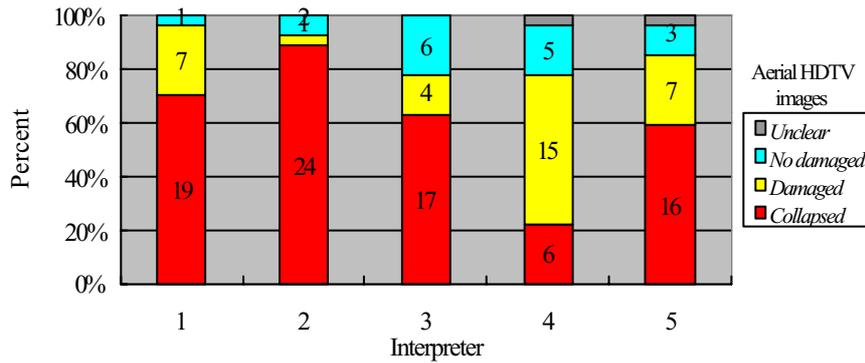
**Figure 10: Difference in the results of five interpreters of the aerial HDTV images for the 27 collapsed buildings with photographs**

The 55 wooden buildings in Area 1 were classified into 3 damage level (*collapsed*, *damaged* and *no damage*) using photographs taken at the time of the damage survey (Table 4). Figure 9 shows an example of photographs and aerial HDTV images for a damaged building. Figure 10 plots the results of the five interpreters for the 27 collapsed buildings with photographs. It was found that the interpretation results for the collapse-type damage of buildings changed with interpreters. One factor for this fact might be time spent for interpretation; the time spent by Interpreter-4 was about 3 hours while other persons spent more than 5 hours. Furthermore, the criterion of interpretation of collapsed buildings from the aerial HDTV images was not very strict. Therefore, a further elaboration on the damage interpretation from aerial HDTV images may be necessary.

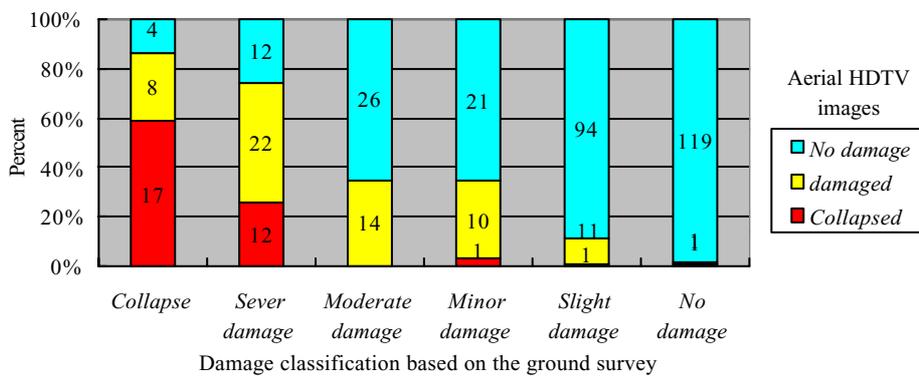
**Figure 11: Relationship between the damage classifications for nonwooden buildings in Area 2 based on the ground survey and the aerial HDTV images**

The relationship between the damage classifications in the ground survey and in the aerial HDTV image interpretation is shown in Figure 11. It is observed in the figure that 59 percent of *collapsed damage* in the ground survey was extracted as *collapsed* using the aerial HDTV images. Most (86%) of the *collapsed* buildings in the ground survey corresponded to *collapsed* or *damaged* in the aerial HDTV images. However, 14 percent of *collapsed* buildings in the ground survey could not be confirmed in the aerial HDTV images. The reason is that the damaged parts located in the blind spot of the aerial HDTV images, i.e., in a shadow of other buildings, or the damage position was different from the direction from which the image was shot. However, since the identifications of layer-collapsed type damage and damage to walls were mostly possible, the advantage of using the aerial images taken at an oblique angle was confirmed. It is observed in Figure 11 that 74 percent of *severely damaged* buildings in the ground survey corresponded to *collapsed* or *damaged* buildings in the aerial HDTV images. *Moderately damaged*, *minorly damaged*, and *slightly damaged* buildings in the ground survey could not be identified well using the aerial HDTV images. It was confirmed that damage classification of nonwooden buildings extracted from the aerial images corresponded to *collapsed damage* and *severe damage* based on the ground survey. Hence, the aerial HDTV images may be useful for the capture of hard-hit areas at an early stage.
