EXPERIMENTAL STUDIES ON THE CYCLIC RESPONSE OF FULL-SCALE STEEL BEAM-COLUMN CONNECTIONS

Egor P POPOV¹, Marcial BLONDET² And Lev STEPANOV³

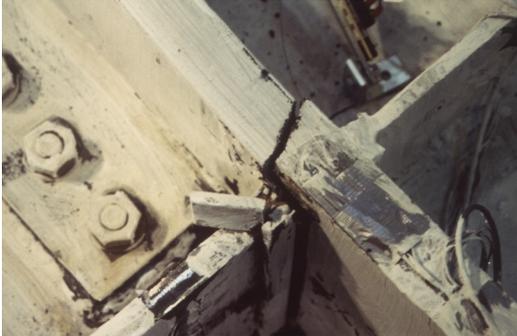
Figure 4: Column failure of specimen PN1

Although the specimens were designed to induce beam failure, in two cases (PN1 and PN2), the failure was in the columns (Fig. 4). This unexpected mode of failure was explained later, when it was determined that, by

mistake, the fabricator had made the beams with Gr. 50 steel, instead of the specified A36 steel. This mistake was fortunate, because it was the first time that column failure could be reproduced in a laboratory. It is plausible that this kind of problem can occur in the field, due to the high variability in the material properties of steel available in the US. The third specimen (PN3) failed through the beam full penetration weld at the column face. Such failures were typical in other laboratories.
