## POST-EVENT DATA COLLECTION USING MOBILE GIS/GPS AND DEVELOPMENT OF SEISMIC EVALUATION TECHNIQUE FOR DAMAGE

Satoshi IWAI<sup>1</sup> And Hiroyuki KAMEDA<sup>2</sup>

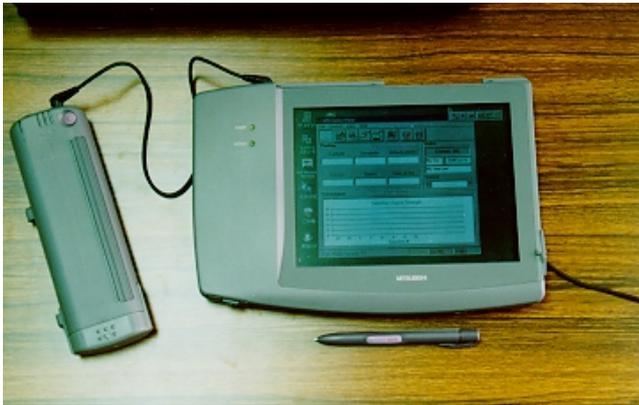
Photo 1 Mobile data acquisition system.

A mobile data acquisition system using GIS (Photo 1 and Fig. 1) is developed for inspectors and/or researchers who want to collect and/or update building and lifeline facility data for the present status in pre-event period and their damages in post-earthquake reconnaissance. In this system, GPS receiver provides positions and field information for GIS functions (Photo 2 and Fig. 2). So the system enables operators to easily navigate to features and to update GIS data when performing routine maintenance or inspections for buildings and other urban facilities. Data collection system's hardware and software are as follows.

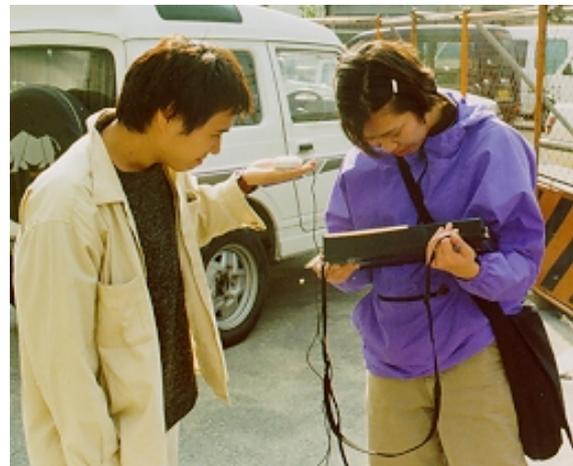
Photo 2 Field test scene.

#### (b) GPS test runs for position accuracy (Photo 2)

- Time for capturing 3 or 4 satellites: first stage = 9 minutes, second stage = 5 minutes, third stage = 1 minutes.

- Position accuracy (Autonomous): first stage = 47 meters, second stage = 22 meters, third stage = 34 meters.

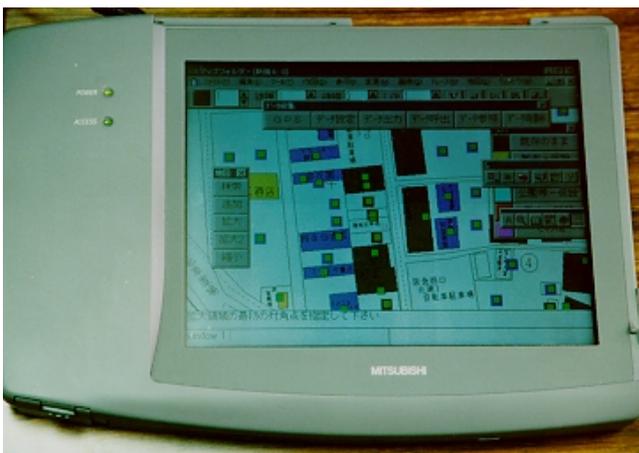
Fig. 1 Data Acquisition in Post-earthquake Reconnaissance using GIS/GPS.

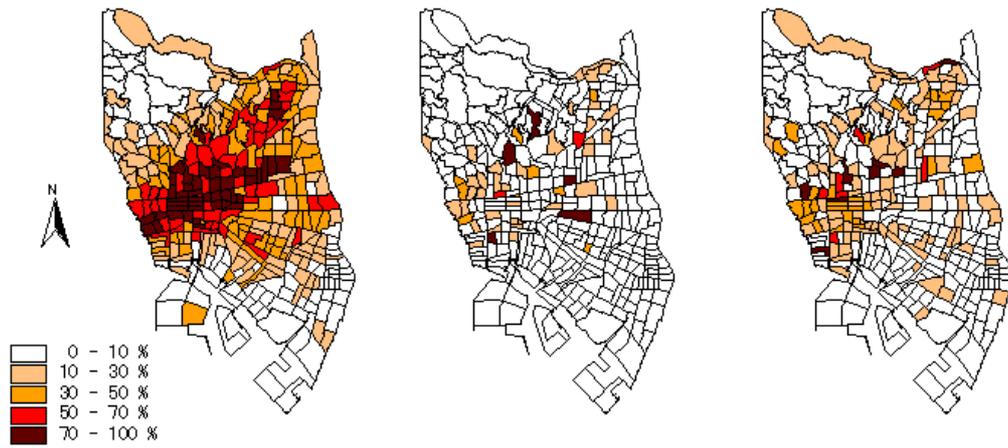
(a) Wood houses.

(b) Reinforced concrete buildings.

(c) Steel buildings.

Fig. 7 Distribution of collapsed buildings.
