SEISMIC ISOLATION RETROFIT IN JAPAN

SUMMARY

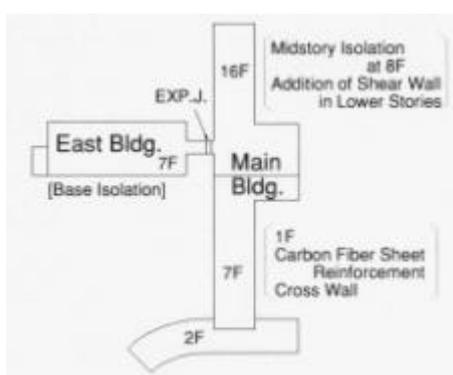
Figure 1 Layout of buildings

The two retrofit buildings are used as the personnel-training center of Taisei Corporation. The site is located in the central part of Japan on the Pacific coast, where earthquakes of Richter magnitude 7 to 8 are worried to occur in the near future. Layout of buildings is shown in Figure 1. Main building is a 16 storied steel encased reinforced concrete building with 7 and 2 storied reinforced concrete portion, whose height is 49m. It is built on direct foundation whose level is partially varied along slope of the ground. East building is a 7 storied reinforced concrete building supported on reinforced concrete piles of 30cm diameter and 6m length. The total floor area is 15,658 . They were built in 1964 and more than 30 years have passed since then. Whole view of the buildings is shown in Figure 2.

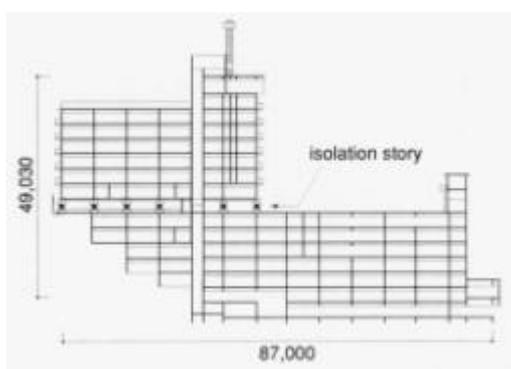
Figure 3 Section of Main Bldg.

Mid-story isolation at the 8th floor was chosen for the main building, as it is partially underground from the 7th floor below. It is difficult to put isolators below the existing foundation stepwise along slope. Mid-height portion of all twenty-two columns of the 8th floor was cut off to install a lead rubber bearing (LRB). Longitudinal section of the main building is shown in Figure 3. Among 22 units of isolator, 4 units are 80cm in diameter and 18 units are 70cm, whose layout in plan is shown in Figure 4.

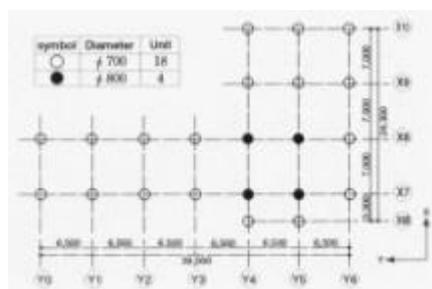
Figure 4 Layout of isolators (Main Bldg.).

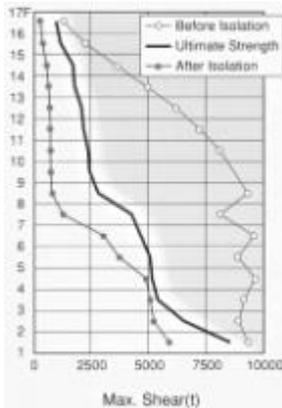
Figure 5 Response reduction

By the preliminary linear response analysis maximum acceleration and shear force of the upper structure above isolators are reduced to 1/5~1/10 of the elastic response of the existing structure (Figure 5). Nonlinear response analysis was done by the 3D model as shown in Figure 6. As seen in Figure 7, no strengthening is necessary in the upper structure. In the lower structure seismic loads are also reduced by large amount. However, to prevent the torsional motion parallel to the slope and to enhance the stability of the lower structure, reinforced concrete shear walls were added in some stories. Also columns on the 1st floor were jacketed by carbon fiber sheet and also strengthened by putting precast concrete cross wall between columns.

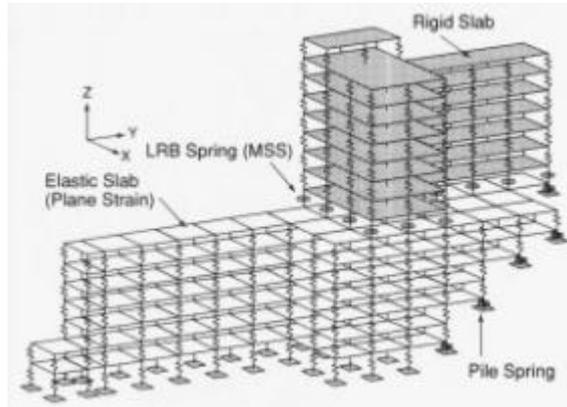
Figure 6 3D model of main bldg.

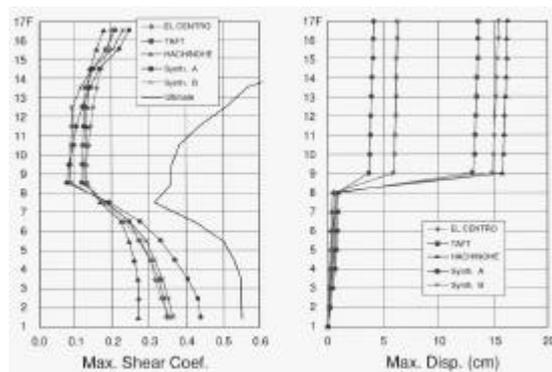
Figure 7 Response of main bldg. (X direction, Y4 axis)

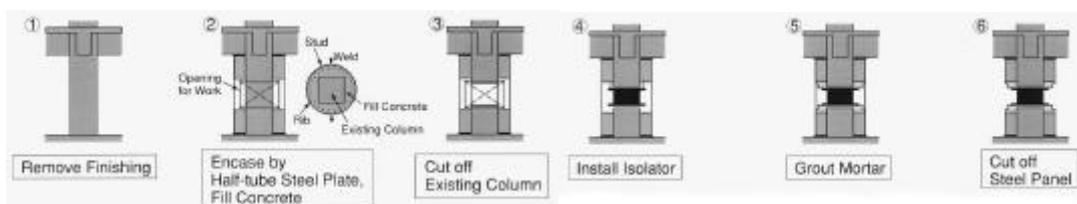
Figure 8 Reform process of mid-story isolation

Non-jack method was adopted to support 6,500tf upper structure during cutting and reform 22 columns. As shown in Figure 8 the reform work was done.

It was designed so as to maintain the safety of the building during the reform procedure even in case of earthquake. Due to the transition of vertical load from column to tube and from tube to isolator, about 1mm and 3mm settlement occurred respectively. No harmful differential settlement or cracking of concrete members was observed. Prior to the execution of the work, full-scale model test was done to assure the safety and workability of the method.

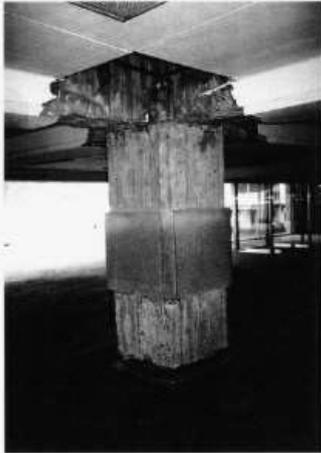
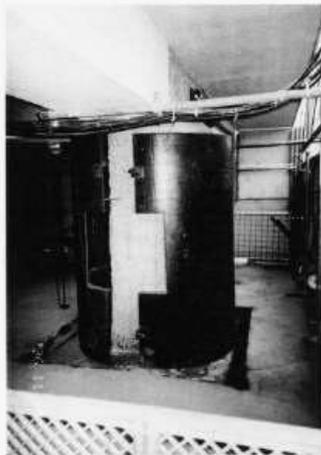
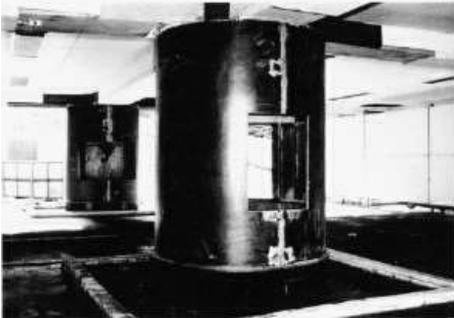
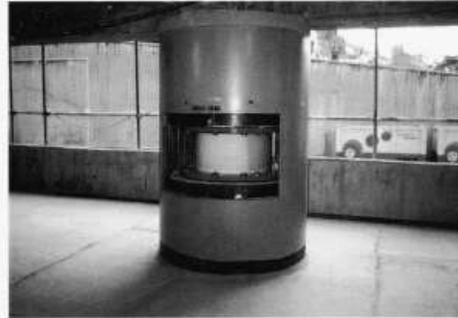
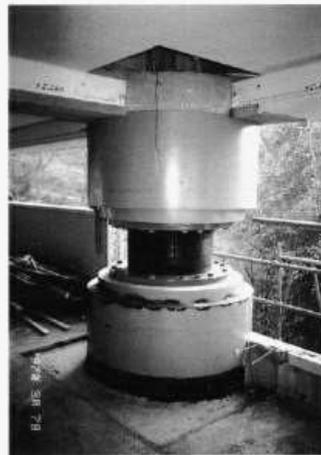
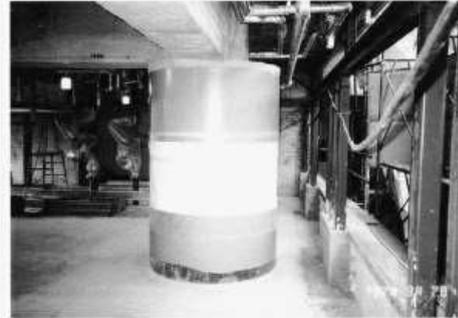
Figure 9 Reform work of mid-story isolation

(1) Remove Finishing

(4) Install Isolator

(2) Encase by Half-tube Steel

(5) Cut off Steel Panel

(3) Cut off Existing Column

(6) Cover for Fire-resistance

Figure 9 is the photos of actual work. As jacks and laborious temporary works were not necessary, the work site was very neat and reliable. Owing to the well-schemed method, the construction time was quite short. The total time was 9 months from August 1996 to April 1997.

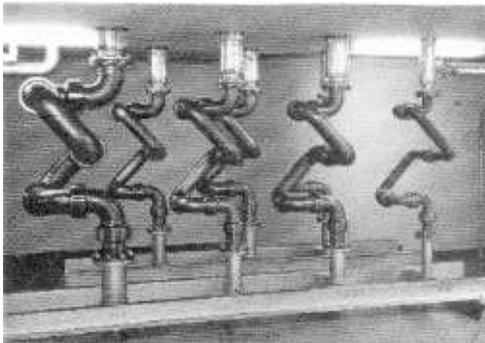
Figure 10 Swivel joint

Piping, elevator, staircase and walls were schemed so as to be able to move maximum 40cm which is twice as much as the maximum response displacement of the isolation floor. The maximum drift of the isolation story is 7cm for level-1 earthquakes and 18cm for level-2 ones. Pipes were connected by swivel joint (Figure 10) or flexible metal/rubber joint. Deflection-smoothening mechanism (Figure 11) was installed for the elevator to move smoothly even when displaced as much as 20cm in the isolation story. Dislocation of guide mechanism and collision of cage with pit wall can be avoided.

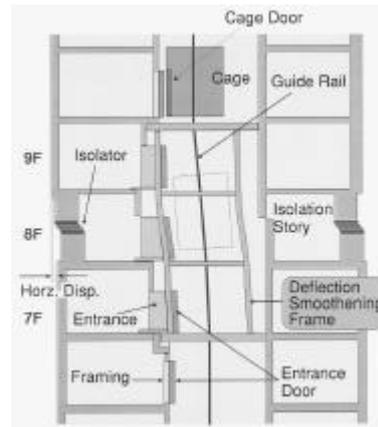
Figure 11 Deflection following elevator

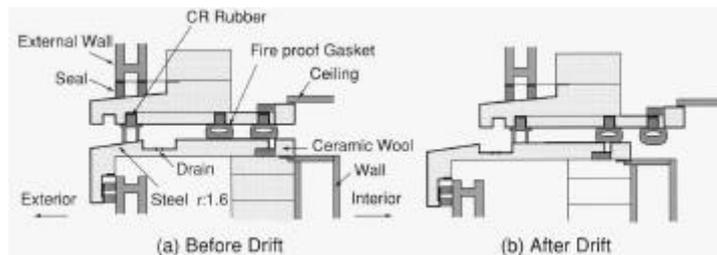
Figure 12 External wall with horizontal slit

Exterior wall was composed to have horizontal slit with rain barrier and fire-resistant gasket (Figure 12) which is effective up to 10cm relative displacement. Fire-resistant casing of isolator is tubular prefabricated ceramics of 2 hours fire-resistance capability. It is split horizontally to allow lateral sliding motion. For the convenience of inspection of isolator, a small window is prepared.

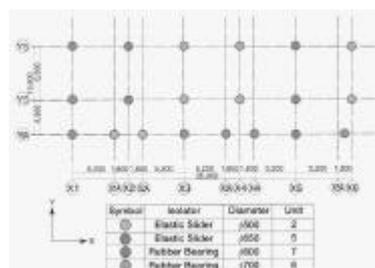
Figure 14 Layout of isolators

Base isolation was adopted for the east building which is supported by piles on flat ground. Piles were cut at their head to install rubber and sliding isolators. Figure 13 is the longitudinal section of the east building. Figure 14 is the layout of isolators; 7 units of sliders and 13 units of rubber bearings. In this case "Hybrid TASS system" was used, which is the combination of rubber bearings and sliding bearings in parallel. This system is superior to the conventional rubber bearing system, as more elongation of equivalent natural period and more absorption of response energy can be realized.

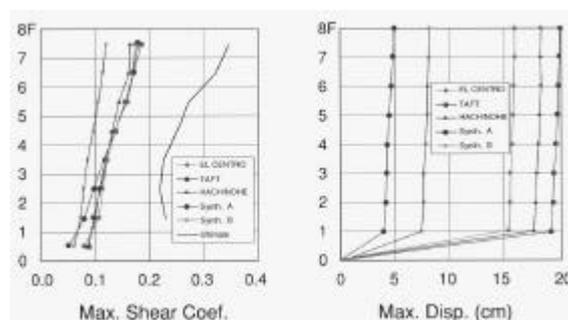
Figure 15 Maximum response of east bldg.

The fundamental period in X direction has been changed from 0.51sec to 1.43sec before sliding and 4.07sec after sliding. That in Y direction has become from 0.24sec to 1.38sec before sliding and 4.05sec after sliding. Nonlinear response analysis was conducted, whose results are shown in Figure 15 in terms of maximum shear coefficient and displacement.

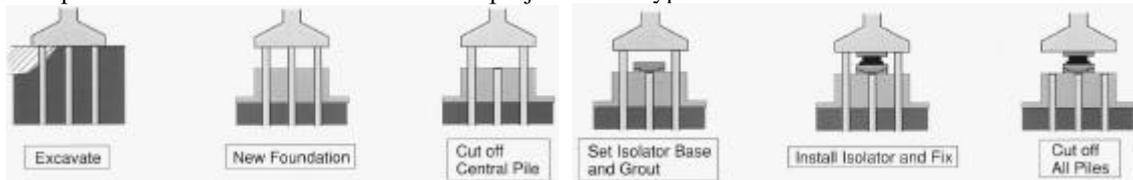
Figure 16 Reform process of base isolation retrofit

Figures 16 and 17 show the work procedure of base isolation retrofit. As there is an open courtyard in front of the building and also the 1st floor level of the east building is elevated as high as the 2nd floor level of the main building, excavation was done laterally from the front side more easily.

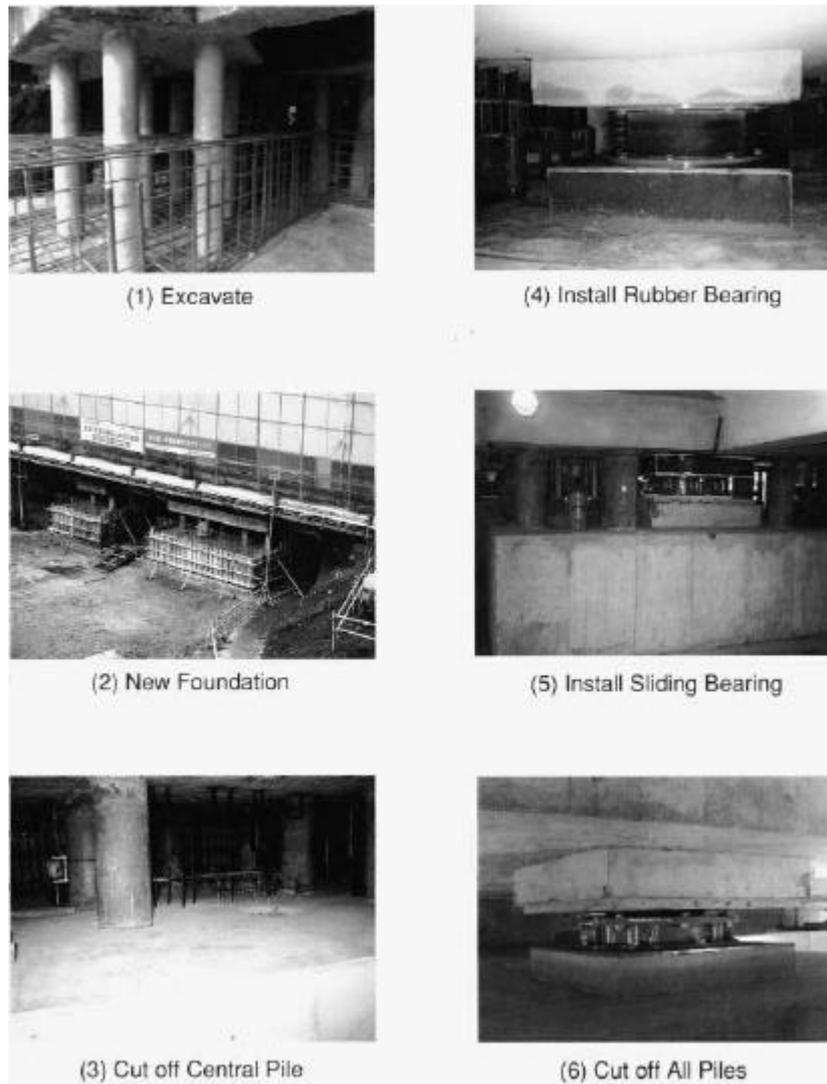
Figure 17 Reform work of base isolation retrofit

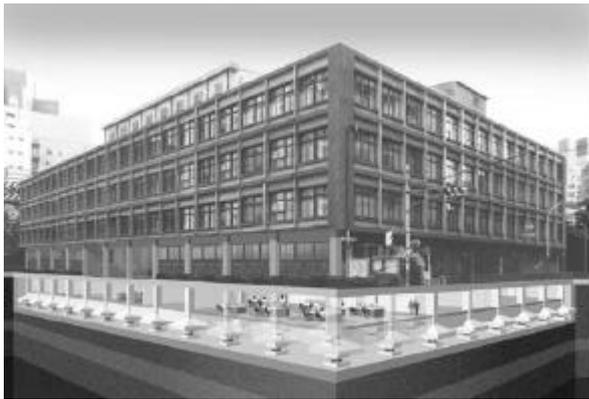
Figure 18 Base isolation retrofit of a government building (Toshima-Ward, Tokyo)

Figure 18 is the government office of Toshima-Ward of Tokyo. It is now under construction of seismic isolation retrofit putting rubber and sliding isolators below the existing foundation. The building is used as usual by officials and citizens even during the construction work.

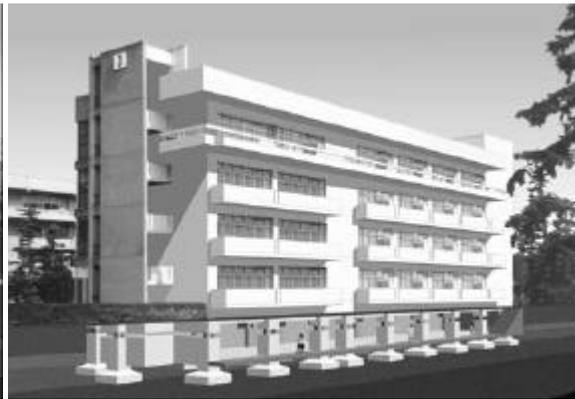
Figure 19 Mid-story isolation retrofit of a school building (Nihon University)

Figure 19 is the school building of Nihon University, where mid-story isolation is applied at the top of the columns of basement floor. Also in this case the building is used for research and education uninterrupted during construction work.
