Experimental Investigations on the Seismic Performance of Un-Retrofitted and Retrofitted RC Frames

SUMMARY:

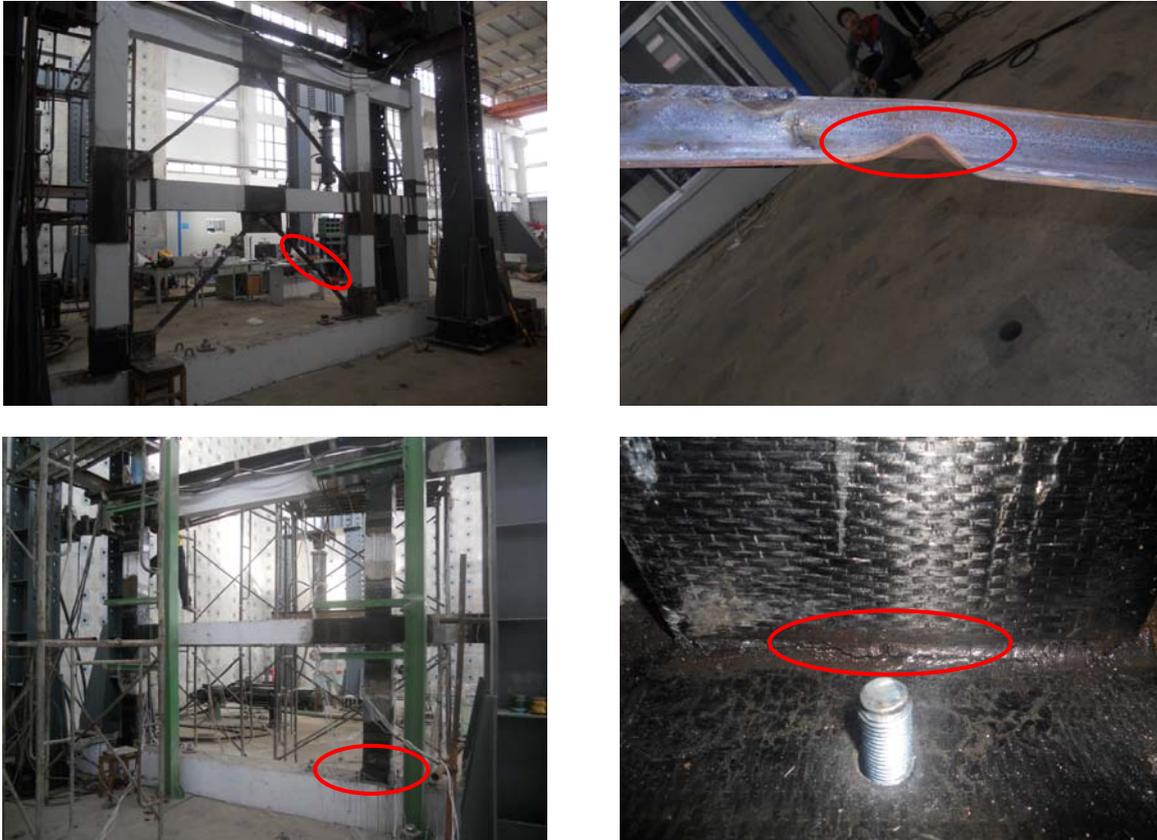
In Figure 6, the failure mode of steel brace and FRP retrofitted specimens are shown. It is evident that the damage mechanism in initial stage of three specimens is about the same: cracks opening at the bottom and top of the columns, followed by the failure of the transverse beam. But in the later stage, the brace buckling and FRP tinseling are the characteristic response of the two retrofitted specimen.

Figure 6. The failure mode of steel brace (a) and FRP (b) retrofitted frames
