# The Mw 7.1 Sept 4 2010 and Mw 6.3 Febr 22 2011, New Zealand Eqs. Comparison of EMS<sub>1998</sub> and ESI<sub>2007</sub> Data

Two major earthquakes struck the city of Christchurch and the broader Canterbury region, the magnitude Mw 7.1 on the 4<sup>th</sup> of September 2010 and the Mw 6.3 on the 22<sup>nd</sup> of February 2011. The two earthquakes caused significant damage to the urban environment and infrastructure as well as induced changes to the natural environment such as surface fissures, lateral spreading and slope failure. For both seismic events the intensity scales EMS<sub>1998</sub> and ESI<sub>2007</sub> were estimated, based on the observed structural damage and the impact on natural environment respectively. Both EMS<sub>1998</sub> and ESI<sub>2007</sub> scales resulted in similar maximum intensity values. For the September earthquake the comparison was achieved by normalizing the EMS<sub>1998</sub> intensity values, observed in Christchurch city, to epicentral ones, using well established formulas. The convergence of the two methodologies for each event and the complement of their values based on different data, are important for seismic hazard and risk assessme

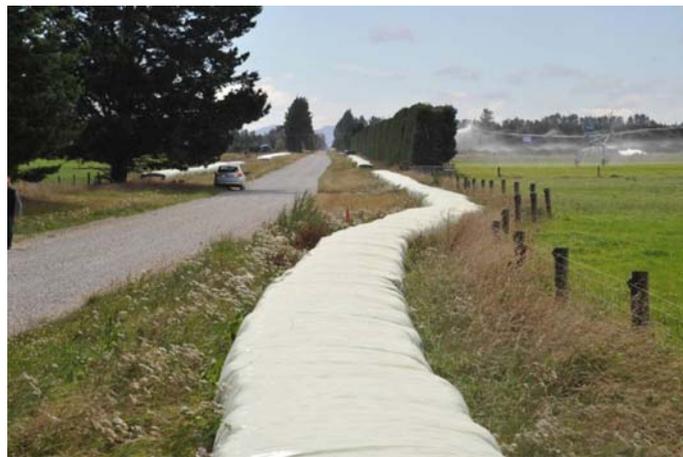
**Figure 2.** Horizontal displacement of approximately 5 meters caused by the Greendale fault.

The earthquake produced a surface rupture of approximately 29 km length and displacement of the order of few meters ( $D_{max} = 5.3 \pm 0.5$  m and  $D_{average} = 2.5 \pm 0.1$  m, Quigley et al. 2012), see Figs 1 and 2. Widespread liquefaction and lateral spreading occurred in various parts of Christchurch significantly affecting the eastern suburbs along the Avon river that meanders through the city (Avonside, Dallington, Burwood and Bexley), localized areas to the north and southwest of the city, the town of Kaiapoi and the beachside settlements near the Waimakariri River, (Allen et al. 2010). The co-seismic geodynamic phenomena are observed in an area of more than 1,000 km<sup>2</sup>. The diameter of the sand volcano cone formations reached several meters in areas close to river channels and surface subsidence was measured about 1 m, often due to lateral spreading. Additionally, subsidence of the east-side on the NW-striking western segment of the fault resulted in partial diversion of the spring-fed Hororata River, (Allen et al. 2010). Based on the above data the resulting maximum intensity is estimated up to  $X_{ESI-2007}$ .

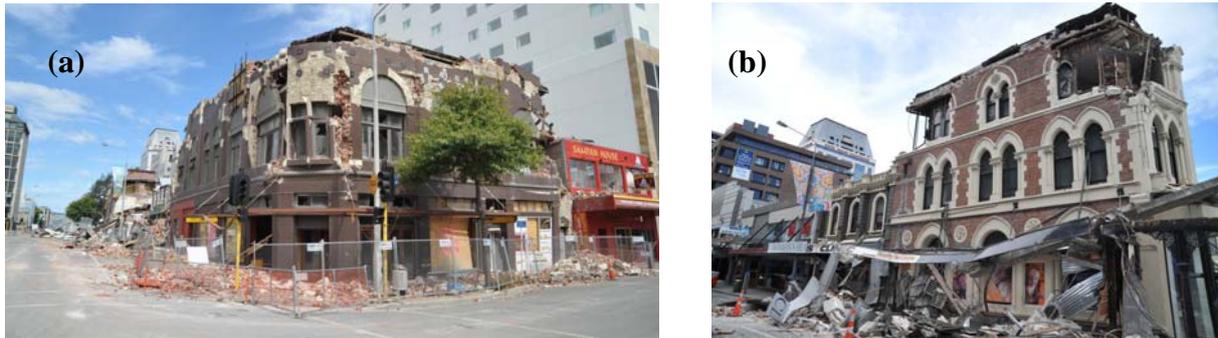
**Figure 3.** a) Three storeyed traditional corner building. It is an unreinforced masonry structure with higher storey heights. It is functioning as a shop in the CBD. Therefore the structure (floors and non load bearing structural members, the materials and workmanship) is strong enough. On the other hand the openings inside the building must be larger than common residential buildings. Nevertheless the facades present a robust structure. The vulnerability is estimated to be class C. The upper part and the corners of the building are damaged. It seems as if the roof had hammered over the lower part of the building. A large part of the roof collapsed. No horizontal displacements or diagonal cracks are noticeable. The observed pattern of damage is indicative of the strong vertical seismic component, a fundamental characteristic of the seismic action in epicentral regions of shallow focus earthquakes. The damage is grade 3 (substantial to heavy damage); b) Three storeyed unreinforced traditional masonry corner building. The building is functioning as a shop in CBD of the city. Each floor of the building is symmetrical along the two horizontal axes. There is also symmetry along the height. Also, it is quite well built, composing a robust structure. The plan of the building is trapezoidal having its shorter dimension perpendicularly to the facade. The stiffness along its shorter dimension is much smaller than along its facade. The vulnerability is estimated to be between class C and class D. The third storey suffered quite symmetric damage. The corner elements of the top, third, storey at the facade collapsed, while the roof is still standing up. Not any diagonal crack or any lateral displacement is noticeable. The only reason for the damage is due to the effects of the dominance of the vertical seismic motion. The damage grade is 4 (very heavy damage).

The February earthquake caused much more extensive damage to a large part of the built environment, which consists of different types of structures, due to the strong seismic shaking. Particularly, based on the guidelines of  $EMS_{1998}$  scale, (Grünthal 1998), in order to estimate the seismic intensity per different construction type, official data records (Kam et al. 2011, Data source: Christchurch City Council) were used and the following impact was observed, see Figs 3, 4 and 5.

- Unreinforced Masonry. Classified in Vulnerability Class B. Many buildings suffered damage of grade 5.
- Reinforced Masonry. Classified in Vulnerability Class C. Many buildings suffered damage of grade 4 and a few of grade 5.
- Reinforced Concrete. Classified in Vulnerability Class D. Many buildings suffered damage of grade 3 and a few of grade 4.
- Steel Structures. Were classified in Vulnerability Class E. Many buildings suffered damage of grade 2 and a few of grade 3.
- Timber Structures. Classified in Vulnerability Class D. Many of these structures suffered damage of grade 3 and a few of grade 4 and 5.

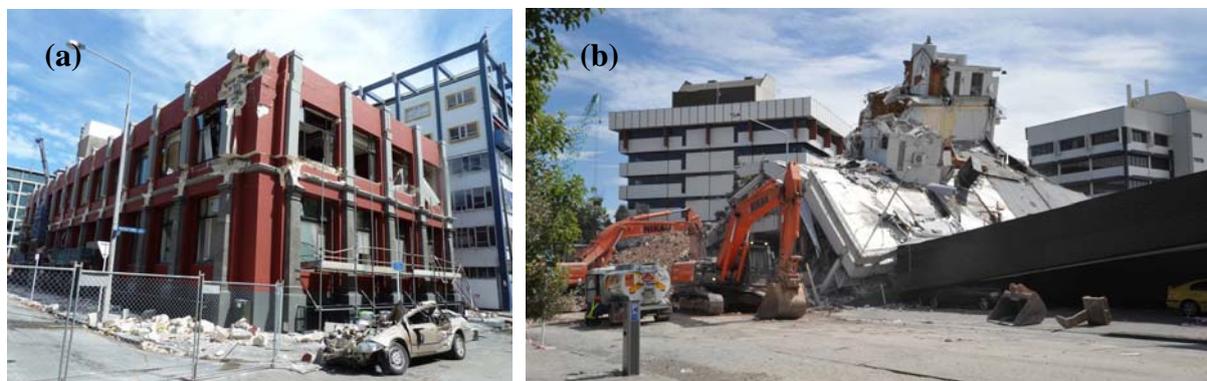
**Figure 4.** a) Two storeyed building with a reinforced concrete load bearing system. The ground floor is taller than the second floor. It seems to be quite robust and stiff. Its plan is orthogonal with the one dimension quite long. It seems as if it has been strengthened and probably the second storey has been added later. The

vulnerability is estimated to be of class D. The damage is concentrated in the column to beam joints of both levels and especially more in the mass of the columns and less in the mass of the beams. The elongated side of the building suffered more damage. There is not any horizontal displacement of the building nor any diagonal crack. The damage may be attributed to the strong vertical seismic component. Based on the observation that there are no damages in the column to beam joints along the short side of the building (except the one at the corner) the following point of view might be expressed: Due to the strong vertical seismic motion the framing beams of both levels vibrated vertically. The beams compose frames with the columns. These frames are functioning along the short side of the building. Due to the vertical vibration these beams functioned as levers against the joints. The damage grade is grade 2 (moderate damage); b) Multistoreyed building with a reinforced concrete load bearing system with frames. The level of earthquake resistance design and construction is of a low to moderate level. The vulnerability is estimated to be between class B and class C. The building has totally collapsed. There is no offset of the penthouse, that in despite of the total collapse maintains the same inclination of the below standing storeys. Small appendices, lightly connected to the penthouse stand intact. The building seems to have collapsed at two or three parallel and separated blocks. It is not possible to identify and assess the exact reason of the damage. Nevertheless, the non-uniform vertical loading of the structure due to multi-storey penthouse, combined with the gap along the vertical axis between the above mentioned blocks, together with the rather prevailing immobility of the penthouse, guide us to infer that besides the earthquake inefficiency of the structure a strong vertical seismic component was dominating and greatly contributed to that damage. The damage grade is 5 (destruction).

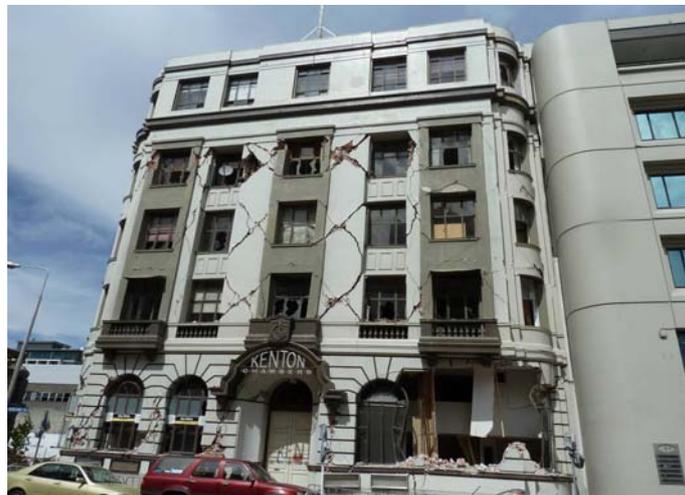
**Figure 5.** Five storeyed building, rather old, following traditional architecture. The last (fifth) storey looks as if it has been added after the completion of the lower four storeys. Most probably the load bearing system is reinforced concrete (slabs, beams and columns). Due to the estimated period of construction, most probably the building may be characterized as of low earthquake resistance. But due to the rather thick and strong masonry exterior wall paneling the stiffness and earthquake resistance of the whole building is increased. The vulnerability is estimated to be class C. The damage is concentrated in the first up to the fourth storeys. The fifth storey is intact. (Perhaps the added fifth storey is constructed with different materials and technology. It seems that it is stiffer than the other storeys). The heaviest damages are in the first (ground) storey and in the fourth storey. The damages give the impression as if the four storeys have been smashed. The vertical elements of the windows have been buckled. There is neither any horizontal displacement nor any diagonal cracking. The appearing diagonal cracks are due to an excess vertical loading that surpassed the strength of the vertical load bearing elements during the earthquake. The whole structure stands absolutely vertical. The whole damage might be attributed to the strong vertical seismic component that dominated the seismic action. The lack of any horizontal displacement, in despite of the almost equally strong horizontal ground motion, it is probably due to the above mentioned type of damage and due to an increase of the horizontal period of the structure. The damage grade is grade 3 (substantial to heavy damage).

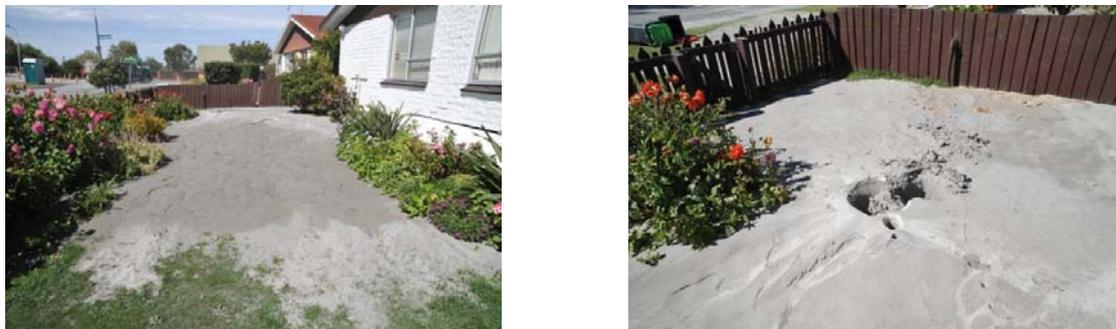
**Figure 6.** Views of liquefaction phenomena in the area of Christchurch after the earthquake of February 22, 2011.

Despite its lower magnitude, the Christchurch earthquake also induced widespread environmental effects in Canterbury region. The most severely affected by liquefaction and lateral spreading suburbs after the February earthquake were yet again areas along the Avon River to the east and northeast of CBD such as, Avonside, Dallington, Avondale, Burwood, and Bexley, (Cubrinovski & Taylor 2011, Cubrinovski et al. 2011a, GEER Report 2011). The liquefaction manifested as sand boils and large amount of sand / silt ejecta as a result of low cohesion soils, high water table ( $< 5\text{m}$ ) and the intensity of the ground shaking (up to  $2.2\text{ g}$  in Heathcote valley close to the epicenter and up to  $0.8\text{ g}$  in the CBD (Kaiser et al. 2012). The severity of liquefaction, although predominantly of moderate intensity was not uniform, reflecting the complex and highly variable soil conditions even within the CBD area, (Cubrinovski et al. 2011b). The diameter of sand volcano cones which was several meters in the worst affected areas and measured subsidence of  $> 1\text{m}$ , often associated with the occurrence of lateral spreading, indicate maximum intensity value of the order of  $X_{ESI-2007}$ , see Fig. 6.

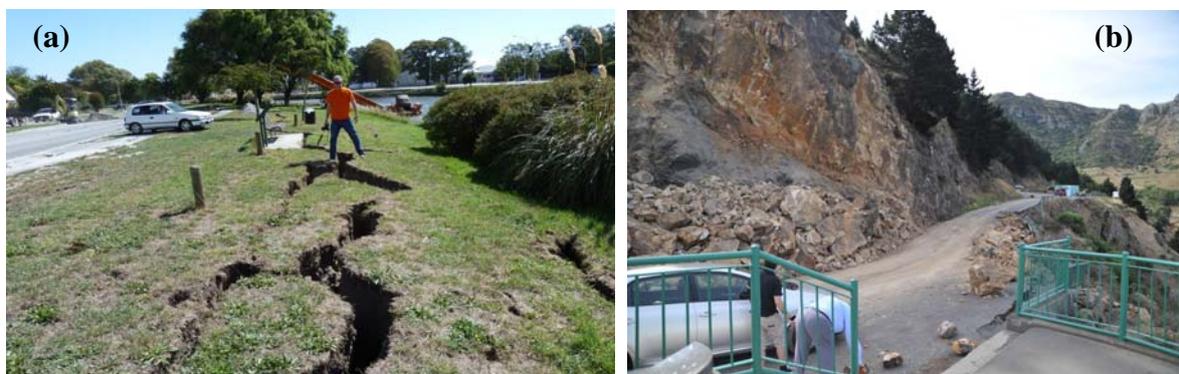
**Figure 7.** a) View of surface ruptures caused by the earthquake of February 22nd, 2011 in suburban area of Christchurch; b) View of co-seismic landslides triggered by the February 22nd earthquake along Sumner road, Lyttelton.

Furthermore, observed surface fissures of  $> 1\text{m}$  width and up to few hundred meters length are also indicative of a maximum intensity value of  $X_{ESI-2007}$ , see Fig. 7a. Finally, extensive slope failures were triggered by the strong seismic shaking of the February 22 earthquake, see Fig. 7b, causing human losses and injuries, and damaging residential houses and infrastructure in RedCliffs, Mt Pleasant, Sumner, Lyttelton, Cass Bay and Rapaki areas (Hancox et al. 2011). The estimated landslide deposit volumes of the order of  $10^5\text{ m}^3$  and even  $> 10^5\text{ m}^3$  in some locations suggest a maximum intensity value of  $IX_{ESI-2007}$ .
