# In Plane Behavior of Polypropylene and FRP Retrofitted Brick Masonry Wallets under Diagonal Compression Test

## **SUMMARY:**

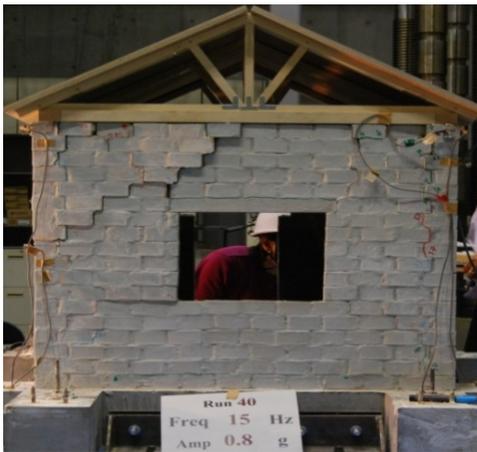
a) Shake table test of 1/4-scale non-retrofitted masonry house

**Figure1.** Shake table test of 1/4 scaled non-retrofitted and PP-band retrofitted masonry houses [Sakthi and Meguro, 2008]

Along with above retrofitted methods, Meguro and Mayorca [Meguro and Mayorca, 2005] have developed polypropylene band (PP-band) retrofitting method considering economic affordability, local acceptability, material availability and technological applicability required for retrofitting. PP-band is a very cheap material with fairly large deformation capacity. Main objective of PP-band retrofitting is to hold the masonry components into a single unit and to prevent the collapse of masonry structure. After carrying out a series of experiments ranging from small-scale model to full-scale masonry house, it was found that PP-band retrofitted walls can withstand much stronger input ground motion without collapse [Sakthi and Meguro, 2008]. Figures 1 (a) and (b) show the non-retrofitted and PP-band retrofitted scaled models under shake table test.

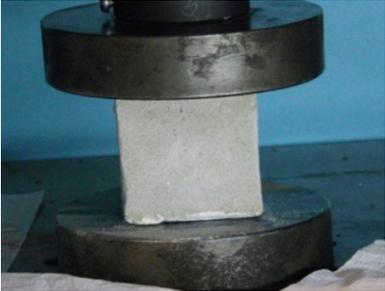
(b) Setup of mortar cube compression test

Clay burnt bricks were used for experiments. The scaled burnt brick dimensions are  $75\text{mm}\times 37\text{mm}\times 50\text{mm}$ . Samples are tested according to ASTM C-67. Three samples of burnt brick were tested under direct compression. Test setup for brick compression test is shown in Fig 3.(a). All three brick samples have shown a very close agreement of compressive strength with an average value of 26.1 MPa. Table 4 shows the compressive strength of three brick samples. Three mortar cubes of  $50\text{mm}\times 50\text{mm}\times 50\text{mm}$  containing a weight mixed proportion of cement, lime and sand (140g: 1,110g: 2,800g) were tested with 0.14 water/cement ratios. After curing period of 28 days, mortar strength is examined according to ASTM C-109. Figure 3 (b) shows the experimental setup for mortar cube test. Results for direct compression test of mortar cubes are presented in Table 4. A large variation in the test results has been observed. Three samples of brick triplets, each triplet consisting of three bricks joined together by 5 mm mortar thickness were prepared to evaluate the shear strength of masonry units. Test setup is shown in Fig. 3 (c). Curing time for all three samples was 28 days. Figure 3 (d) shows the test setup of bond test. For bond test, specially cut steel plates were used and connected with opposite faces of brick by a strong epoxy. Two screwing steel rods are used to fix the sample in tension test machine. Samples were tested under constant rate deformation of 0.05 mm/min. Experimental results show a scatter of values which is a characteristic of bond strength. Test results for shear test and bond test are summarized in Table 4.

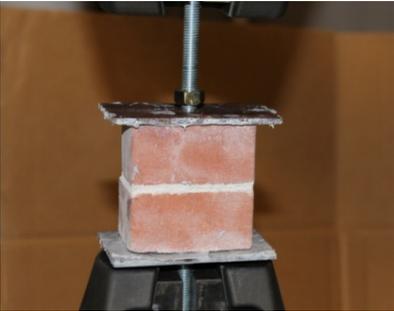
(d) Setup of bond test

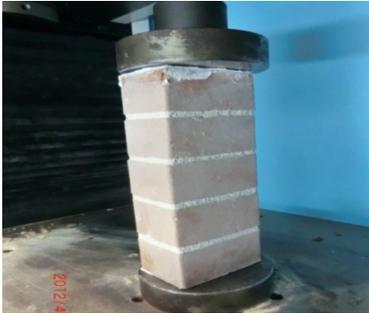
(e) Setup of compression test of masonry of prism

Three masonry prisms each consisting of 5 bricks joined together with 5mm mortar were prepared and cured under the same conditions for 28 days, in which the wallets were cured, i.e. water spray for 14 days after construction. These are the conditions according to ASTM C-1314. Figures 3 (e) and 3 (f) show the test setup and typical failure and crack patterns of masonry prisms. Average compressive

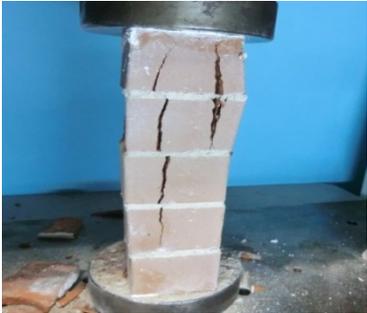
(f) Crack patterns of masonry prisms

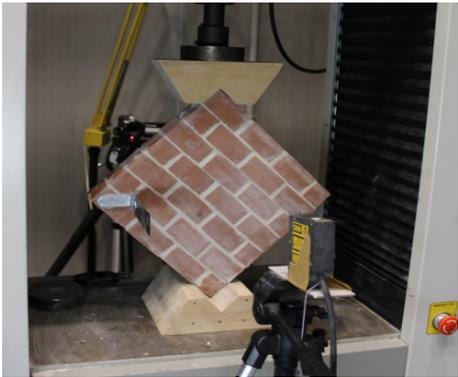
(a) Test setup of non-retrofitted wallet of diagonal compression test

**Figure 4.** Test setup of in-plane diagonal compression test of non-retrofitted, PP-band, CFRP retrofitted and CFRP+PP-band retrofitted wallets

A schematic test setup of diagonal compression test is shown in Figs. 4 (a) and (b). All test wallets were built under same constituent and cured for 28 days under same environmental conditions. Two specially made strong wooden wedges are used to apply diagonal force over the corners of masonry wallets. Wooden wedges are connected with 100 KN Shimadzu UTM top and bottom platens. Loading rate over different test specimens are given in Table 5. For displacement response measurement, two different type of test setup are used. Two high power lasers are used for in plane horizontal deformation and out of plane bulging for non-retrofitted and PP-band retrofitted masonry wallets. Horizontal displacement using laser is monitored by attaching a stiff target with epoxy to the wallet as shown in the Fig. 4 (a). While LDTV displacement transducer with  $500 \times 10^{-6}/\text{mm}$  sensitivity are used for CFRP retrofitted and CFRP+PP-band retrofitted wallet. Six strain gauges are also used on each CFRP and CFRP+PP-band retrofitted wallet. Three strain gauges at an angle of  $45^\circ$  from each other are pasted using CN bond after application of PS bond over the brick surface where as 3 strain gauges are directly applied over the CFRP surface using CN bond after rubbing the CFRP surface using a sand paper. Different displacement loading rates are selected depending upon the failure displacement and duration of test. In order to connect the PP-band, sufficient lap is provided between bands and ultrasonic welding device is used to connect PP-bands with each other. In case of PP-band retrofitting bands on two faces of wallets are connected by provision of small hole at spacing of 40 mm from each corner at four points connected by ultrasonic welding device as shown in Fig. 4 (d). CFRP and PP-band is applied on the both faces of wallet.

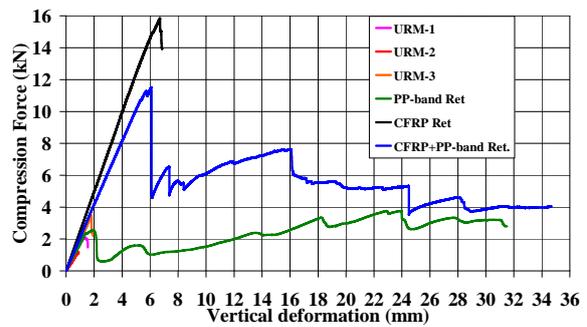
(d) Load-displacement curves of non-retrofitted, PP-band retrofitted, CFRP retrofitted and CFRP+PP-band retrofitted wallets

Load versus displacement of all specimens are plotted in Fig. 5. Non-retrofitted wallets show a variety of peak strength with an average value of 2.23 kN. Sliding type of failure has been observed exhibiting a weak brick mortar joint at vertical displacement range from 0.9mm to 1.8mm as shown in Fig.5 (a). From Fig. 5(b), PP-band retrofitted wallet shows the peak strength of 2.5 kN. Sudden drop of load occurred due to failure of brick masonry inside PP-band but with the further increase of vertical displacement, it again started taking load with a residual effect due to inter locking effects of cracked masonry and confining effect of PP-band. Even after the displacement range of 16mm, PP-band confining effect become more prominent and system showed a loading capacity even greater than initial peak strength of masonry. Beyond 24mm of vertical displacement, crushing of bricks started. Figure 5 (c) demonstrates the load-displacement curves of non-retrofitted wallets, PP-band retrofitted wallet and CFRP retrofitted wallet. CFRP has increased the peak strength of URM from 3.4 kN to 15.7 KN. The initial failure displacement of non-retrofitted wallet also increased from 1.7mm to 6.7mm. But final failure of CFRP retrofitted was sudden and highly brittle. Initial stiffness of URM-1, URM-2, URM-3 and PP-band retrofitted were not exactly similar but within a close range to each other where as CFRP retrofitted wallet has shown higher initial stiffness and peak strength. Figure 5 (d) shows the load-displacement curves for all specimens including CFRP and CFRP+PP-band retrofitted wallet. Peak strength of CFRP+PP-band retrofitted was significantly higher then non-retrofitted wallets and only PP-band retrofitted wallet but less than only CFRP retrofitted wallet. Increased rate of loading has been used for CFRP+PP-band retrofitted wallet to avoid long test durations. After the initial failure of CFRP+PP-band retrofitted wallet, a sudden drop in load carrying capacity was observed, even peak strength of 11.45 kN reduced to 4.6 kN. But after that system again become stable and started taking load. At displacement of 16mm, the load carrying capacity of damaged wallet was 7.55 kN which is even 3 times bigger than that of the non-retrofitted wallet. System has shown a good residual load carrying capacity after the initial damage. Because in case of CFRP+PP-band retrofitted wallet, CFRP is not completely separated due to holding effect of PP-band. CFRP and PP-band composite system has shown not only a fairly long deformation capacity as compared to non-retrofitted and CFRP retrofitted wallet but also a significant increase in peak strength of non-retrofitted and only PP-band retrofitted wallet. Figures 5 (e) and (f) have shown the strain distribution of FRP and brick at their respective locations. Strains are recorded by digital dynamic strain meter (DDSM). FRP strain gauge-1(St-1), strain gauge-2(St-2) and strain gauge-3 (St-3) have shown a low initial increase up to the loading value of 4 KN for CFRP retrofitted wallet and up to 2 kN for CFRP+PP-band retrofitted wallet. After these values, the strain rate increased and reached their maximum values close to peak and then again reduced due to debonding and cracking after the peak strength. Peak strain of 0.002 is recorded in the CFRP which is in fair agreement of values provided by different effective strain based models like AC 125 model ICC Evaluation Service, Inc (2007). In CFRP and CFRP+PP-band, no damage was observed on the surface of CFRP. Strain gauges for CFRP+PP-band retrofitted were removed after initial drop in peak strength. All wallets exhibited almost a linear behaviour about 75-90% of peak load. Variation of experimentally obtained brick and CFRP strains was in consistent with the peak load. Very low strains were recorded for brick element because the location of strain measurement for brick element was inside straining action of CFRP and major share of load was

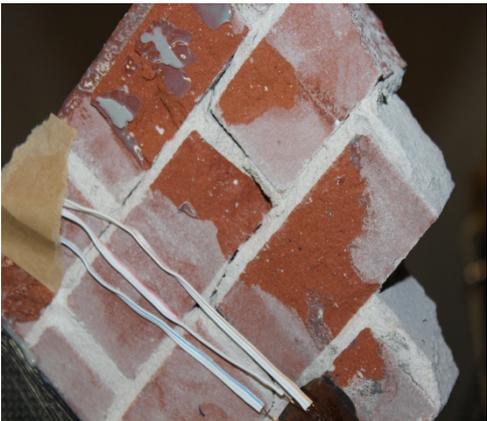
(c) Debonding of CFRP from brick surface crack patterns of CFRP retrofitted wallet

**Figure 6.** Failure, debonding and crack patterns of CFRP and CFRP+PP-band retrofitted wallets under diagonal compression loading

The strength of non-retrofitted wallets depends upon the governing failure mode. In all non-retrofitted and only PP-band retrofitted wallets, a shear sliding type of failure was observed exhibiting a weak brick to mortar cohesion and weak mortar. Where as in case of CFRP retrofitted wallet, the failure mode was changed from shear sliding to diagonal tension cracking as shown in Fig. 6 (a). Furthermore, failure was first initiated in CFRP retrofitted wallet by CFRP debonding over the brick surface and then completely separation and debonding. There could be three possible failure mode of FRP retrofitted wallets, 1) epoxy debonding, 2) brick surface tension failure, 3) FRP rupture. Mostly epoxy debonding and brick surface tension failure are observed. Figure 6 (c) shows a close view of brick surface tension failure which assures a good bond between CFRP and epoxy. In case of CFRP+PP-band retrofitted wallet, the failure was initiated by brick surface debonding but it was gradual and diagonal crack passes through the brick and reaches up to the other CFRP strip as shown in Fig. 6 (b). But there was no full separation and structural system of wallet was still stable for residual strength. Figure 6 (d) shows the crack opening and brick crushing of CFRP+PP-band retrofitted after a significant amount of deformation and still this wallet was acting as single body due to holding effect of PP-band. PP-band has played an important role and changed the sudden brittle failure of only CFRP retrofitted wallet to a ductile type of gradual failure with sufficient warning.
