# Comparison of different earthquake strengthening methods for masonry buildings

## SUMMARY:

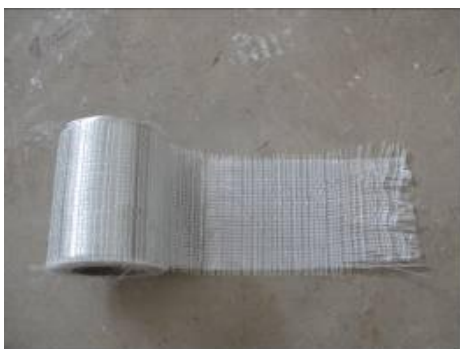
**Figure 2.1.** Uniaxial fabric for stripes

Two different fabrics were used in the experimental campaign. The first is a 15 cm wide uniaxial glass-fibre textile for stripe application with epoxy resin and the second is a hybrid multiaxial fabric for full covering the masonry surface. As new system a 425 g / m<sup>2</sup> heavy glass fibre/ polypropylene fabric was developed that takes into account all possible failure modes of masonry. It is woven in four fibre directions in angels of 0°, 90° and +/- 30° with the two different fibre materials. In a sandwich structure consisting of a layer of high-strength epoxy-cement mortar, a layer fibre fabric and a covering layer of the same mortar, the whole system is applied flat to the outside surface of a building. The system is called “eq-grid” (see figure 1 + 2).

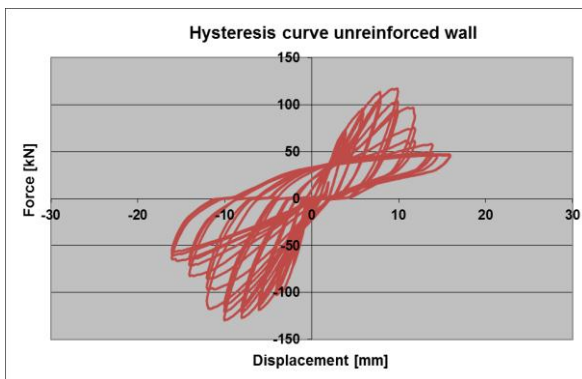
**Figure 3.1.** Test result on a unreinforced wall

Representative results of an unreinforced masonry (URM) and a reinforced masonry (RM) wall test (1.25 m x 1.25 m) are shown below in figure 3.1. & 3.2.. The strengthening was conducted on only one side with Sikagard 720 EpoCem and a hybrid quadaxial glass-fibre and polypropylene- fibre fabric. The maximum resistance force of the URM wall was 117 kN and the maximum load of the RM structure was 147 kN. This is an increase in maximum force of 25 %. But the more important effect is the increase in ductility. Both walls failed in diagonal cracking through the mortar joint and the stones. While the crack opening was more than 30 mm after a wall displacement of 16 mm in the case of the unreinforced wall, only 3 mm were measured after 28 mm displacement with fibre reinforcement. Much more small cracks were observed in the last case and the increase in maximum displacement reached in comparison 75 %. Further dynamic studies are presented in the next chapter.

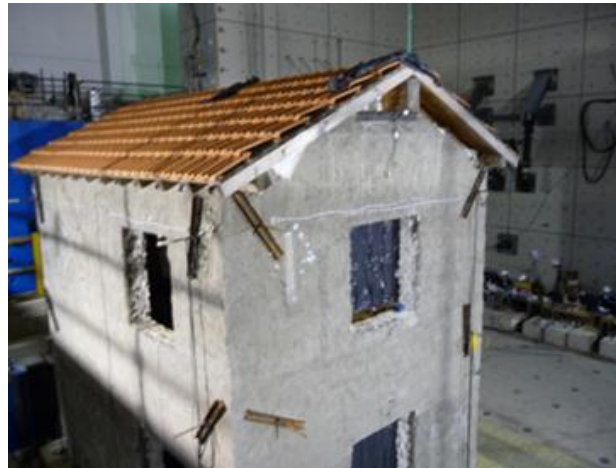
Figure 3.4. Reinforced building with quadaxial fabric

After repairing the displaced roof and the wooden slab as retrofitting tool the eq-grid system was used to repair all the cracks in the masonry which occurred in the tests before. The tests of the repaired building showed no cracks after 0.4 g PGA, the maximum level of the URM building. Further tests at 0.5 g led to small micro cracks at the window locations. The maximum possible PGA for table was reached after 0.6 g. At this stage cracks in the glass fibres occurred local under both windows at the front side which is seen in figure 3.3. Also delamination between the first layer mortar and textile was observed, but the total building was in good shape. The textile as repairing solution after the damage could retrofit the building at least to the original strength plus 50% more capacity.

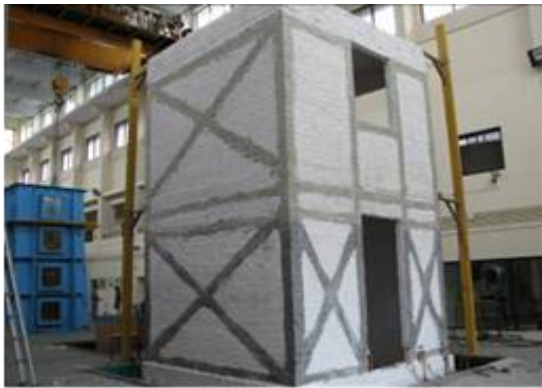
**Figure 4.1.** Clay brick building with stripe application (east – north side)

While the first unreinforced building got only a painting the second one was strengthened with glass-fibre-strips UNIE410 which were glued with an epoxy resin Araldite LY556. The stripe configuration was like timber framing and was applied in X-Style to the masonry surface (see figure 4.1).

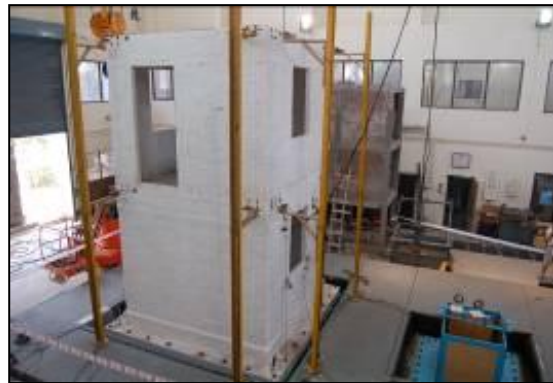
**Figure 4.2.** Application with quadaxial textile (west-south-side)

For the third building the full covering solution with the multi-axial textile embedded in a cement based matrix was chosen. Therefore the mortar *Sika MonoTop-722-Mur* was applied directly to the whole masonry surface on the outside and the textile was embedded into the fresh mortar.

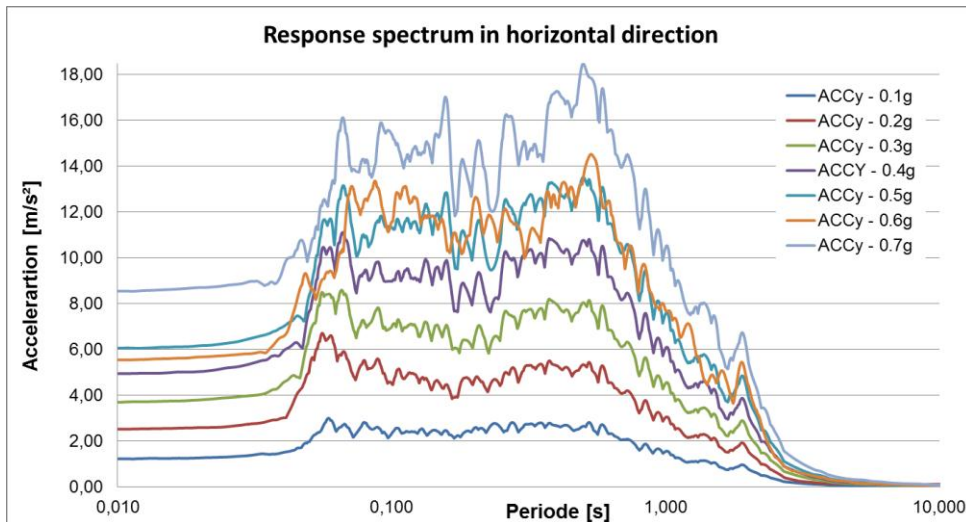
**Figure 4.3.** Response spectrum for the earthquake acceleration in the north-south direction

The response spectrum as input was according to the Indian Standard 1893:2002. While the maximum horizontal accelerations (X and Y direction) were kept similar, the vertical component (Z direction) was only two-third to that given in the X and Y axes. The response spectrums in vertical and horizontal direction for the third test are presented in figure 4.3 and 4.4. To mention is that both horizontal response spectra are similar.

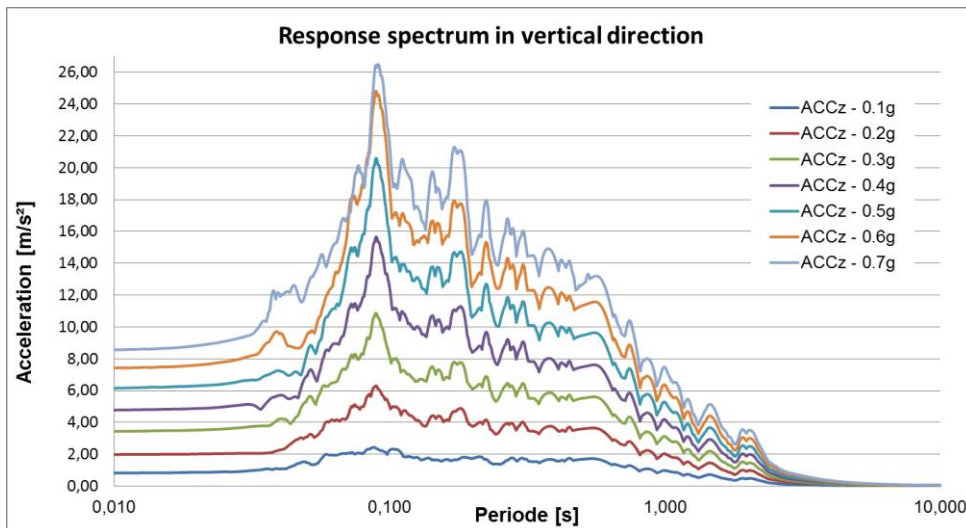
**Figure 4.4.** Response spectrum for the earthquake acceleration in the vertical direction

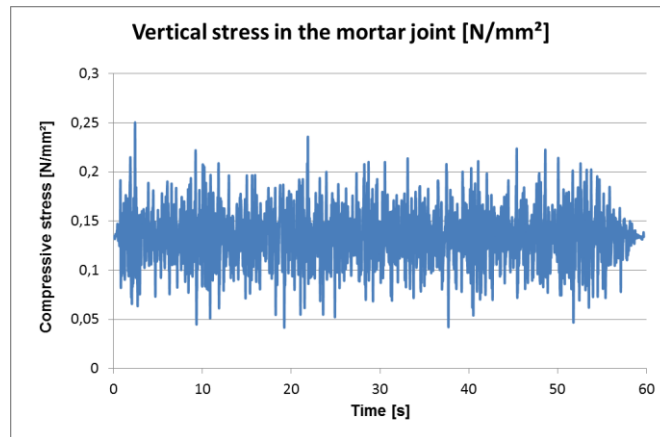
**Figure 4.5.** Calculation of the stresses in the failed mortar joint

In comparison to the uniaxial shaking table test in the chapter before, the main difference was introduced with the vertical acceleration component. This lead to very unsteady and a wide range of normal stresses  $\sigma_y$  between 0.05 N/mm<sup>2</sup> and 0.25 N/mm<sup>2</sup> in the bed joint dependent on the time like shown in figure 4.5.

This shows that the shear resistance  $f_{vk}$  is time dependent and equation (3.5) in the EC6 can be written as follows:

$$f_{vk}(t) = f_{vk0} + 0.4 \cdot \sigma_d(t) \quad (4.1)$$

This shows the importance of the vertical component for the calculation of masonry buildings. In building 3 with vertical and diagonal fibres the normal stress  $\sigma_d$  was increased through the vertical force-component of the fibres after small displacement. The result was a 55% higher earthquake capacity through this effect.
