Investigation of Existing State and Assessment of Seismic Stability of Reinforced-Concrete Chimney

V. Micov, M. Vitanova & M. Stojmanovska

*Institute of Earthquake Engineering and Engineering Seismology (IZIIS), Skopje,
Republic of Macedonia*

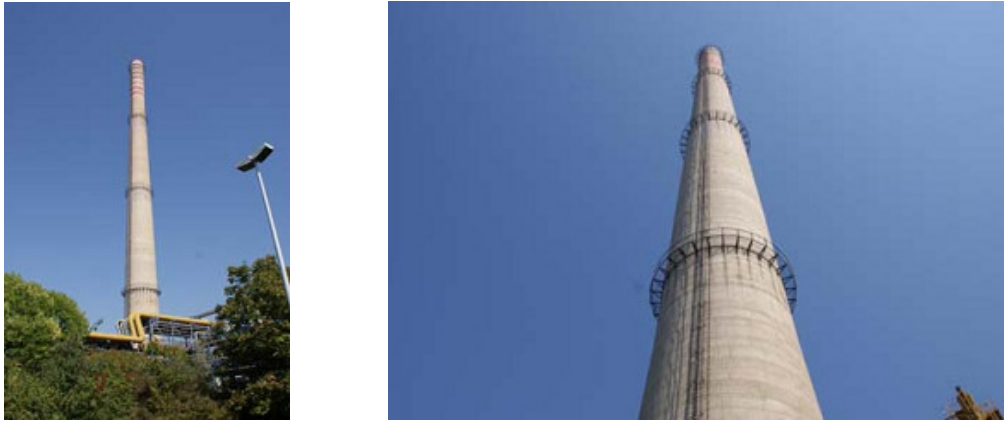
Herein results from the diagnosis of the existing condition of the “Negotino” power plant chimney and corresponding analytical investigation have been presented. The chimney is a reinforced concrete structure with height of 160m, clear span at the top of 5.60m and outer diameter at the bottom of 14.0m (Figure 1).

Figure 1. Power plant “Negotino chimney

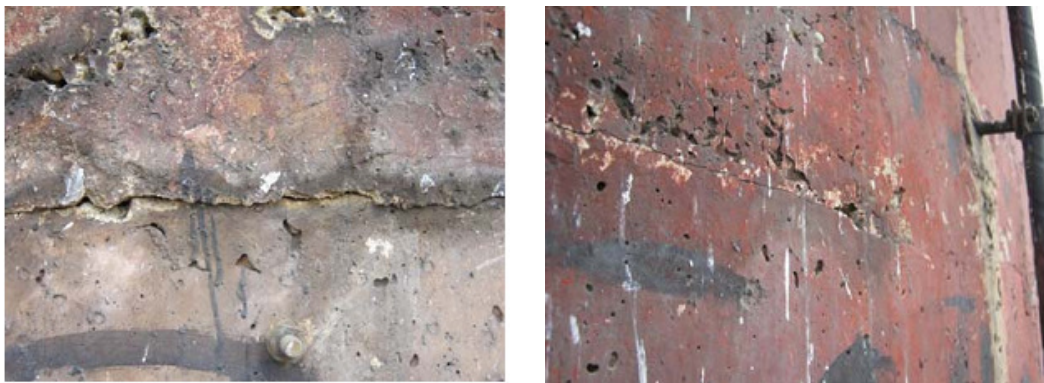
Thorough survey of the structure has been carried out and numerous micro-cracks in horizontal and vertical directions as well as mesh like cracks have been detected. Openings of the cracks are visible within the range of 0.1 mm to maximum of 1-2mm. Most damage was noticed at the 142-146 m height. Horizontal cracks that open and close under the wind action are noticed at 142 m and 143 m height and stretch on the $\frac{3}{4}$ of the diameter of that part of the chimney (Figure 2).

Figure 2. Horizontal cracks at level +142.00

Based on the results obtained from the analytical investigations, the seismic stability of the investigated chimney was assessed and recommendations were given for its possible repair and strengthening.

In order to avoid sub-structural behaviour of the upper part of the chimney and protect its stability, a model of strengthened and repaired structure was proposed and analyzed. Strengthening elements in the upper part of the chimney were proposed and modelled. The complete static and dynamic analysis was done using nine load combinations including permanent loads, temperature, wind and seismic forces. The maximum displacements due to permanent loads and wind were $x_p=22.1\text{cm}$ but the tensile strength at critical sections was $\sigma_1=1.68\text{MPa}$, which is larger than the allowed stress 2.4MPa . Through permanent loads and seismic effects, the displacement at the top of the structure was $x_p=12.0\text{cm}$, while the tensile stress at the critical section was $\sigma_1=0.48\text{MPa}$.

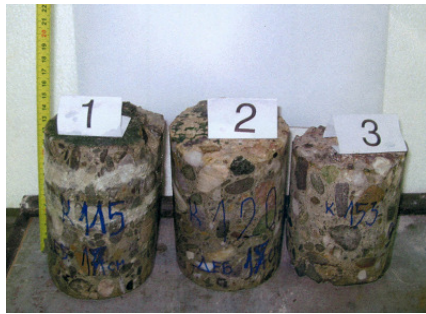
DIGI-SHMIDT digital concrete test hammer has been used for verifying the concrete strength and confirming previously obtained results from the test on cylinders taken from the body of the structure (Figure 4).

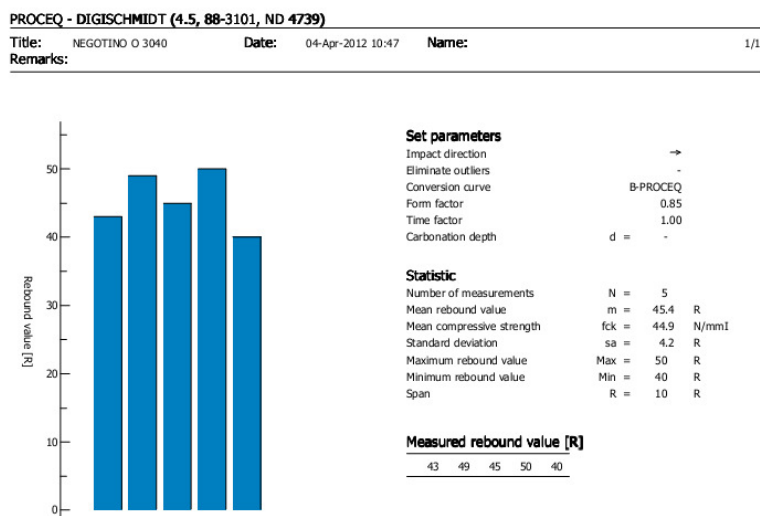
DIGI-SHMIDT digital concrete test hammer offers non-destructive measure of the concrete compressive strength. The compressive strength f_c is established by measuring the hardness (rebound value R) of the concrete surface and with the conversion curves. The measuring range is between 10 to 70 N/mm².

Following the defined procedure strength characteristics of the concrete were obtained at several measuring points, at two levels (at height of 5.0 m and base). Example of the graphic results that is instruments outputs at certain point are shown in Figure 5.

Figure 5. Instrument output of concrete strength

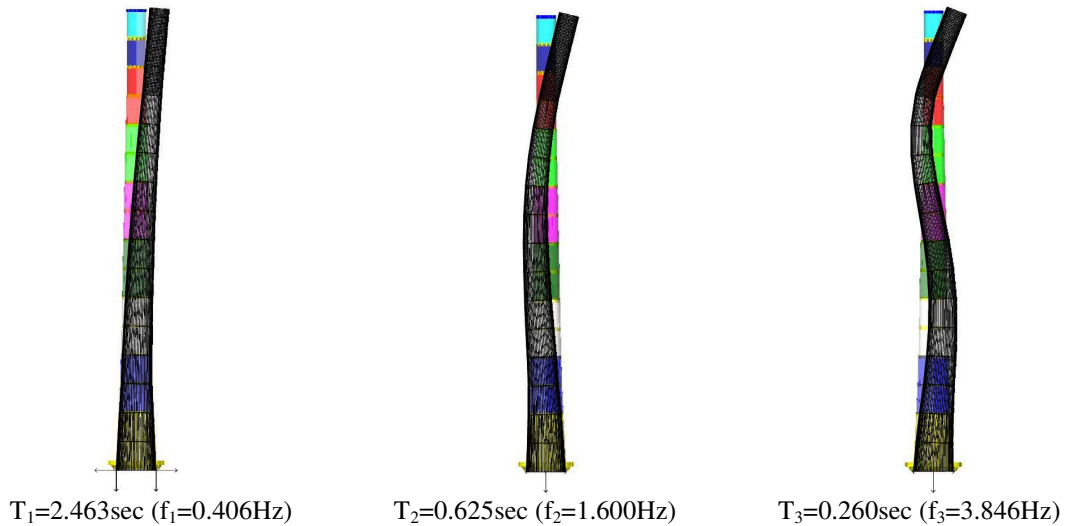
The obtained first three mode shapes for the strengthened structural model are shown in Fig.8. In the case of the strengthened structural model, the third period of vibration (in which the sub-structural effect was evident) was reduced significantly compared with the existing state model. The difference between the first and the second period of vibration was not so relevant. The used method of structural strengthening led to restoring the periods of vibrations in the designed one, before occurrence of cracks.

Figure 8. The first three mode shapes of the strengthened structural model
