ANALYSIS OF THE PROCESS OF BUILDING DAMAGE INSPECTION DUE TO LIQUEFACTION DURING THE GREAT EAST JAPAN EARTHQUAKE

Kishie Shigekawa and Satoshi Tanaka

Graduate School of Disaster Research, Fuji Tokoha University, Japan

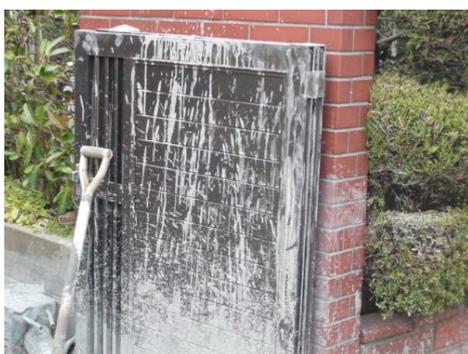
Photograph 1. Mark of liquefaction

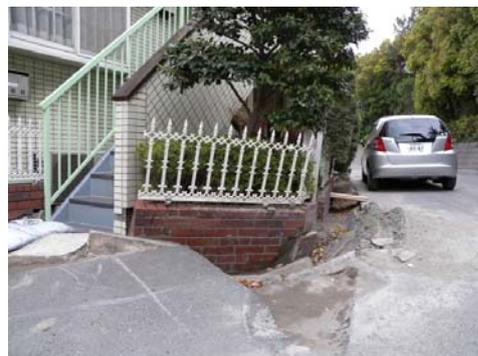
Photograph 2. Building damage because of liquefaction

The population of Urayasu is 164,040—or 72,714 households (as of the end of March 2010). Of the 164,040 citizens, 24% live in detached houses and as many as 76% reside in multiple-dwelling houses. During the Great East Japan Earthquake, detached houses were seriously damaged by liquefaction; 88.9% of the detached houses in the Naka-machi and Shin-machi areas suffered partial destruction or more serious damage.

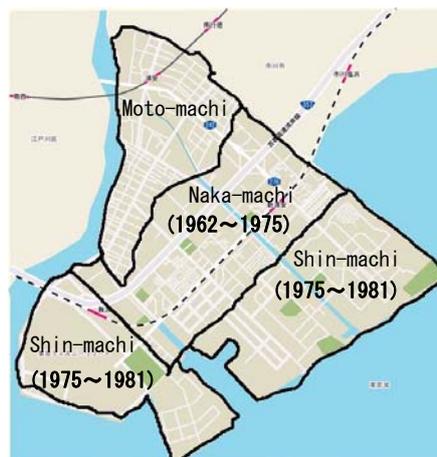
Figure 1. Reclamation time of Urayasu-city

The city of Urayasu is divided into three major areas: the Motomachi area (tracing back to the old Urayasu-machi area), the Naka-machi area (which consists of phase-1 reclaimed land [1962 through 1975]), and the Shin-machi area (which consists of phase-2 reclaimed land [1975 through 1981]). The Naka-machi and Shin-machi areas are ranked high among “towns people desire to live in” and are known as popular residential areas. However, these two reclaimed land areas sustained devastating liquefaction damage by the earthquake, whereas few houses incurred damage in the Motomachi area.

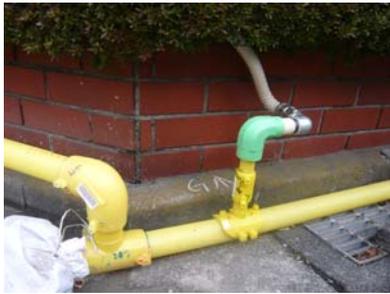
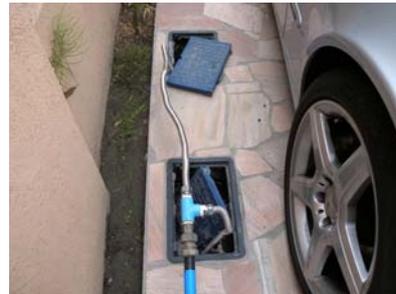
Photograph 3. Temporary water supply pipe(April,6,2012)

Liquefaction also caused serious damage to lifeline infrastructure, including public water supply, sewerage, gas, and electricity. Water supply to up to 33,000 households was cut off, and 10 days after the earthquake, as many as 4,000 households were unable to receive public water supply. As of April 2012, more than one year after the earthquake, public water is still supplied through temporary water pipes in some areas.

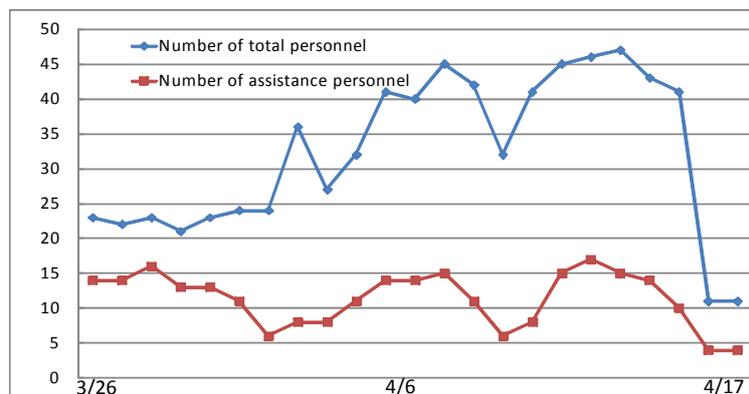
Figure2. Changes in the number of inspection personnel
