Dynamic Analysis of a Strengthened Two Story Concrete Building

15 WCEE
LISBOA 2012

SUMMARY

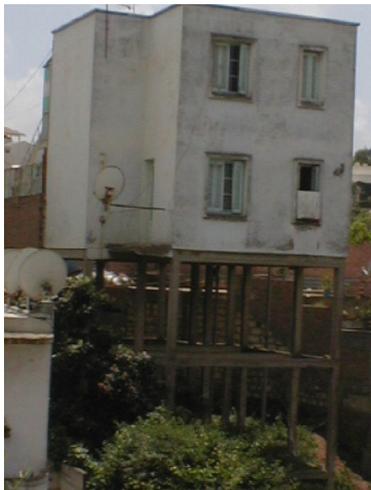
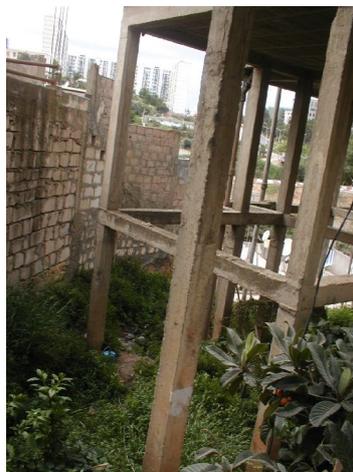
The studied building located in Algiers city was built in the Fifties. It is made up of 2 levels supported by a column-beam structure (Fig. 1.1). The first level is situated approximately at six meters from the rigid ground (rock) level where are anchored the foundations. The columns have a section of 25 cm X 25 cm and the beams 25 cm X 30 cm. The hollow concrete blocks floors have 20 cm thickness (Fig. 1.2). This building was strengthened between 2008 and 2009.

Figure 1.1. View of the building, left, view of piles, right

The 4 levels structure of this building (house) is RC frames system. The 3rd and the 4th levels are the inhabitable space and the two first levels (piles) are the empty space supporting the building (Fig. 1.1). The RC frames constitute an irregular plan form (Fig. 1.2).

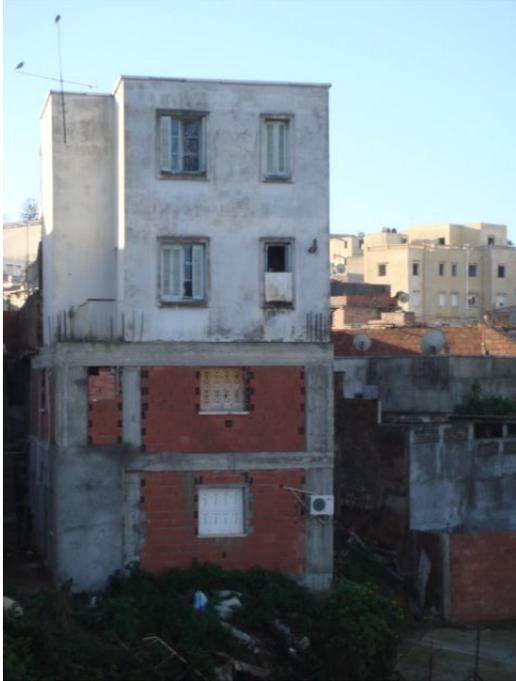
Jackets with section of 45 X 50 cm were used for all the columns and beams. The jackets at the corners have been reinforced by RC wings of 25 cm length and 15 cm thickness (Fig. 2.2). A new 20 cm thickness slab at the first level was realised in order to create two apartments in the two first levels (Fig. 2.1)

Figure 2.1. View of the strengthened building

The strengthening technique that has been adopted has certainly rigidified the building structure and has limited the storeys displacements. However, as the strengthening has been carried out, i.e due to a limited budget, the columns strengthening has stopped under the first inhabitable storey (Fig. 2.1), behaviour problems, which did not exist before, have been created. First, the new fundamental frequency of the strengthened structure is ranged between 5 and 6 Hz, this can generate resonance phenomena with soil vibrations. Second, the strengthening has rigidified only the two first levels of the piles (Fig. 6.2) while the inhabitable storeys continue to move as the initial structure. In addition, this strengthening has created short columns between the first inhabitable slab and the end of jackets (Fig. 2.1).
