# Seismic Vulnerability of Santo Domingo Church, Cusco, Peru

**C.H. Cuadra**

*Akita Prefectural University, Japan*

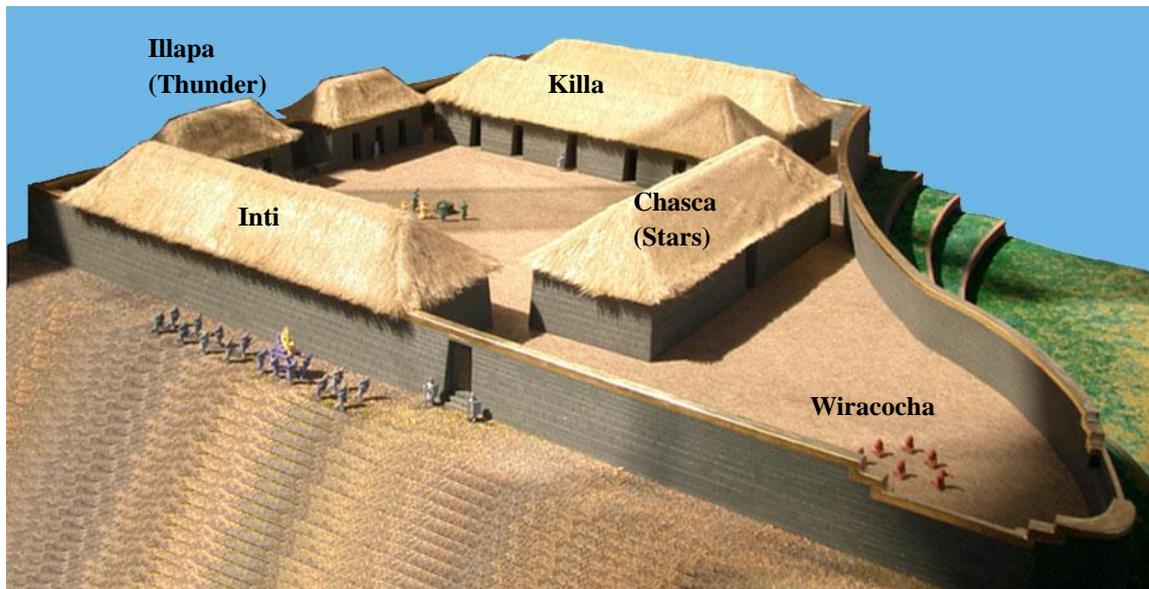
It is believed that the original complex of Inca temples was dedicated to Inti, the sun god, and was formed by a group of constructions located around a central square, as can be observed in Figure 1, which is a view of a scale model. Each building was dedicated to one god respectively. The name of the god corresponding to each temple is indicated in Figure 1. These gods were Inti (sun), Killa (moon), Chasca (stars), Illapa (thunder, rainbow). Also, it is thought that the Incas believed in a creator god, called Wiracocha.

**Figure 1.** Scale model of the Coricancha complex

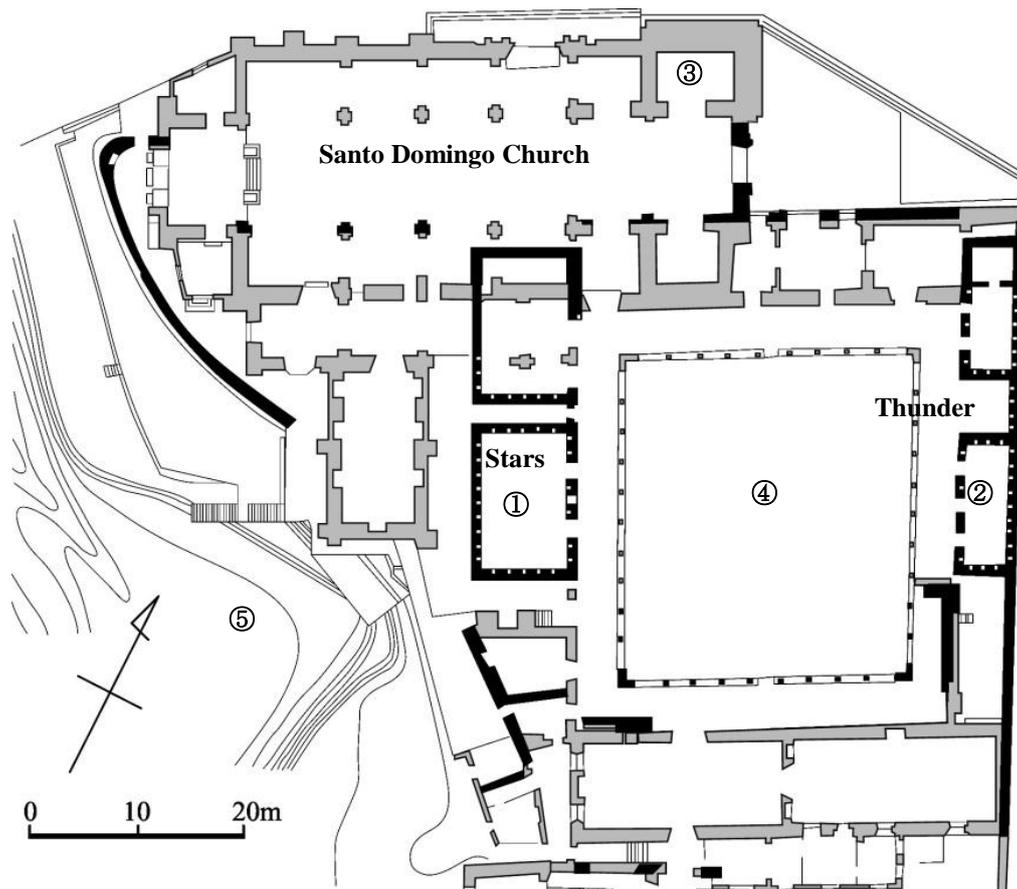
In the 16<sup>th</sup> century, the Christian Catholic Church was built over the Inca stone structure. For the construction of the church, the Spaniards destroyed some part of the temples that formed the complex and some parts were used as a foundation of the Catholic Church. In this way, the Inca stone structure was incorporated to the colonial construction resulting in a magnificent monument that shows a mixture of Spanish and Inca culture. The Figure 2 shows the plan view of the current building, where the black part represents the remaining Inca's walls and the gray part represents the colonial construction. The Santo Domingo Church is located at the upper part of the Figure and it can be appreciated that was constructed on the Inca base.

Figure 2: Location of Santo Domingo Church inside the Coricancha complex

A series of ambient vibration measurements were carried out in the complex that includes the Santo Domingo Church. The stars and the thunder temples, the tower of the colonial church and the inner at outer yards were selected for these measurements. These locations are indicated by encircled numbers in Figure 2. The meaning of the numbering and the purpose of the measurements are described as follows.

① Star Temple (Chasca): Structure Vibration. Measurements of horizontal vibrations in the two principal directions of the building were performed. The sensors were located on the floor level and at walls on all four sides. The sensors at the wall were located on the sill of rectangular offset on the inner wall face closest to center of the wall. The directions were designated NS and EW respectively. However, the actual directions are Northeast-Southwest (NS) and Northwest-Southeast (EW).

② Temple of Thunder (Illapa): Structure Vibration. In a similar manner to the temple of the stars, measurements of horizontal vibrations in the two principal directions of the building were performed. The sensors were located on the floor level and on walls on four sides. The sensors at the wall were located on the sill of rectangular offset on the inner wall face closest to center of the wall. Again, the directions were designated NS and EW, respectively.

④ Interior Yard (Ceremonial Fountain): Ground vibration measurement. At this site, array measurements of the vertical components of the ground vibration were carried out. The triangular array configuration of sensors on the yard consisted of approximately 25 meter sides triangles. The array measurement is intended for F-K spectral analysis (F: frequency, K: wave number) to obtain the Rayleigh wave dispersion curve, from which the shear wave velocity profile of the ground may be estimated by inverse analysis.

⑤ Exterior Garden (Sacred Garden of Sun): Ground vibration measurement. In a similar manner to the interior yard, array measurements of the vertical components of the ground vibration were carried out here. The configuration of sensors again consisted of triangular array with sides of approximately 30 meters. As noted above, array measurement is intended for F-K spectral analysis.

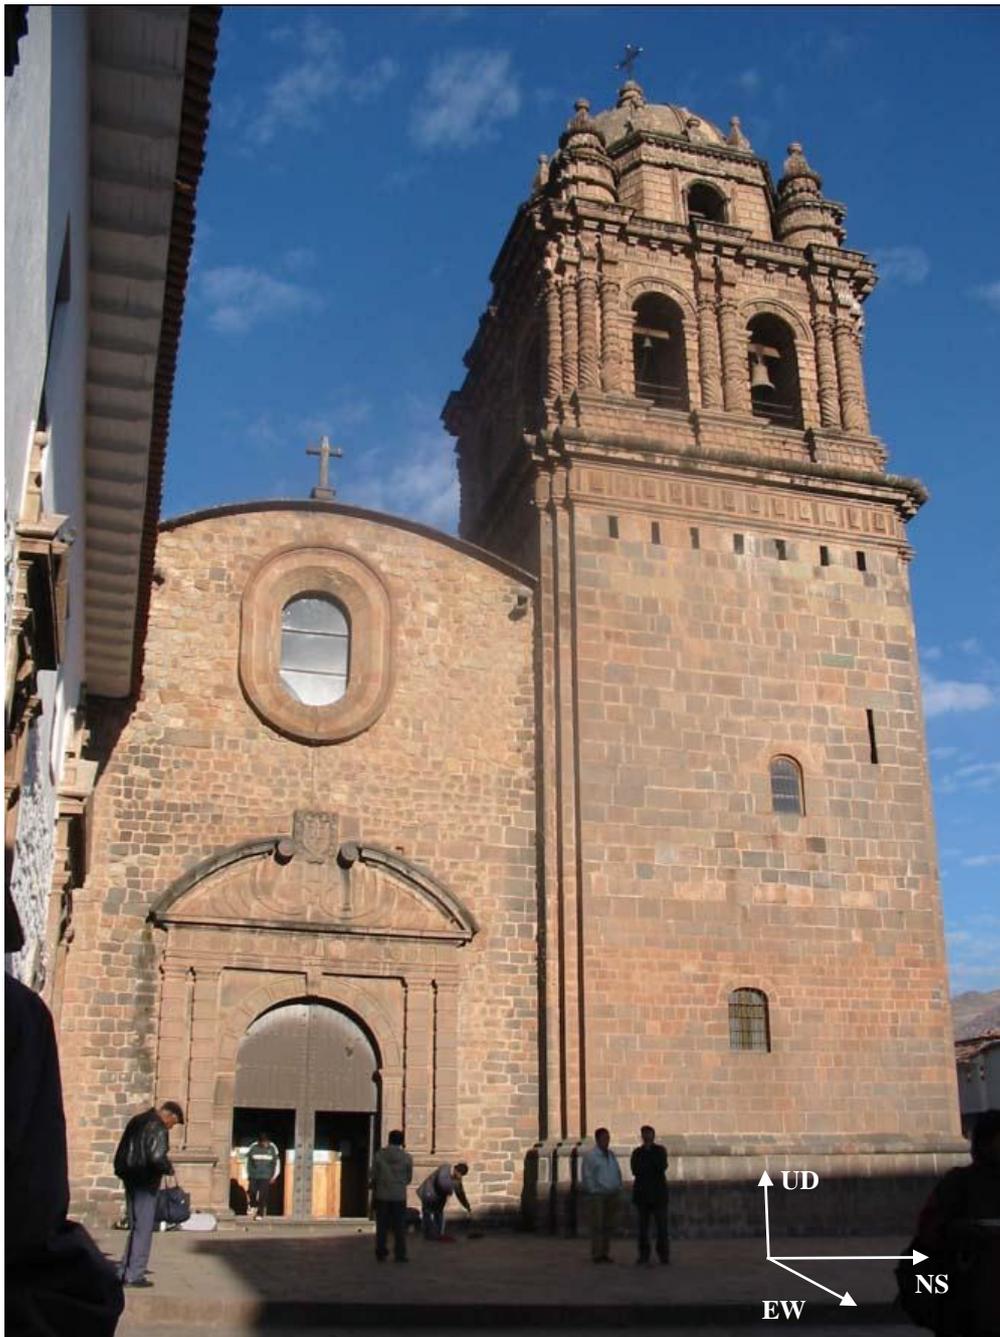
③ Tower of Santo Domingo Church (Figure 4): Structure Vibration. Three component of vibration were measured at the top and bottom of the tower. The directions for measurements are indicated in Figure 3.

Figure 3: Tower of the Santo Domingo Church

The analysis is focused on the behavior of the tower of the church since this portion of the structure is the most vulnerable part of the structure during earthquake as was observed during the earthquake that hits Cusco city in the year 1950.

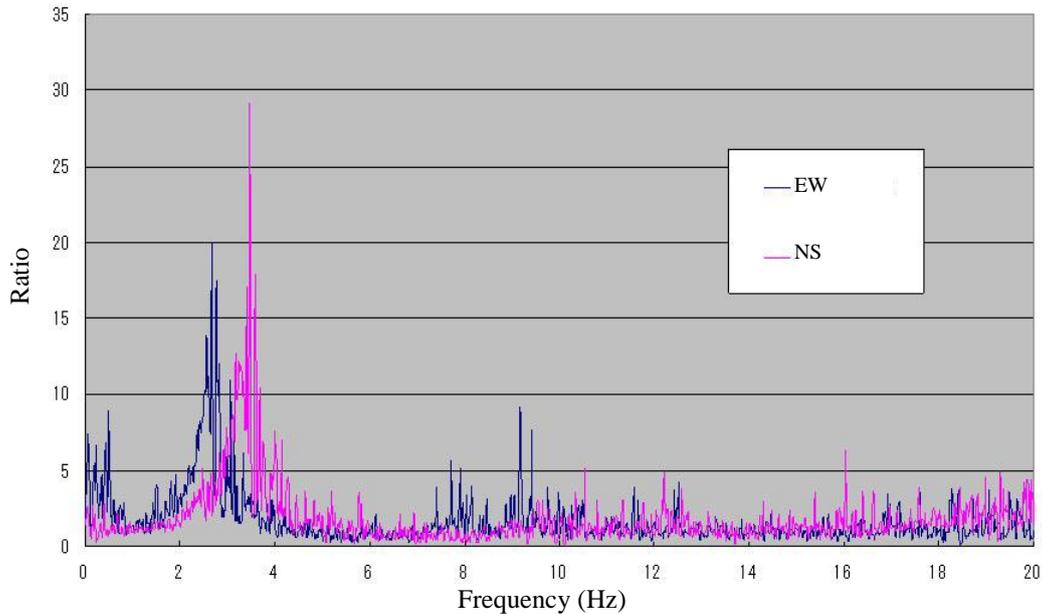
Figure 4 presents the results of the Fourier analysis for the horizontal vibration of the Colonial tower. These directions NS and EW are indicated in Figure 4. The Fourier amplitude spectrum obtained at the top of the tower was divided by the one obtained at the ground level, to obtain only the vibration characteristics of the structure. It can be observed that the value of the predominant frequency in the EW direction is 2.7 Hz, and in the NS direction is 3.3 Hz.

**Figure 4.** Fourier analysis results for the tower of Santo Domingo Church

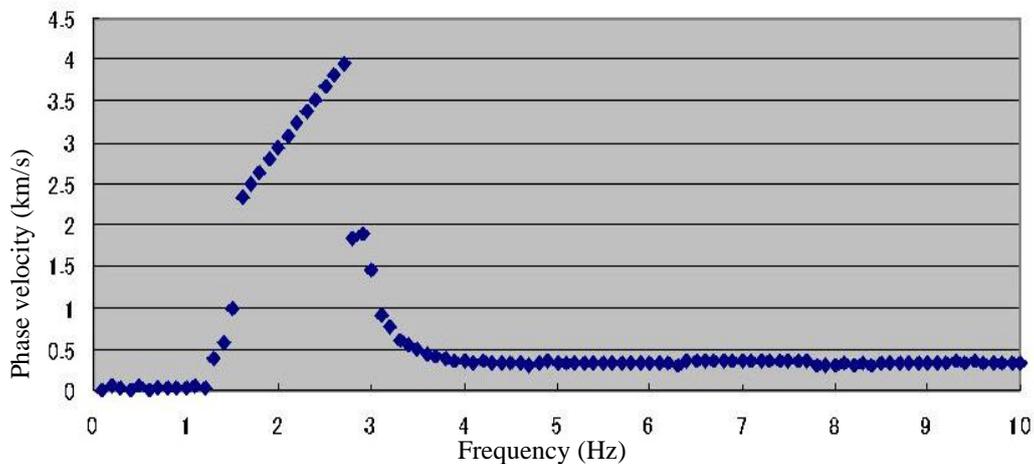
Figure 5 presents the dispersion curve obtained from the FK analysis. This result permits to estimate the predominant frequency of the ground as 2.7 Hz. Then, if the result is compared with that obtained for the tower of the Colonial Church, it can be observed that the frequency of the structure and soil are similar, and therefore, the resonance phenomenon is expected to occur. This coincidence of the predominant frequencies could be the explanation of the repeatedly failure of the tower during past earthquakes.

**Figure 5.** Rayleigh wave dispersion curve for Coricancha ground site

It was found that the predominant period of vibration of the church tower is comparable to the predominant period of the ground, and therefore the tower appears to be more vulnerable in case of earthquake occurrence because of the possible resonance phenomenon to be expected.

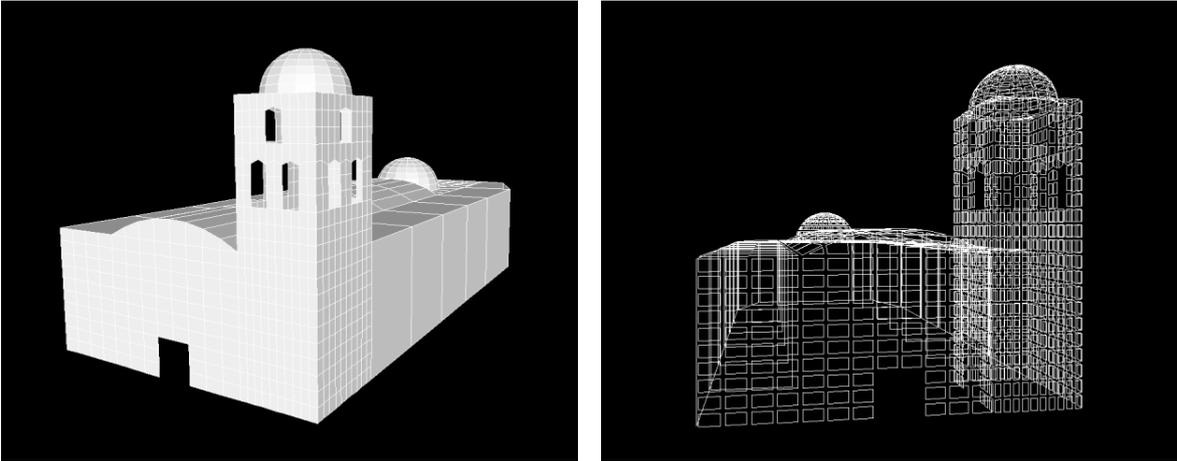
To compare the characteristics obtained from ambient vibration measurements with analytical results, finite element method is employed to formulate the analytical model. The FEM model was constructed based on available data and based on direct measurements of the dimension of the building. As can be observed in Figure 6, the general shape of the Santo Domingo Church is reproduced in the model where only main openings (main door and windows of the tower) are considered. The columns and arches are modeled by means of frames, the walls are modeled by plate elements and the floors and roofs by are modeled by shell elements.

**Figure 6.** Finite element model of Santo Domingo Church

The material of construction is stone masonry and it is assumed that the mechanical properties of the masonry are dominated by the property of the mortar. The visual inspection of the walls and tower structure has shown that lime mortar has been used to lay down the stone blocks. Therefore low value of 0.5 Gpa is assumed as equivalent elastic modulus.

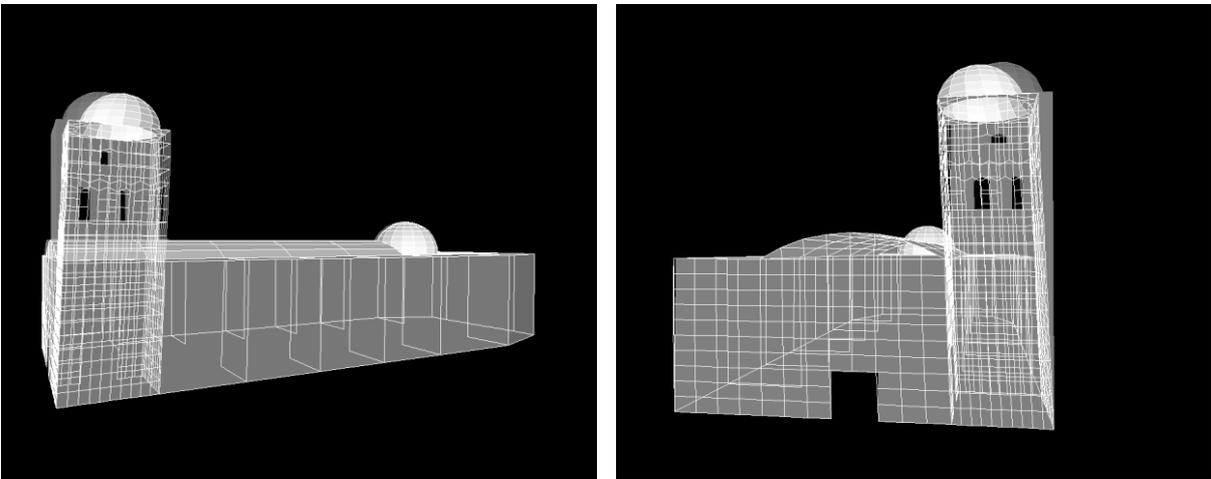
Modal analysis using the finite element method gives as a result that the first mode of vibration corresponds to normal mode in the EW direction (or in the longitudinal direction of the church) with a frequency of 3.66 Hz. The second mode corresponds to the vibration in the transversal direction with a frequency of 3.69 Hz. These modes of vibration are show in Figure 7 where the gray shadow indicates the undeformed shape of the church.

**Figure 7.** Modes of vibration of Santo Domingo Church
