Strengthening of Historical Monuments in Seismic Regions

Nataliya Y. Vorontsova

Earthquake Engineering Research Center, TsNIISK, Moscow

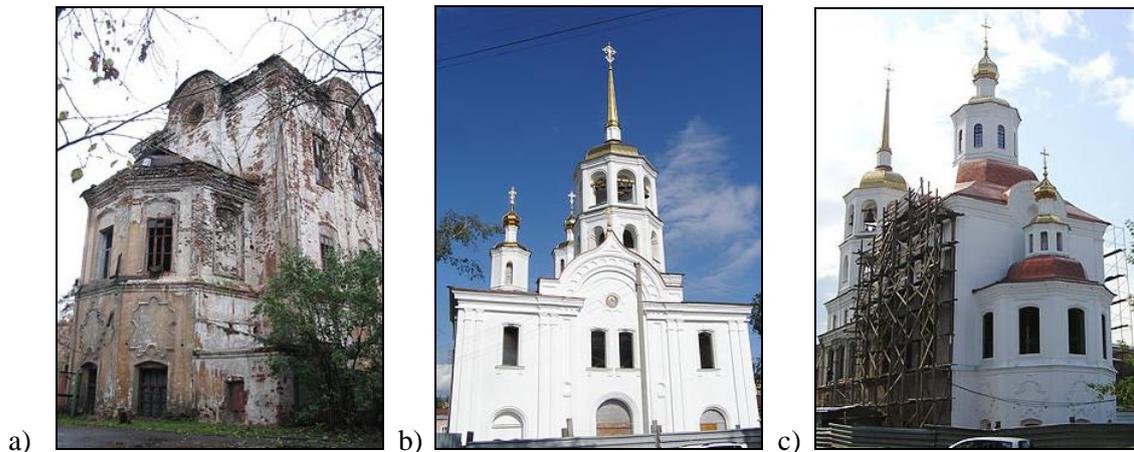
Figure 5. Mikhailo-Arkhangelskaya (Kharlampiyevskaya) church: a) before reconstruction, b) and c) after reconstruction

Mikhailo-Arkhangelskaya (Kharlampiyevskaya) Church is a historical and cultural monument built in 1779-1790 in the Irkutsk-City (see Fig.5). Restoration work began in 2005. The structural concept includes an asymmetric in plan (see Fig. 4), columnless brick masonry structure. The building consists of different parts of the design decisions, tied by walls into a single block. The northern and the southern side-chapels have similar structural concept in the form of two-storey parallel bays of different length. On the east side, the bays are completed with the multifaceted apses.

Project of seismic isolation system in the form of lead-rubber bearings in the foundation of the church is used to provide seismic stability of the building. Total number of lead-rubber bearings is 92. These measures are aimed at increasing the natural periods of vibration of the building and the reduction of energy transmitted from the ground to the superstructure.
