Analysis of masonry walls strengthened with RC jackets

S. Churilov & E. Dumova-Jovanoska

University "Ss. Cyril and Methodius", Faculty of Civil Engineering, Skopje, Macedonia

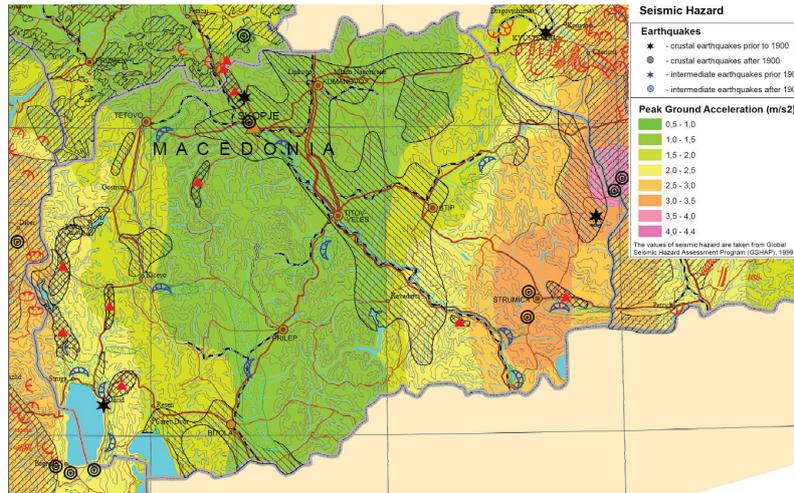
Figure 1.1. Seismic hazard map of Macedonia

Macedonia is one of the most active seismic places in Balkan Peninsula, see Fig. 1.1. It lies in the south part of the Eurasian plate where three tectonic plates, African, Asian and European meet. It is mostly the work of African plate sliding beneath Eurasian plate that caused the geographic formation which we see today, and it is also the reason why there are frequent earthquake tremors in the region. The friction between the plates has brought about a number of fault lines which run across Macedonia approximately along the course of river beds. The one under Kochani along the river Bregalnica contributed to the 1904 earthquake, and the Skopje fault line along the river Vardar contributed to the 1963 earthquake which destroyed about 10% of the buildings, while other 65% were damaged beyond economical repair.

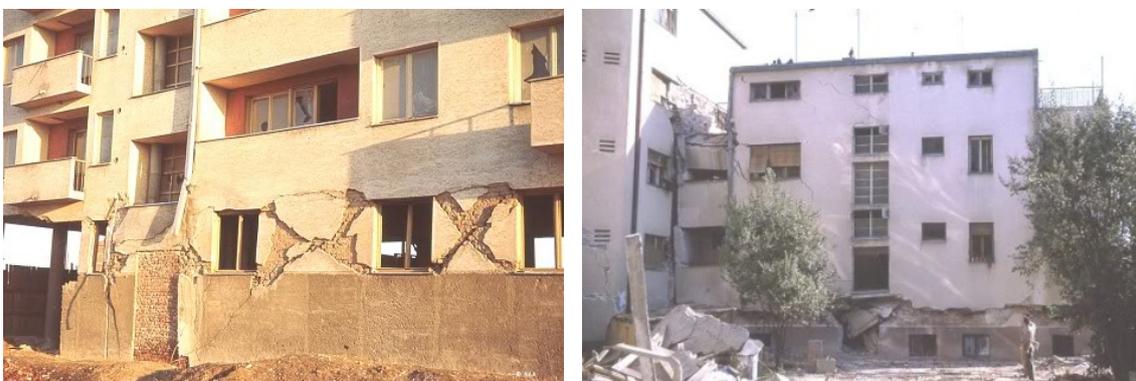
Figure 1.2. Damage on residential masonry buildings after 1963 Skopje earthquake (Ambraseys, 1967)

In-plane resistance of unreinforced masonry walls is mainly depended on mortar strength and masonry unit strength and proportions. If the horizontal forces are strong enough to exceed the in-plane strength capacity of the wall, then a shear failure will occur. Shear failure is most common failure mode associated with unreinforced masonry characterized by brittle tensile cracking through mortar; masonry unit and mortar-unit interface, see Fig. 1.2. As can be observed after 1963 Skopje earthquake, most of the damage in masonry buildings occurred in the ground floor, by formation of typical X-cracks and/or collapse of the weak ground floor.

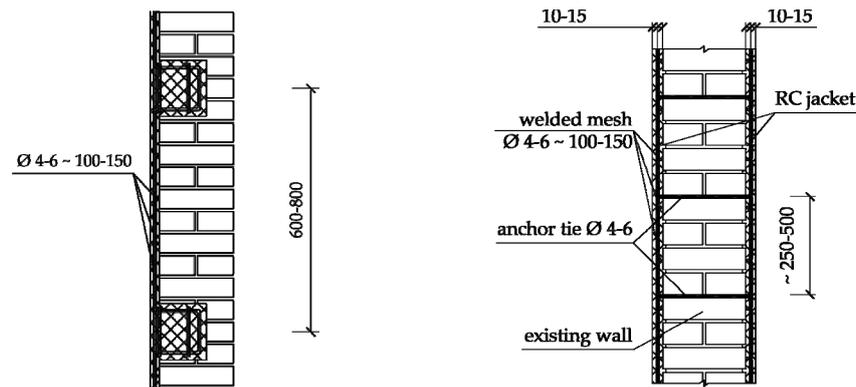
Figure 1.3. Application of single- and double-sided RC jackets to brick masonry wall

RC jacketing is strengthening and retrofitting technique that consists of application of single- or double-sided RC walls or coatings. This technique is suitable both for stone and brick masonry. In case of using reinforcing steel, first the plaster is removed from the walls and mortar joints are cleaned from mortar. If any cracks appear, they are grouted and then anchor ties are built in pre-drilled then the surface is cleaned, moistened and spattered with cement milk. The concrete is applied in two layers with reinforcing mesh between them. The mesh is connected on both sides with the steel anchors by welding or by tying with wire. The usual total thickness of the jacket varies from 30-100 mm, depending on the method for application of the concrete layers.

Although similar to shotcrete, it has some distinctive features. Establishing good bond between the new and old material is one of the crucial steps in the application. The shear connection which transfers the loads from the new jacket to the existing wall is provided with reinforcing cages in case of single-sided RC jacketing and with cemented or epoxied reinforcing anchor ties in case of double-sided RC jacketing, see Fig. 1.3.

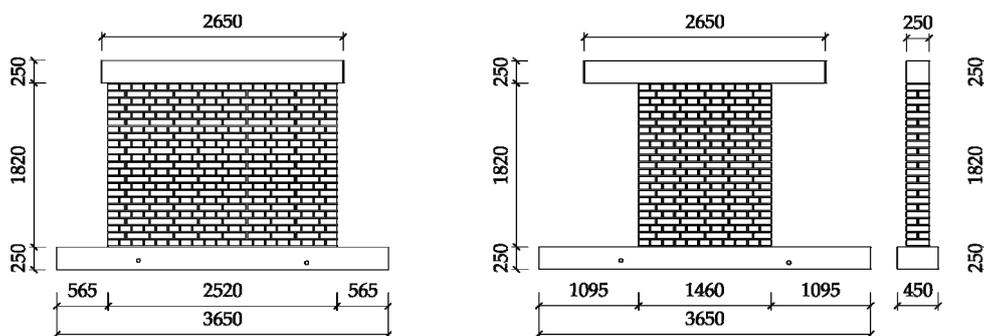
Figure 3.1. Geometry of the squat and tall walls for in-plane testing

The experimental program was based on in-plane static cyclic loading tests performed on UMW and SMW walls. Two geometry configurations appropriate for the laboratory test set-up were selected. The lengths of the walls were 1460 mm and 2520 mm and the height of the walls was fixed to 1820 mm. In total eight walls with solid clay bricks and lime mortar were constructed. These walls were specifically developed for the experimental research purposes of Churilov (2012). Two geometry aspect ratios h/l of 0.7 (squat walls) and 1.2 (tall walls) were used. The wall geometry in longitudinal and transversal section is shown in Fig. 3.1. Two vertical load levels of 0.5 N/mm² and 1.0 N/mm² were applied and kept constant during the tests.

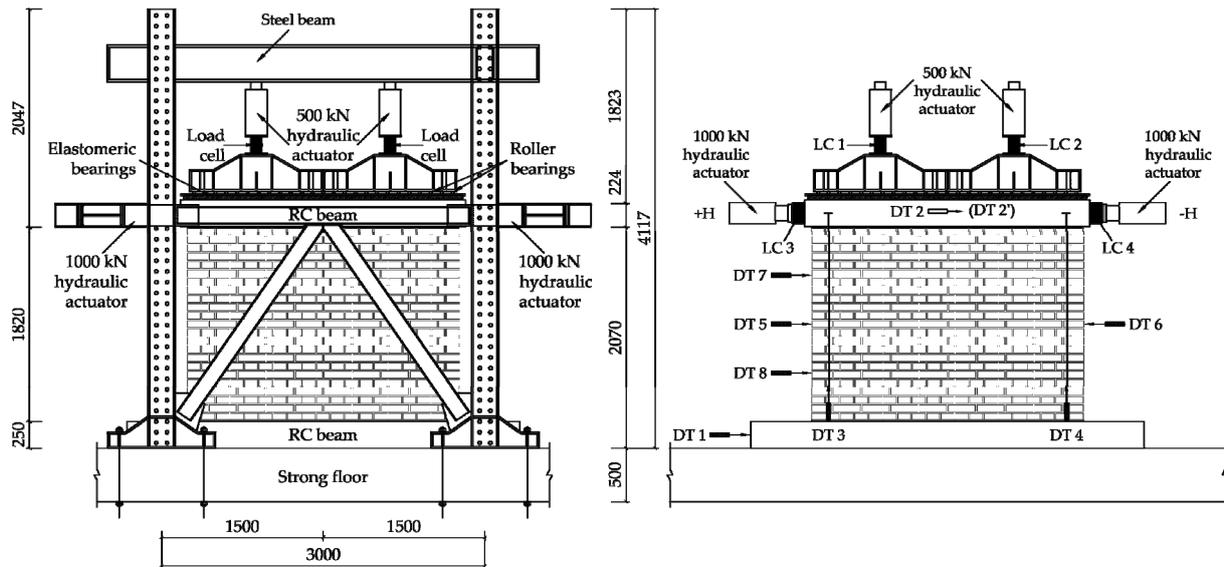
Figure 3.2. Test set-up for in-plane horizontal cyclic loading and instrumentation with displacement transducers and load cells

The tests were carried out according to the test set-up shown in Fig. 3.2. Normal compressive loads were applied by two vertical actuators with capacity 500 kN. The vertical load was transferred on a stiff steel load distribution beam positioned over a series of steel roller bearings over the top RC beam. To obtain uniform vertical load distribution over the whole horizontal cross-section of the wall, elastomeric rubber bearings were inserted between the top RC beam and the steel plate. The walls were placed over a layer of mortar on the bottom RC beam which was fixed to the strong floor by steel anchors. Thus, the set-up enables fully fixed boundary conditions on the top and bottom edges of the walls. Lateral loads were simulated with horizontal actuators with capacity of 1000 kN placed on both sides of the wall and were manually applied on the top RC beam with loading rates of 0.2 - 0.5 kN/s until reaching the specified displacement increments. The cyclic load tests were carried out with displacement controlled increments and stepwise increased amplitudes repeated three times at each specified increment.

Horizontal and vertical displacements under cyclic loading have been instrumented with a set of displacement transducers. Applied forces were instrumented with load cells located between the actuators and the load application point. Data acquisition was automatic with 8 channels Spider8, PC-based DAQ unit. Horizontal displacements at points DT 2, DT 2', DT 5 and DT 6, as well as horizontal forces obtained with the load cells LC 3 and LC 4 were automatically stored in digital form with the computer software. Other measured values were manually recorded after each displacement cycle.

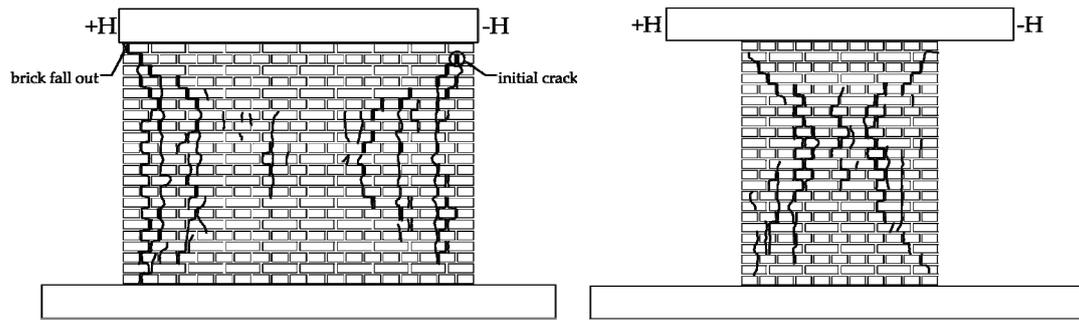
Figure 3.3. Failure modes of UMW3 and UMW4

The most important results are summarized and presented through obtained failure modes and force-displacement hysteresis curves. All unreinforced walls failed in shear due to the formation of diagonally oriented cracks in the bricks or passing through the bricks or in the brick-mortar interface, see Fig. 3.3. No local buckling or crushing of the bricks was observed except for crushing of the bricks

in the bottom left corner of the wall UMW1 and small brick fall-out in top left corner of the wall UMW3. However, a difference in the crack pattern was noticed for squat and tall walls. In particular, walls UMW1 and UMW3 presented mainly vertically oriented cracks passing through the bricks or along the head joints. At ultimate state, the cracking pattern with ‘hour-glass’ shape was observed. Initially, vertical cracks started to develop in the vertical planes closest to wall edges and subsequently started to propagate to the centre of the wall. Walls UMW2 and UMW4 demonstrated typical diagonally oriented cracks.

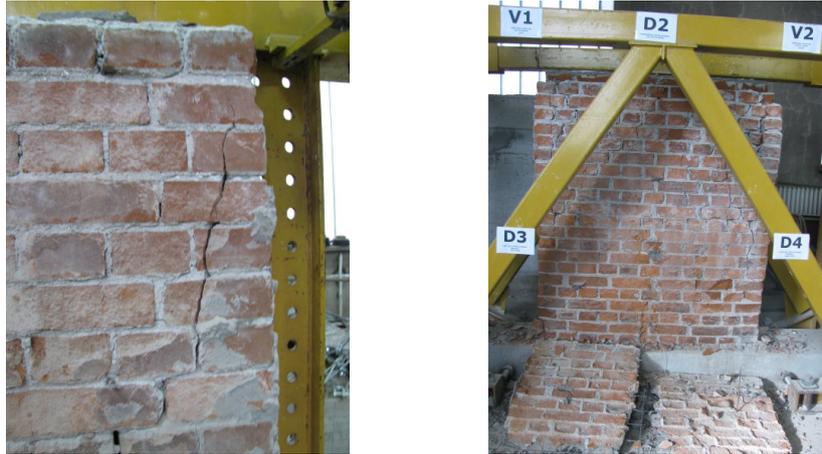
Figure 3.3. Experimental cracking pattern for strengthened masonry walls (masonry part)

Since the walls did not show many cracks on their outer surface and to inspect the level of damage in the masonry wall, it was decided to remove the RC jackets from the walls prior their complete demolition. The jackets were carefully removed from the masonry by using power hammer. The most interesting finding was that the walls loaded with higher precompression level exhibited cracking in the masonry wall. The most extensive cracking was obtained at tall wall SMW2, see Fig. 3.4. On contrary, the walls subjected to lower precompression stresses did not suffer any particular damage in the masonry. A possible explanation for this might be that the walls with lower precompression level behaved as one compact element and the shear and tensile strength were not exceeded. From the imprint on the inner surface of the jackets it can be concluded that the bond strength between the concrete and masonry was not exceeded. The separation of the jackets was due to splitting of the bricks in the vertical direction with respect to the wall. This result may be explained by the fact that the splitting strength of the bricks was achieved. It can therefore be concluded that the splitting strength of the bricks is important mechanical property which can control the separation failure mode.

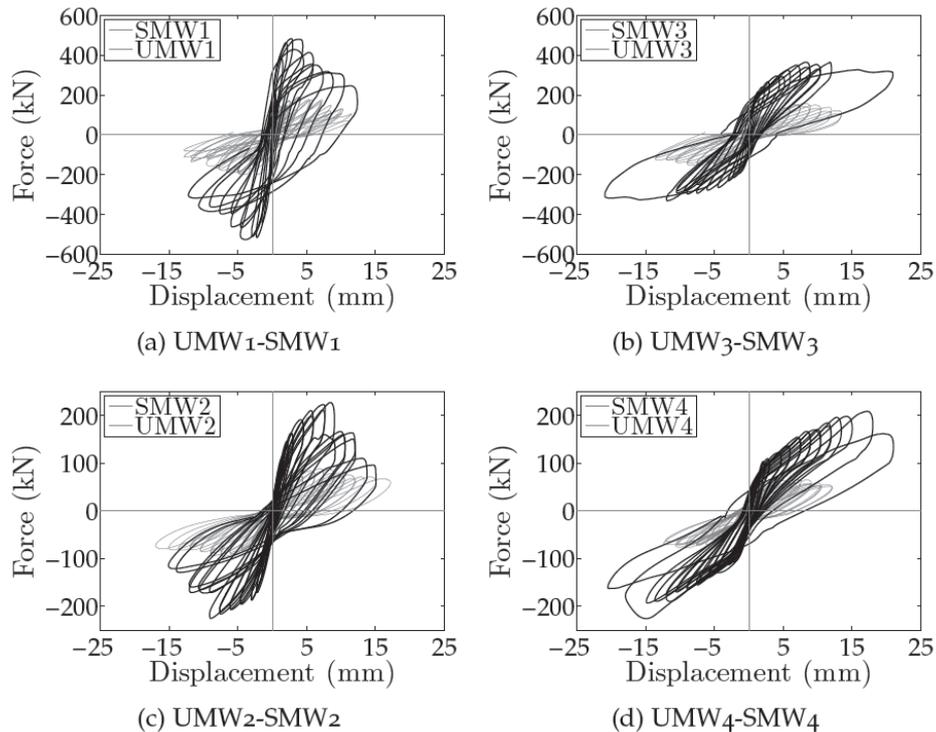
Figure 3.4. Comparison of force-displacement hysteresis loops of UMWs and SMWs

The effects of the strengthening intervention on the resistance of masonry walls have been compared to the in-plane seismic resistance of the unreinforced brick masonry walls. Significant improvement of the shear capacity of SMWs compared to UMWs was achieved, see Figure 3.4. The maximum forces observed at strengthened specimens were higher than the corresponding forces obtained in the unreinforced specimens within the range of 123–204 %.

The highest effect of the strengthening to the lateral capacity was obtained at tall wall loaded with moderate level of vertical stresses $\sigma_0=0.5 \text{ N/mm}^2$ (SMW4). The deformation capacity in the ultimate limit state of the strengthened walls was increased with significant improvement in the walls loaded with $\sigma_0=0.5 \text{ N/mm}^2$. One unanticipated finding was that the deformation capacity of the walls loaded with high vertical stresses was not improved. Moreover, for tall wall SMW2 it was decrease for about 5%, although positive effect was obtained for the other limit states. Table 3.1 presents the average test

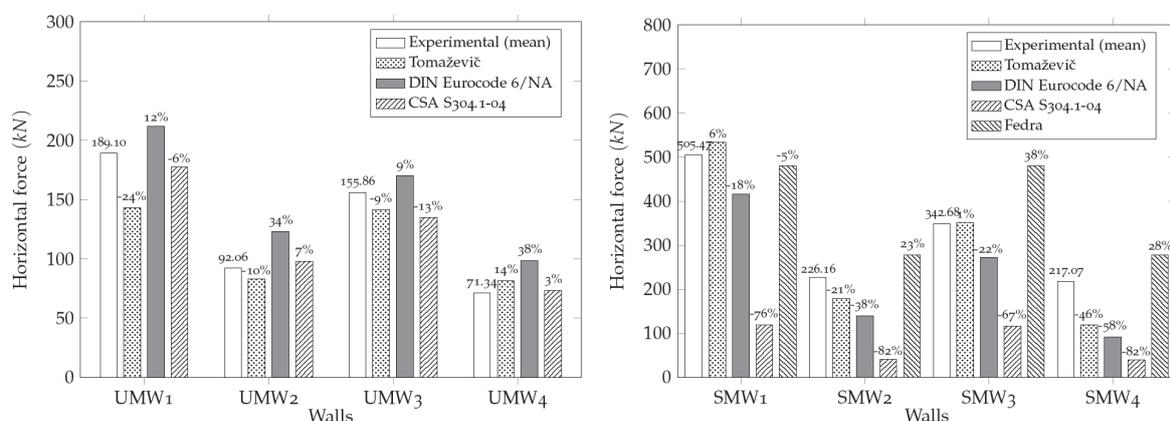
Figure 3.4. Comparison between experimental and analytical shear behaviour for UMWs and SMWs

In order to provide simplified analytical models for analysis of RC jacketed masonry walls, the current and code defined design procedures for in-plane shear and bending in masonry walls have been investigated. Shear capacity design and bending design procedures in design codes PIOVSP (1981), EN 1996-1-1 (2005) and DIN EN 1996-1-1/NA (2011), CSA S304.1-04 (2004), provisions given by Tomažević (1999) and proposed design equations developed in FEDRA (2003) were considered. Predicted shear and bending resistance of unreinforced and strengthened masonry walls were compared with the lateral capacity of the walls obtained from the tests. Bending resistance was included due to mixed failure modes of the strengthened walls. Due to the effects of symmetrical application of RC jackets on both sides of the walls and the limited experimental programme, analogy with reinforced masonry was established. The correlation between test results and analytical models for unreinforced and strengthened masonry is presented in Figure 4.1. Comparisons between the data were made without considering the contribution of the vertical reinforcement. This was due to the fact that the tested walls were not anchored with the vertical reinforcement to the bottom and top RC beam. The closest results to the experimental ones were obtained with the analytical model proposed by Tomažević. This model was particularly precise for squat walls giving only 1 – 6% difference from the experimental values. The higher disagreement was obtained for tall walls. DIN EN 1996-1-1/NA predicted relatively well as a result of the contribution of the masonry failing in diagonal shear, while as in case with CSA S304.1-04 the contribution of the steel was ignored. Overall, good prediction was shown with the model found in FEDRA. But, it is based on the shear strength of the jacketed masonry section and it is not applicable for the case of failure mechanisms obtained with the tests. The results suggested that the analytical model for reinforced masonry walls proposed by Tomažević could be used in analytical studies of the lateral resistance of RC jacketed masonry walls.
