Empirical and Analytical Vulnerability Assessment of the Masonry Building Stock in Antakya (Hatay/ Turkey)

L. Abrahamczyk, J. Schwarz & T. Langhammer

Earthquake Damage Analysis Center, Bauhaus-Universität Weimar, Germany

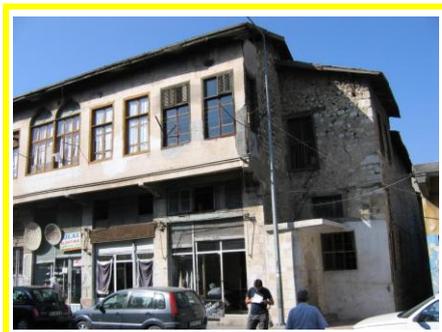
Type: MS
simple stone

a) Example buildings

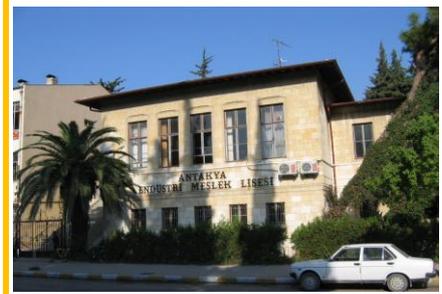
Type: MM
massive stone

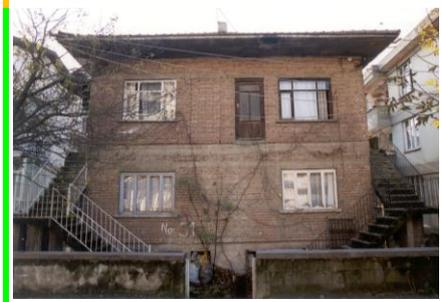
Type: MU
unreinforced
masonry

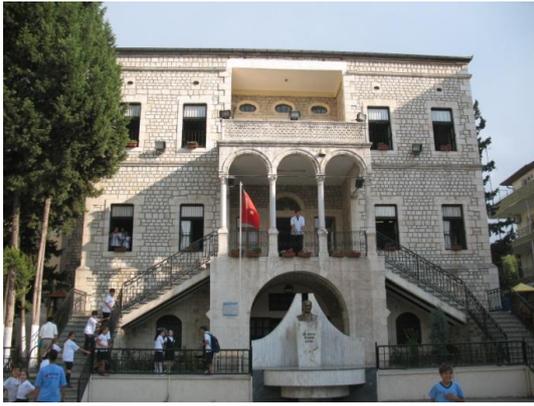
a) View of the instrumented school building

Figure 4. Applied Building monitoring system and response of the building to first EQ record

In the framework of the project, different kinds of tests are foreseen to provide data for the analytical investigation to improve the quality of the structural models as well as the final damage prognosis. At the current state of the project, one masonry building could be already equipped and the instrumentation of another one is in progress. The first masonry building (Figure 4a) could be instrumented by four triaxial strong-motion recorders. Figure 4b indicates the applied instrumentation scheme, which follows the schemes from previous instrumentation of reinforced concrete buildings in Antakya (Abrahamczyk *et al.*, 2008). Due to limited space around the building and the use as a school, no free-field station was installed. Instead of it, one sensor could be installed on the 2nd floor in the same line of the sensor on the ground floor and roof.
