Seismic Response Analysis of Typical Rammed Earth House in Disaster Areas of Chinese Wenchuan Ms8.0 Earthquake using Finite Element Method

S. Xu, K. Liu, L. Wang & J. Sun

*Key Laboratory of Loess Earthquake Engineering, CEA, Lanzhou 730000, China
Lanzhou Institute of Seismology, China Earthquake Administration, China*

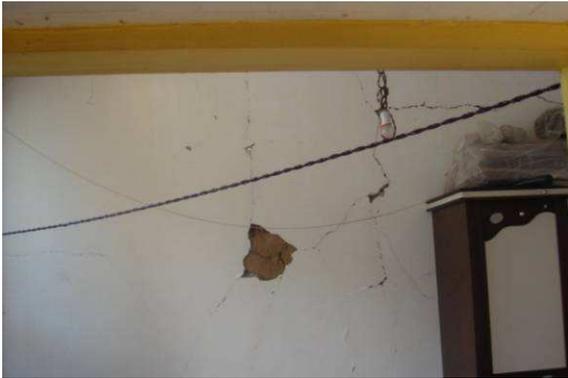
In the region of intensity V, the crack of wall body and dropping of mud skin of earth wall are obviously caught. Although these damages could not cause rammed earth house collapsed and the

people died, the house has lost its function of use in a safe condition (see Fig. 2.1).

(a) Tiny cracks of wall

Figure 2.1. Destruction of rammed earth house in intensity V region

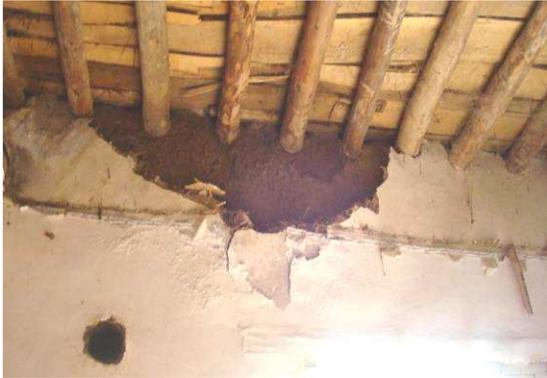
(b) Mud skin dropped

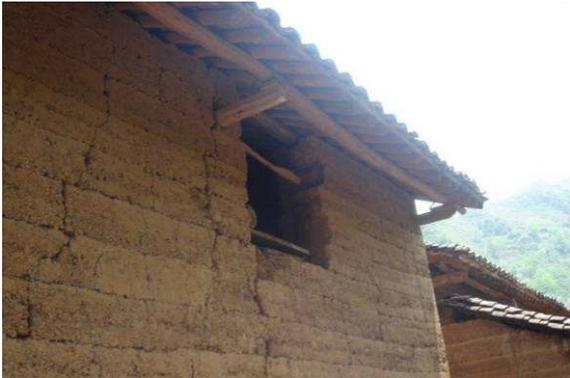
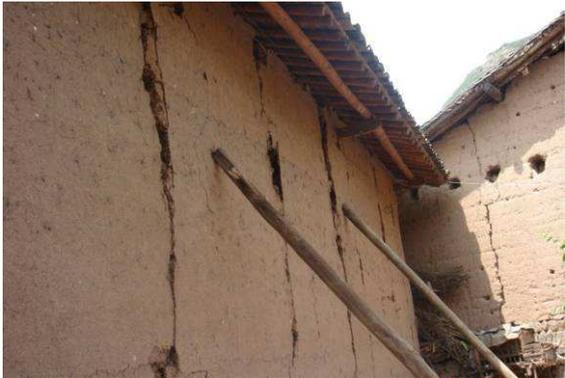
Figure 2.2. Vertical cracks within wall in intensity VI region

In the case of intensity VI region, heavy vertical cracks appeared within wall and at joints between walls, even when these cracks crossed whole wall medium or more serious damages would happen. Some pictures of destruction with rammed earth houses in Wudu city taken just after the Wenchuan Ms8.0 earthquake are shown in Fig. 2.2.

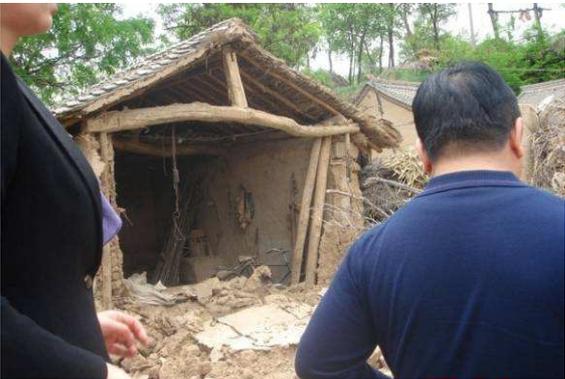
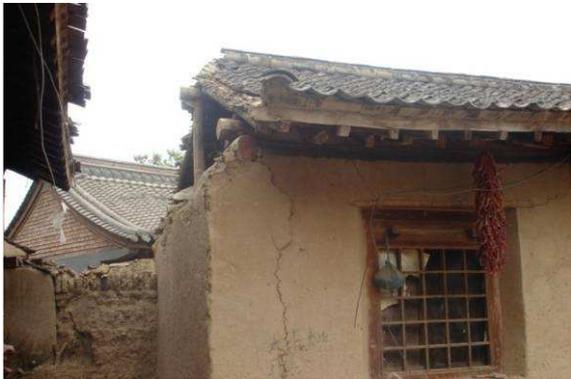
Figure 2.3. Damage of rammed earth house in intensity VII region

For those rammed earth houses located in the region of intensity VII, one typical example is gable wall separating from the structure of the house (see Fig. 2.3).

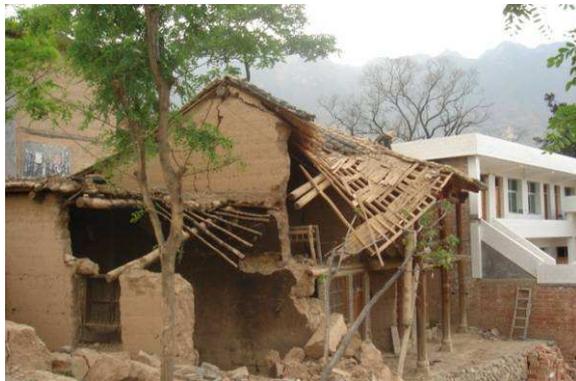
In some special local-areas, e.g. the top of hill, the intensity could reach VIII or even IX due to field effect of ground motion. Consequently, the rammed earth house met serious damage. The field survey shows that rammed earth walls collapsed, broken and even whole house collapsed in those special areas (see Fig. 2.4).

(a) Rammed earth walls collapsed

Figure 2.4. Damage of rammed earth house over intensity VIII

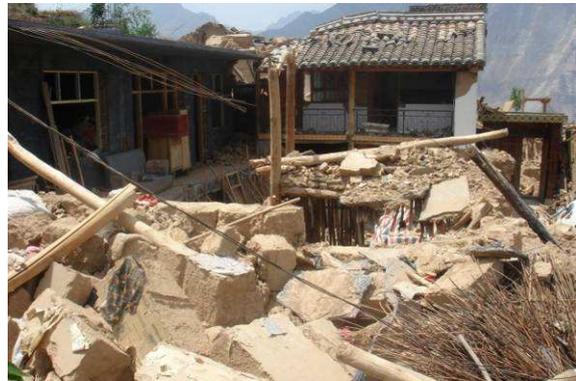
(b) Whole rammed earth house collapsed

The site survey disclosed the situation of rammed earth wall structure of interlayer contacts in Wudu city. Generally, the weak positions obviously distribute in the earth wall due to the traditional building methods (see Fig. 2.5). That might be the direct reason why rammed earth walls tend to broken into bricks in the region of intensity VIII (see Fig. 2.4b).

The weak contacts in rammed earth wall caused by traditional construction method are the main reason why the whole wall is broken into bricks when a strong earthquake happens.

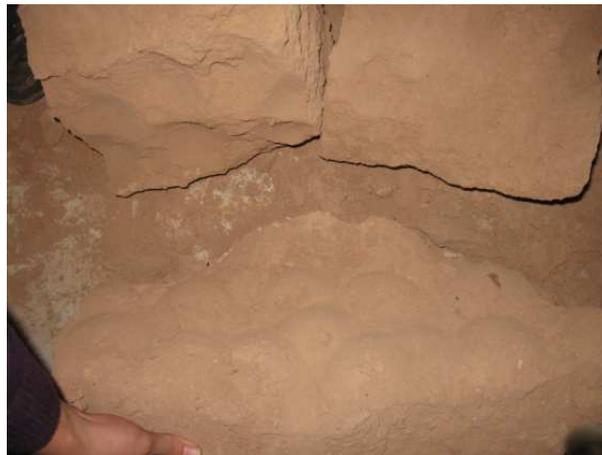
Figure 2.5. Interlayer contacts of the typical rammed earth wall in Wudu city

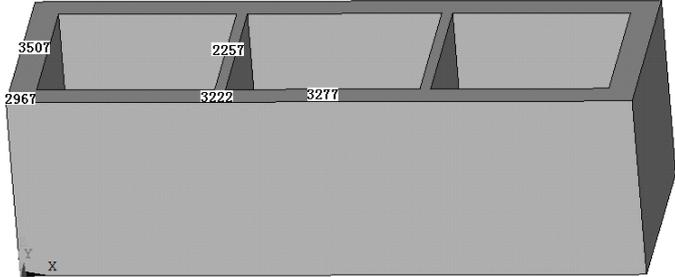
The model of rammed earth house has the length, width and height of 11.6m, 3.6m and 3.6m respectively. According to the real structure of typical rammed earth houses in Wudu city, three rooms were adopted here for this computational model, in which both sides are 3.3m width and the middle is 3.6m width. Meanwhile, enclosing walls of the house model were designed as 0.5m width whereas partition walls as 0.2m (see Fig. 3.1). The roof vertical loading, 37000N/m^2 , is evenly loaded on the top of walls. The parameters of wall are shown in Tab. 3.1.

Computational model of finite element method (FEM) was meshed by 39,500 elements with 50,076 nodes, and all elements are hexahedron with 8 nodes. Considering the complexity of dynamic response of rammed earth under earthquake, the author adopted linear method in this analysis. Analysis works of numeral calculation were completed by using of ANSYS software of Institute of Engineering Mechanics, China Earthquake Administration.

Figure 3.1. Computational model of FEM of typical rammed earth house in Wudu city and nodes for output acceleration record

The nodes of 2257, 2967, 3222 and 3507 are acceleration record positions and respectively for the partition wall, corner wall, longitudinal wall and cross walls (see Fig. 3.1). Computational results show horizontal acceleration at the top of walls is larger than input seismic loading. According to the peak ground acceleration (PGA) records, the cross walls are more dangerous than the longitudinal walls; partition walls are more dangerous than the cross walls; and the corners are more dangerous than others (see Tab. 3.2). For acceleration spectrum, the output bandwidth become narrow, about 5Hz, compared to the input bandwidth from 1Hz to 10Hz (see Fig. 3.4). This result may have relation with the reduction of the seismic energy absorbed by the wall and in the situation the rammed earth wall works as a filter.

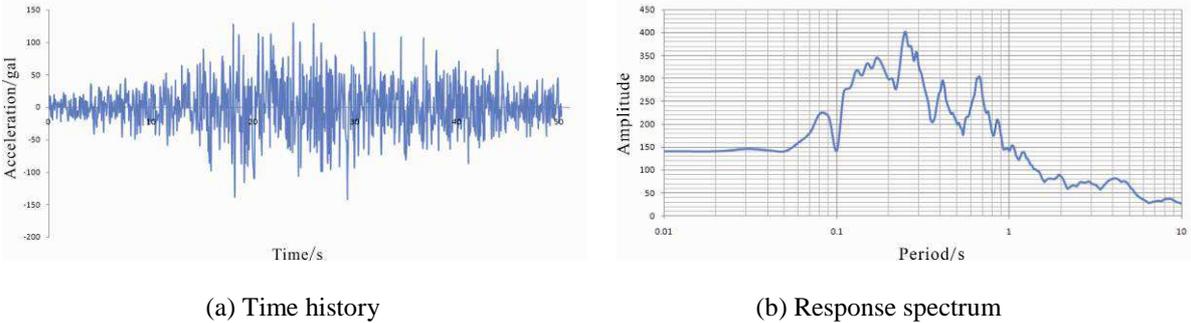
During the analysis process, we adopted a real time-history of Wenchuan earthquake recorded in Wenxian county as the input loading (see Fig. 3.2a). For the target ground motion, the maximum acceleration is about 141gal and predominant period is around 0.25s (see Fig. 3.2b).

Figure 3.2. The record of Wenchuan earthquake in Wenxian county

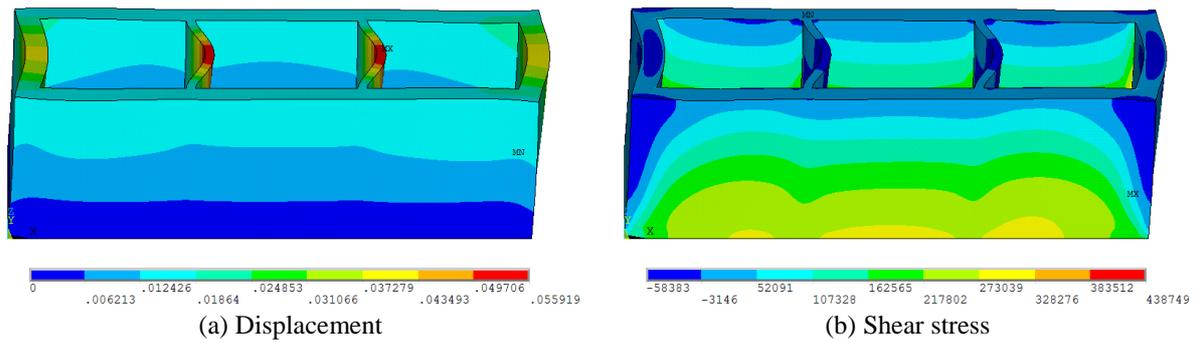
The analysis result discloses that all rammed earth walls move back and forth on horizontal plane and whole building structure appears shear motion response to seismic loading. Moreover, the displacement variation shows that the top of the earth wall could experience a larger deformation than the bottom, and the maximum displacement of partition walls is about 5.59cm (see Fig. 3.3a).

Figure 3.3. Analysis results of displacement and shear stress

The maximum shear stress could reach 0.43MPa at the bottom of the model when whole rammed earth house experience shear movement. For partition walls, the topper is the maximum position of shear stress and for whole model, the bottom and the corners are the most dangerous places (see Fig. 3.3b).

By means of numerical analysis, it is easy to understand that the top of partition walls suffered the maximum of displacement, shear stress and acceleration. Moreover, traditional partition walls are designed thinner and destroyed seriously than other walls according to site survey. The partition walls are positions to be easily destroyed.

The corners of walls are easy to be destroyed under a moderate earthquake. More larger displacement, shear stress and acceleration are founded at the corners in analysis model. There are no contacts to be used for reinforcement at the corners between two walls in traditional construction method. The divorce of two walls is found out in common even a moderate earthquake occurred.

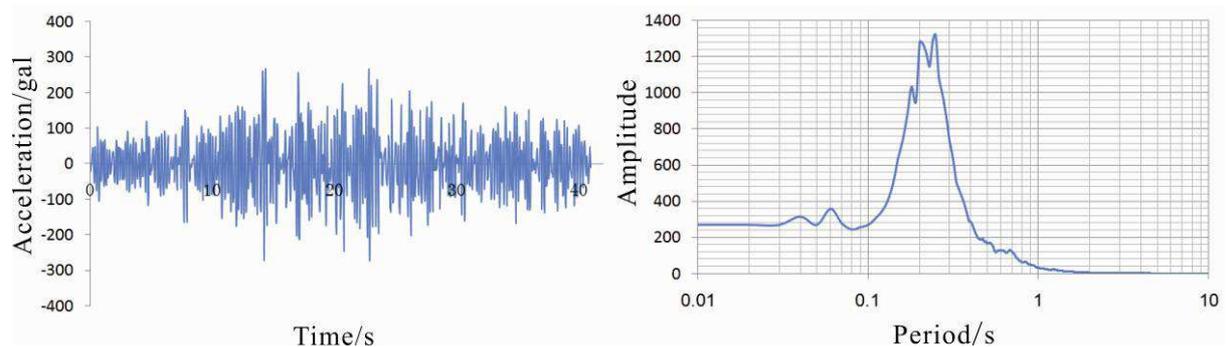
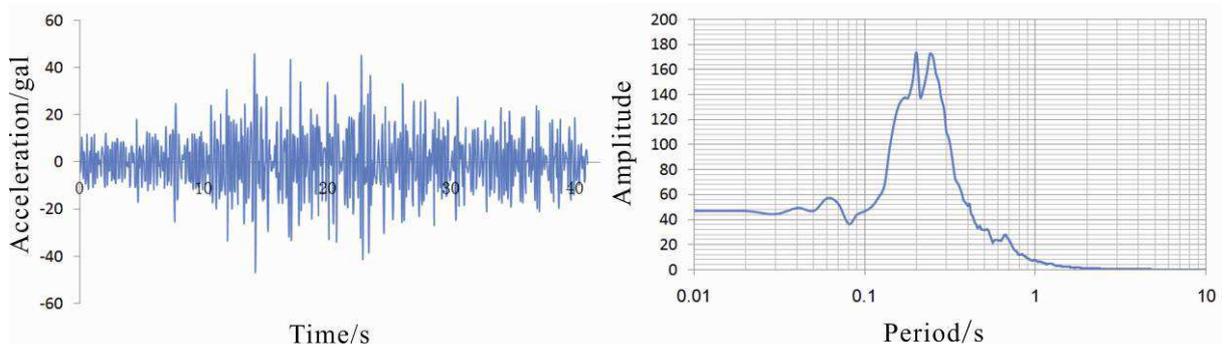
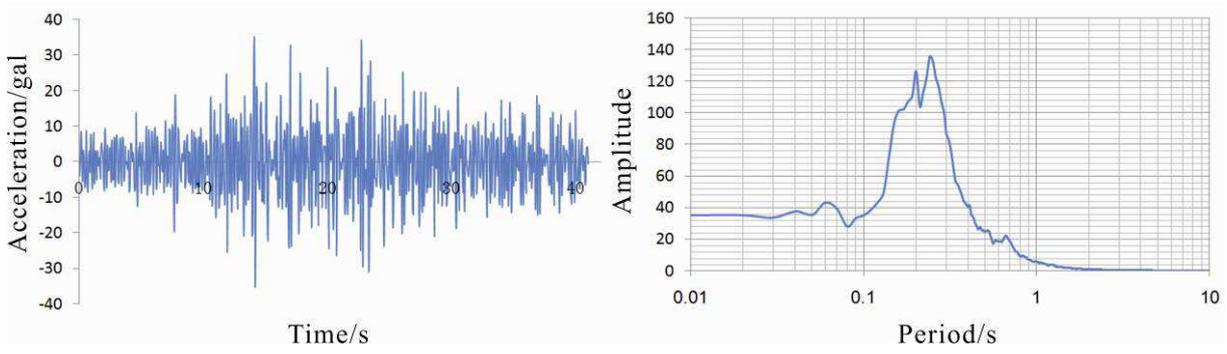
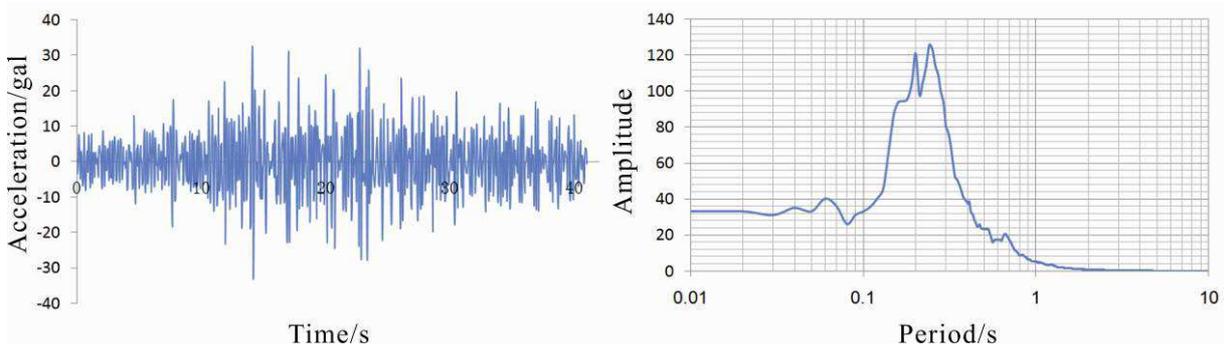
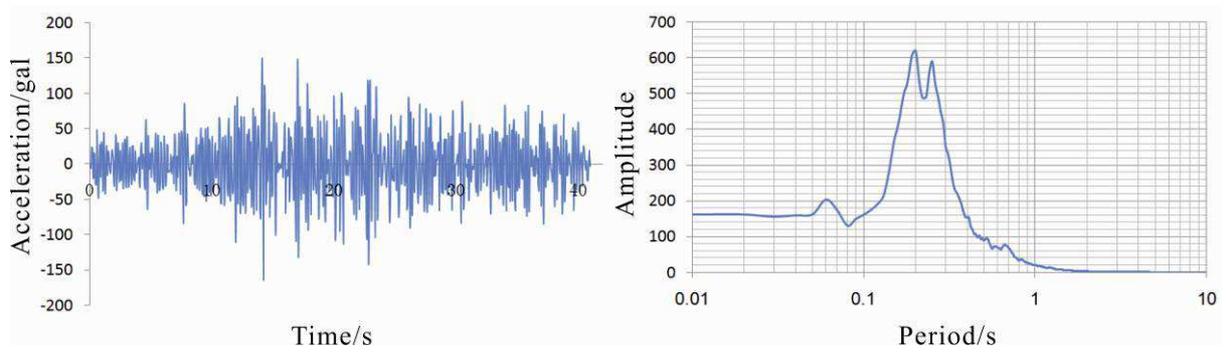
Figure 3.4. Time history of acceleration and spectrum at the nodes

The cross walls are easier to be destroyed than longitudinal walls because the PGA on the top of cross walls is larger than longitudinal walls in computational model. This analysis coincides with the result of site survey.
