Experimental Study on Typical Confined Masonry Structure under Cyclic Lateral Load

An experimental study was conducted to evaluate the behavior of confined masonry structures under earthquake loads. The one-story full-scale model was built based on local standard in Indonesia. Lateral cyclic loads were applied to the model with increasing displacement. Parameters evaluated were crack pattern, failure mechanism, lateral capacity, energy dissipation, ductility, and overall structural performance. The study reveals that initial crack occurred at corners of openings and truss mechanism was later developed for walls. Test shows that the model could withstand 3.5% drift without collapse. The masonry infill walls provided significant strength and ductility, and out of plane walls provided additional restraints for wall movements and improved structural performance. Proper detailing allowed frames to provide confining action to masonry walls, while anchorage of walls to columns limited damage area on walls. The results confirm that structures built according to the standard will behave satisfactorily under the design earthquake load.

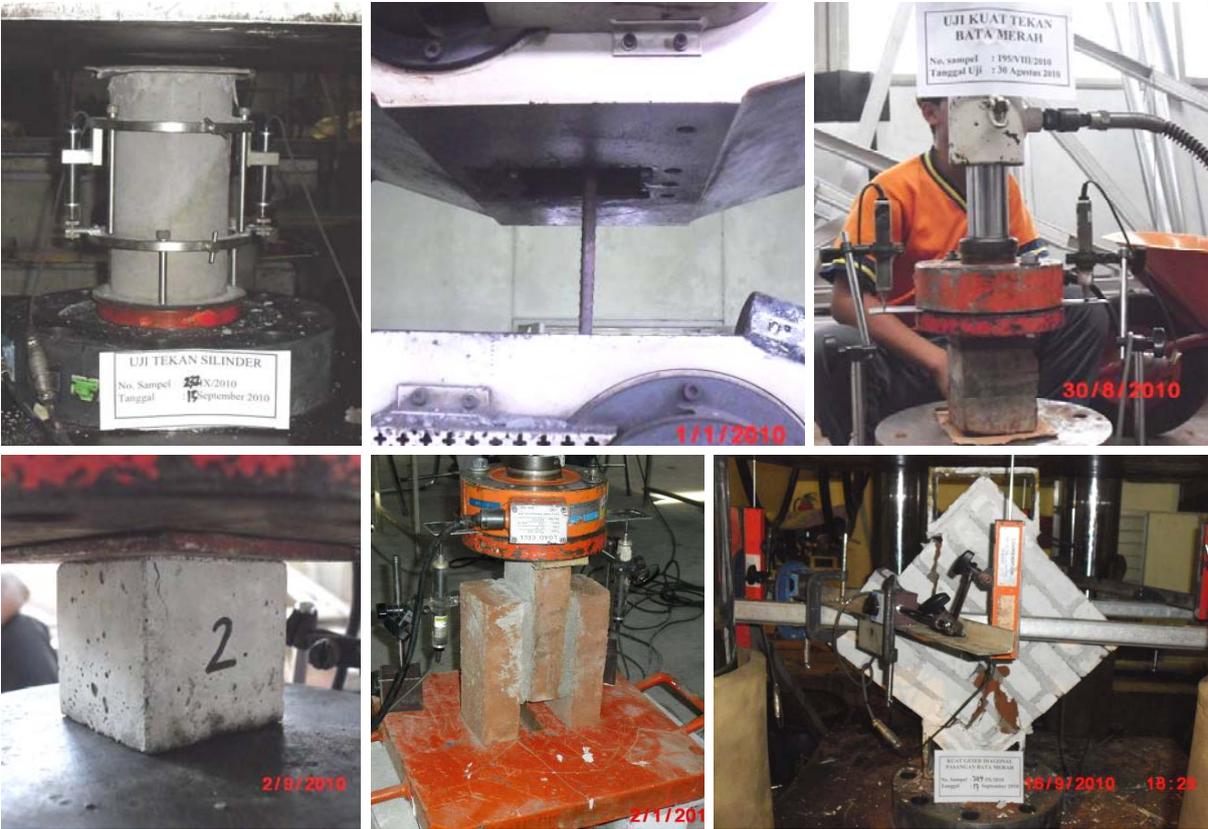
Figure 1 Testing of Materials for Non-Engineered Structural Model

The material tests were intended for analysis and verification on numerical models based on the experimental study. Tests of materials were carried out in line with the schedule of testing of structural model. Figure 1 shows some examples of testing for materials. The complete results of material tests and material properties obtained from these tests are presented in Table 1.

No	Material	Properties	Test Result
1	Concrete	Compressive strength (f_c')	17.2 MPa (tie beam), 17.1 MPa (ring beam), 22.7 MPa (column)
2	Steel rebar	Actual diameter	9.8 mm (longitudinal), 7.6 mm (transversal)
		Yield stress (f_y)	355.6 MPa (longitudinal), 335.9 MPa (transversal)
3	Brick	Compressive strength (σ_b)	3.8 MPa
4	Mortar	Compressive strength (f_m)	19.8 MPa (mortar), 15.3 MPa (plaster)
5	Brick-Mortar Bond	Shear strength (f_{k0})	0.47 MPa (plastered), 0.21 MPa (unplastered)
		Diagonal shear strength (f_{k45})	2.11 MPa (plastered), 0.59 MPa (unplastered)

- The compressive strengths of concrete and mortar are vary from one structural component to another, The discrepancies were due to variation of water volume used in the mixture.
- Tests on steel reinforcement bars show that the actual diameters are smaller than nominal values. The measurement of actual diameter was conducted using the method of measurement weight of rebar, which yielded smaller values than the nominal dimensions.
- The result of shear stress and diagonal shear stress on brick-mortar bond show that the application of plaster significantly increased the shear strength of the walls.

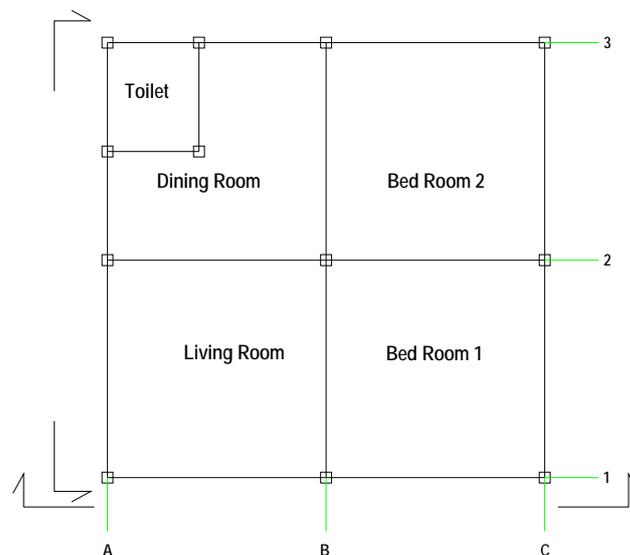
Figure 2 Plan Layout of Non-Engineered Structural Model

A 6 x 6 m with 3m height non-engineered house was tested in full scale as a prototype of a simple house structure without roof elements. Completed with tie beams and ring beams, columns were provided at every wall intersections, thus limiting the wall area into less than 10 m². Proper detailing of beam-column connection was specified with development length and seismic hook. For wall to column connection, anchorage was provided for masonry walls for every six brick layer using a plain bar with diameter 8 mm with the length of 40 times diameter. The interior and exterior masonry walls were plastered with mortar of 2 cm thick. Openings (doors and windows) were provided as in real structure, and framed with wood. The planar geometry layout of the specimen is given in Figure 2. The vertical layout for the masonry infill wall confined by reinforced concrete frame is presented in Figure 3, while Figure 4 shows the detailing of beam column connection.

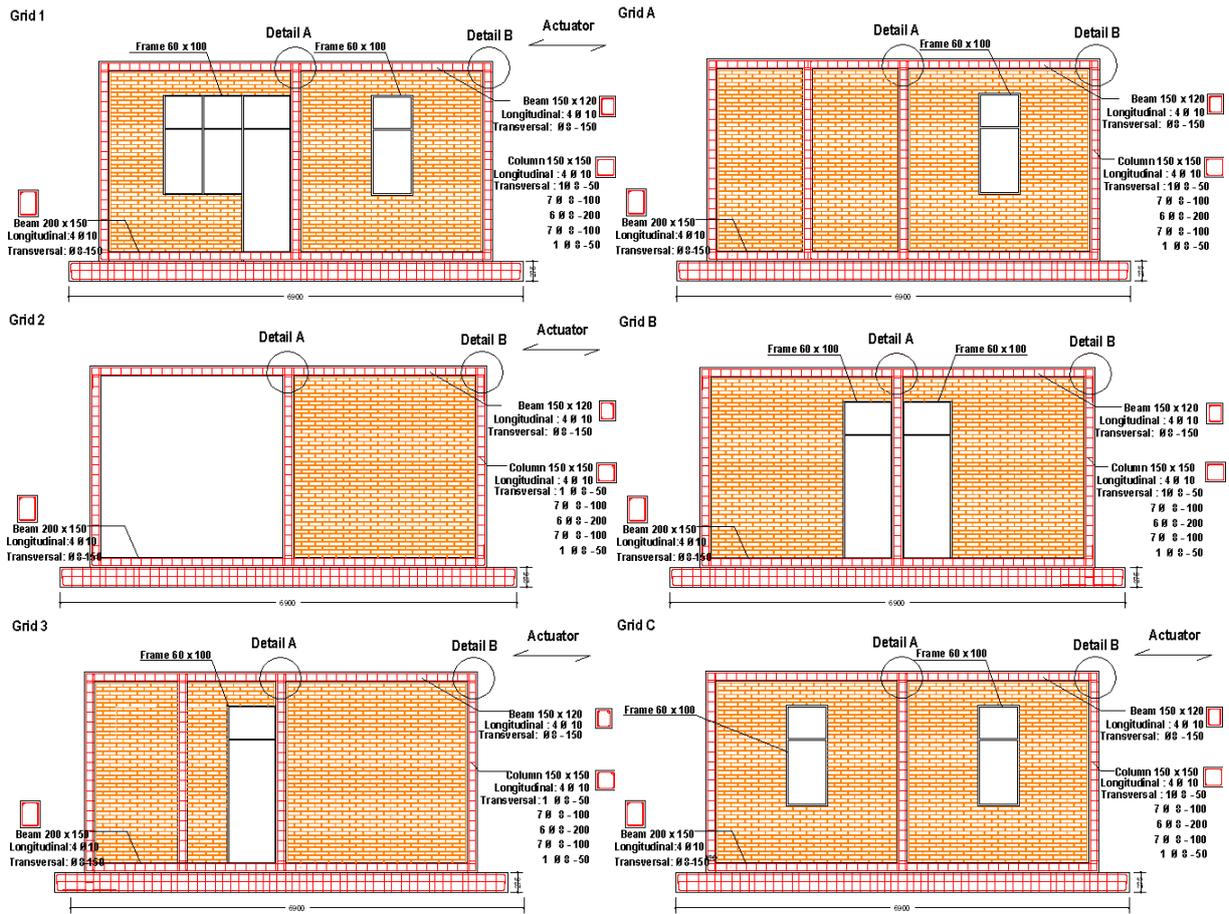
Figure 3 Vertical Layout of Non-Engineered Structural Model

(a) Grids 1, 2, 3

(b) Grids A, B, and C

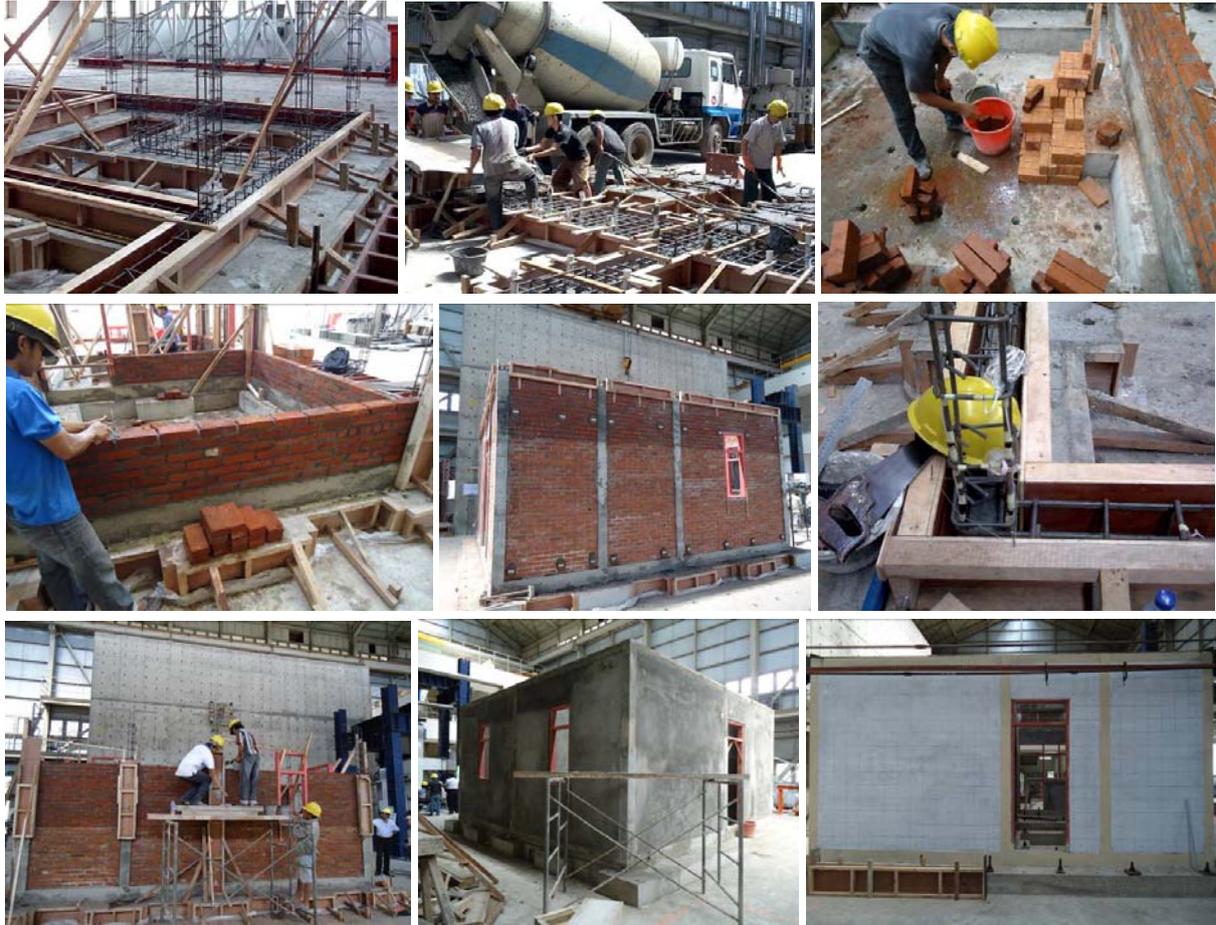
Figure 5 Construction Stages of Non-Engineered Structural Model

The structural model was based on a typical residential structure built using the standard published by the Ministry of Public Works (Boen, et al, 2009). Available for public after the devastating 30 September 2009 West Sumatra earthquake, this guideline was intended as a technical assistance for home owners and workers for reconstruction projects. It is equipped with clear illustrations on how to build typical confined masonry structures, including good construction materials, as well as proper detailing for connections and structural elements. It is envisioned that residential building constructed following requirements in this standard can be considered as an improved confined masonry structure, and will perform satisfactory under earthquake loading. Figure 5 shows various stages of construction of the test model. The construction includes the making of structural foundation as the base.

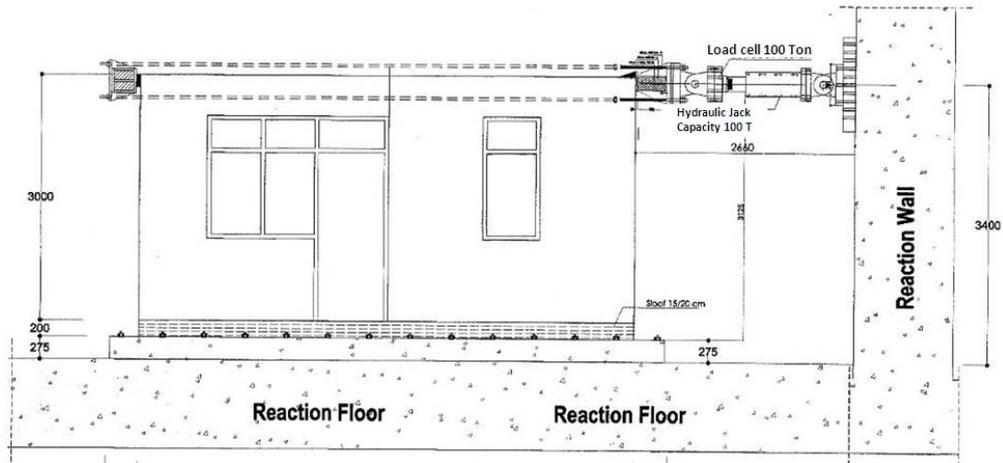
Figure 6 Test Setup for Non-Engineered Structural Model

Considering the limitations of the testing facility, cyclic lateral loads were applied using servo-controlled hydraulic actuator at the ring beam elevation. To transfer the pulling force on the specimen into the reverse direction, 4 stiff steel rods were installed on the beams to accommodate the process. To transfer the lateral loads from the actuator to the middle wall (Grid 2), H-beam was installed on the beam. However, the exact lateral load that was applied to the middle wall could not be obtained due to some flexibility of the H-beam.

The applied load was measured using load cells. To obtain structural responses, strain, shear strain, deformation, and joint rotation were measured using strain gauges and LVDTs. Data were collected using a 100-channels data acquisition system (data logger) in the experiment. In addition, visual data were obtained from documentations and drawings of cracks on the exterior walls of the specimen. The test set up is illustrated in Figure 6.

The test protocol was such that lateral testing was conducted by applying quasi-static load in the direction parallel to Grids 1,2, and 3 (in-plane grids). Thus, cyclic testing loads were applied on the upper beam of the specimen, as two point loads on the corners of the structure. Loading mechanism used displacement control, of which displacement control was determined by maximum deformation measured using 3-way LVDT on the specimen. Strokes were applied in cyclic ways and stopped when the specimen has reached 25% reduction of its strength or drift 3.5%, due to the limitations of testing facility and instrumentations.

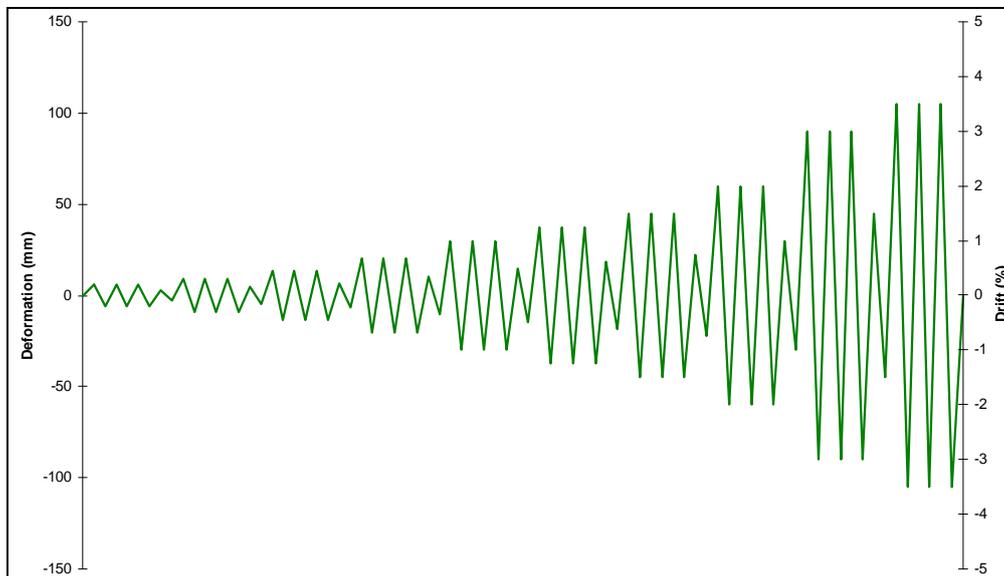
Figure 7 Test Loading Scheme

The loading scheme used in the experiment was applied following FEMA 450 recommendation for testing of structure, and presented in Figure 7. For each displacement, 3 cycles were applied to the model, with a smaller cycle in between the 3 cycles.

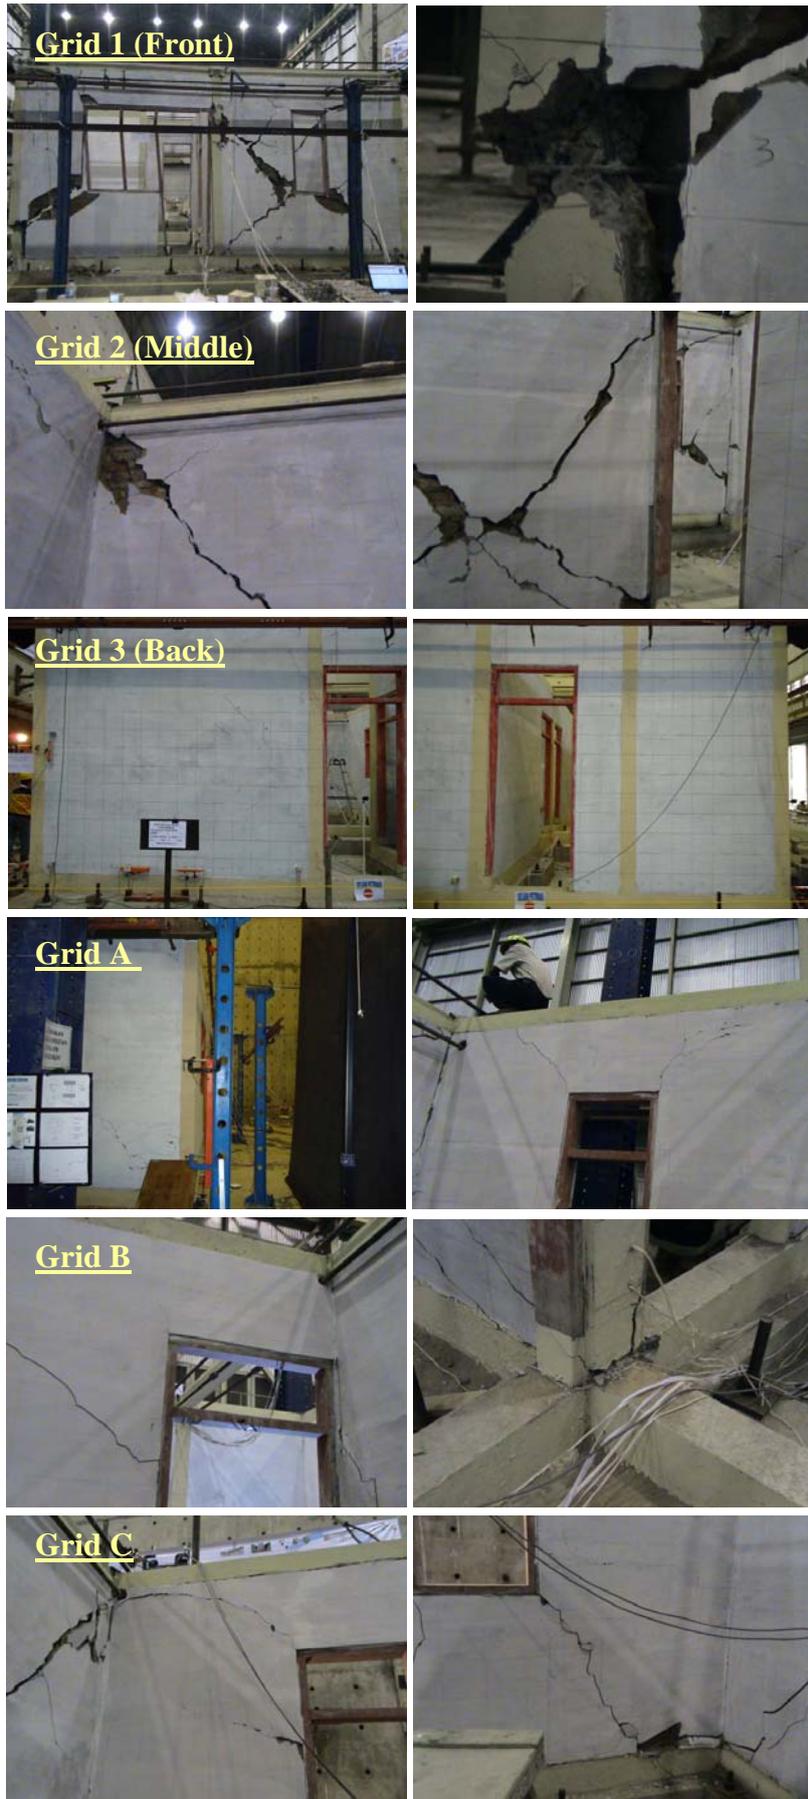
Figure 8 Damages on Non-Engineered Structural Model (Final Stage)

The strength analysis of a confined masonry structure is very much associated with its failure mode. The cyclic lateral test was conducted with increasing displacement up to the structural drift of 3.5% due to the limitation of the test facility. At the end of test protocol, the structure remained standing with no elements (columns, beams, and masonry walls) collapsed, although some elements suffered heavy damage. The final condition suggested that if the test were continued, larger displacement could be achieved for the structure. Figure 8 shows damages of the model at the final stage.

For in-plane grids, first cracks occurred at drift 0.031% at the corners of wall openings at Grid 1. It is expected since Grid 1 had the least wall area and columns, thus the stiffness of Grid 1 is lower than those of Grid 2 and Grid 3. The next cracks mostly occurred on wall area that was clear from anchorage and also at the corners of openings, with vertical cracks of walls were initiated at the end of anchorage. Later, visible diagonal cracks occurred at masonry walls, and truss mechanism was developed for Grid 1 and Grid 2. Grid 3 showed small cracks and the least amount of damage, due to the largest wall area in the in-plane direction. At the final stage (drift 3.5%), the columns at Grid 1 were deformed and bent in-plane outwards, thus confirming flexural behavior of the columns.

The structural model shows that wall separation in the form of vertical cracks was developed in addition to regular diagonal shear mechanism at Grids 1 and 2. The experiment shows that additional anchorage of wall to column prevented separation of columns and wall and limited damage area.

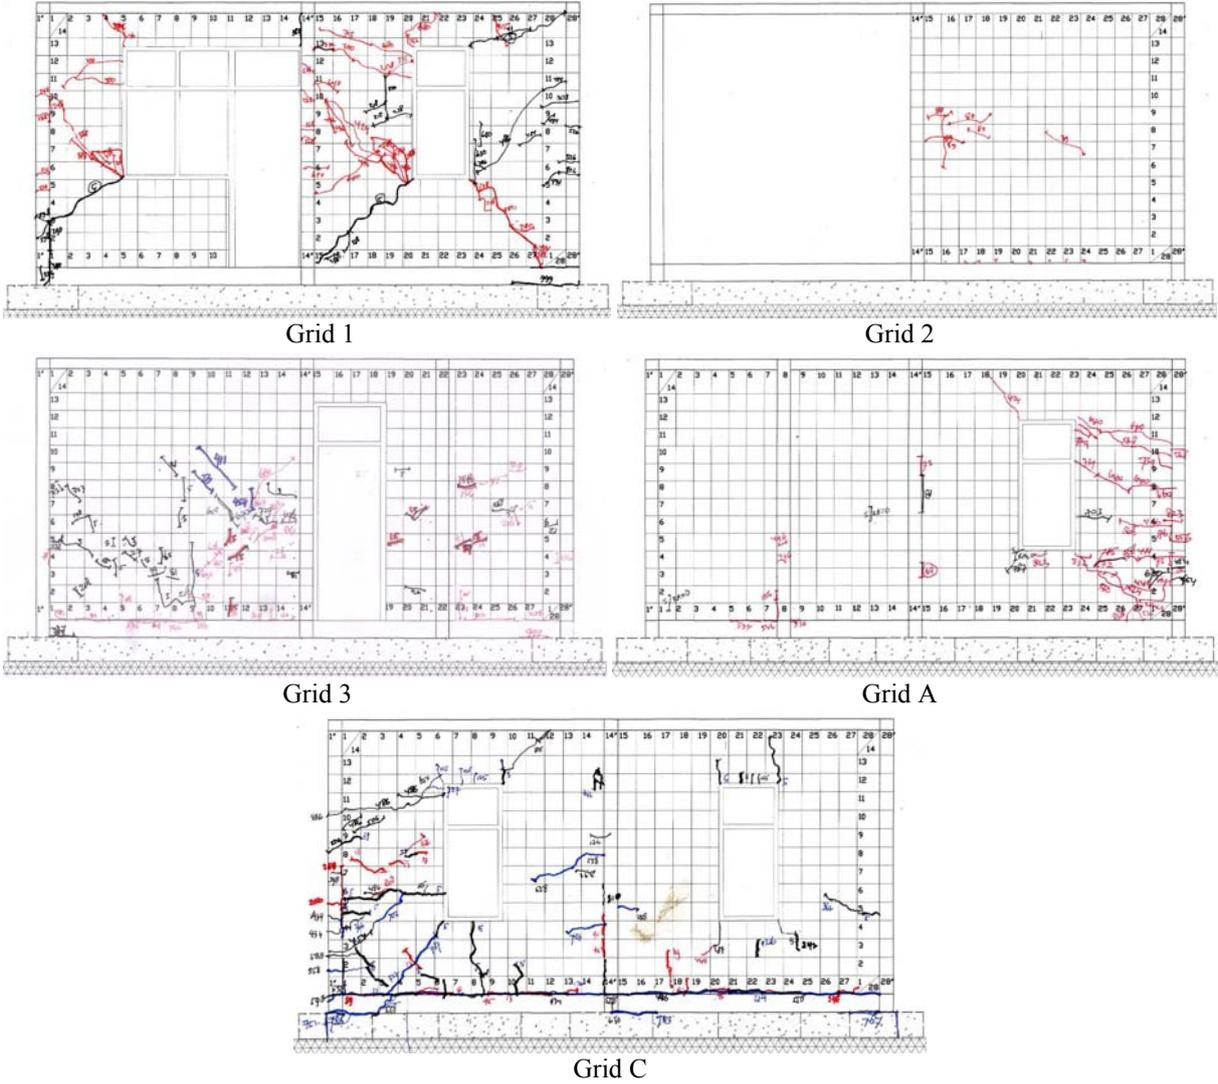
Figure 9 Crack Pattern on Exterior Walls of Non-Engineered Structural Model (Final Stage)

For out-of-plane grids, Grids A, B, and C were also damaged due to unsymmetrical layout of the model, translated into different stiffnesses of Grid 1, Grid 2, and Grid 3, which caused torsion effect and rotation to the model during cyclic loading. Since Grid 1 has the lowest stiffness, the maximum deformation occurred on this grid. Therefore, most cracks at Grid A and Grid C were developed at the corners of openings in the adjacent areas to Grid 1. For Grid B, columns suffered damage at the bottom of structure and cracks were found at the corners of openings. As in the case of in-plane grids, providing anchorage of wall to column greatly reduced damage area on out-of-plane walls. The crack patterns of non-engineered house model at the final stage are presented in Figure 9.

For in-plane grids, crack patterns were recorded for Grids 1, and 3, as well as Grid 2 up to certain drift. Grid 1 is the most damage one due to large opening provided in the masonry walls. Clear diagonal truss was formed on the right panel of Grid 1, while the left panel shows damage concentrated on the area next to the opening with shear mechanism developed in that panel. Grid 3 shows the effect of out-of-plane walls in reducing damage of the panels. Although opening was provided on the right panel, the additional column and out-of-plane wall prevented damage near the opening, and diagonal truss

was not developed for this grid. Due to technical difficulties in obtaining crack pattern for interior walls, development of cracks could not be reported. However, the final stage shows that the absent of wall on the left panel has significant effect in damage of structural elements, and diagonal truss was observed on the right panel.

In the out-of-plane grids, crack patterns were recorded for Grid A and C only, due to technical difficulties in obtaining crack patterns for Grid B during the test. As explained previously, the majority of cracks occurred due to rotational movement with respect to lower stiffness of Grid 1 compared to Grid 3. With less opening and having an additional wall perpendicular to it, damage observed on Grid A was less than Grid C.

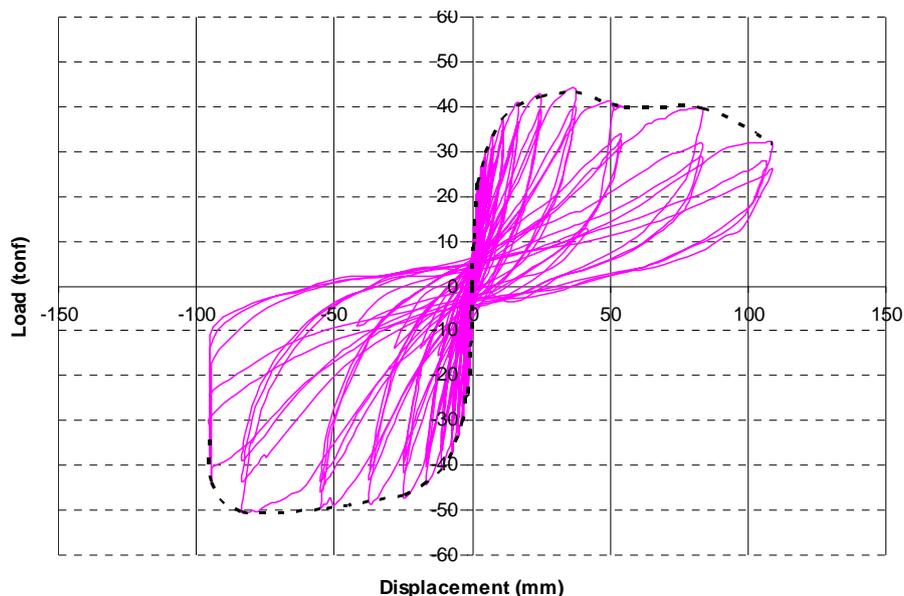
Figure 10 Hysteretic Curve of Non-Engineered Structural Model

The responses of confined masonry structure under lateral cyclic loading were presented in load-displacement hysteretic curve. The lateral displacements were obtained from LVDT reading on the top of the specimen, whereas loads were obtained from the load cell of the actuators. Figure 10 shows the hysteretic curve obtained from this study. From the hysteretic curve, the structural model demonstrated some energy dissipation capacity. Moreover, the structure behaved inelastic with some ductility, illustrated by the minor strength reduction after first yield occurred. The structure was able to maintain its strength capacity well beyond the yield displacement. Evaluation on strain gages reveals that the longitudinal reinforcement bars started to yield when the drift reached 0.35%. However, the yielding of rebars only occurred on beams and columns of Grids 1 and 2.

The maximum strength of the confined masonry structure model is found to be 43.5 ton-force, occurred at a displacement of 37.3 mm (drift 1.191 %.) This force is larger than the design seismic load for this type of structure. At 80% of the maximum strength (20% strength reduction), i.e. a strength of 34.8 ton-force, the correlated displacement is approximately 100 mm (drift 3.2%). This drift is larger than 2%, which is commonly used as the limit of structural inelastic response.
