# Response Analysis of Yokohama Bay Bridge under the 2011 Great East-Japan Earthquake

**D.M. Siringoringo & Y. Fujino**

*Bridge & Structure Laboratory, Dept. of Civil Eng., Univ. of Tokyo*

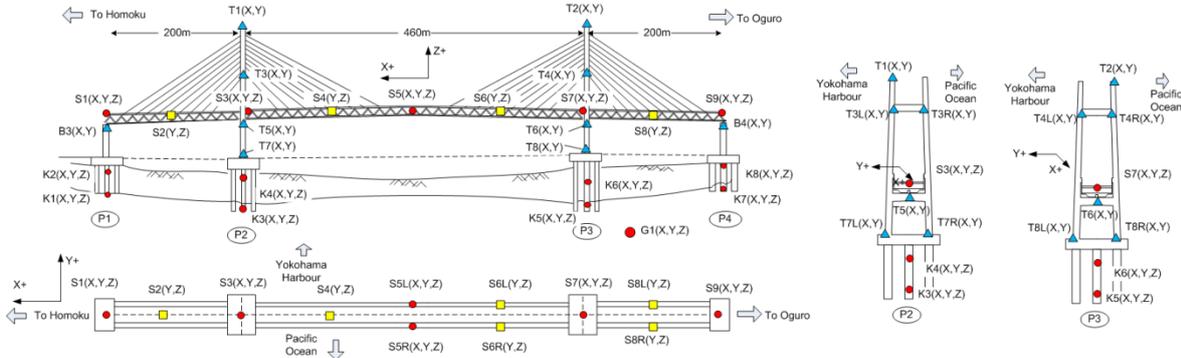
Figure 1. Yokohama-Bay Bridge’s sensor arrangement for seismic monitoring system

Yokohama-Bay Bridge is a part of the Tokyo-Yokohama Bay Shore expressway link that connects Tokyo and Yokohama harbor area. The bridge is a continuous three-span cable-stayed with the total span length of 860m consisting of 460m center span and 200m side spans (Figure 1). The main girder consists of double-deck steel truss-box: six lanes upper deck and two lanes lower deck. The bridge has two H-shaped towers welded as monolithic section with the height of 172m and width of 29.25m. Earthquake resistance is one of the main concerns in the bridge design. Considering seismic history of the area and the possible recurrence of large earthquake such as the 1923 Great Kanto earthquake, the weak ground and high location of the bridge's center of gravity, the bridge adopted a special seismic design measure. Using this measure, the girder is suspended from towers and piers by means of link bearing connections (LBC) in such a way that the effect of superstructure inertia force on the substructure is reduced during an earthquake by maintaining a longitudinal fundamental period of about 7.7sec. As a result, during an earthquake, the girder is expected to have lower acceleration but larger displacement (Yokohama Bay Bridge 1991).

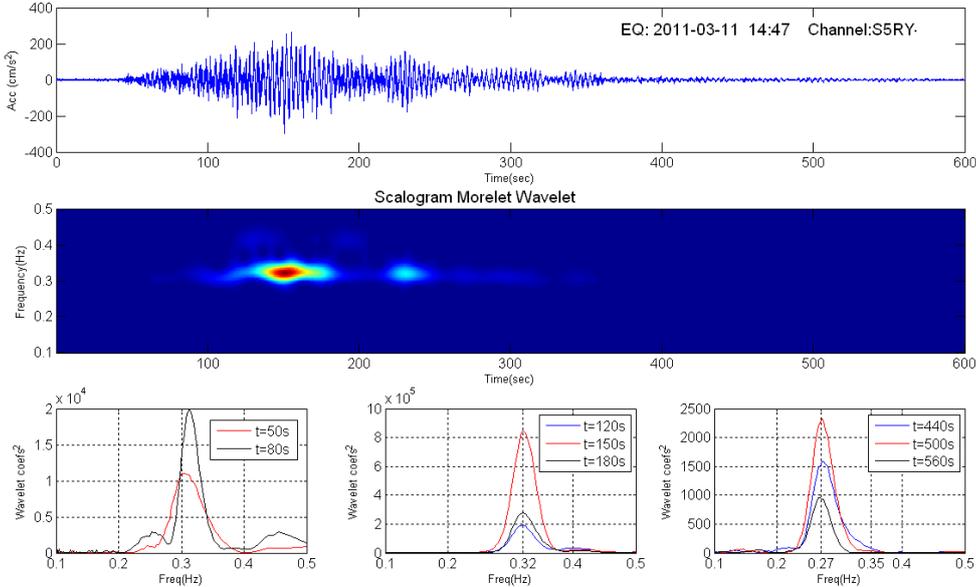
**Figure 2.** Scalogram of girder transverse acceleration during main shock and its ridges for several time stamps

analysis by wavelet transform was conducted. The scalogram of transverse acceleration shows frequency peak at the initial response appears at 0.29Hz (Figure 2). The frequency increases and reaches up to 0.32Hz during the largest excitation (i.e.100-200sec) before later decreases to 0.27Hz near the end of response. On contrary for the vertical acceleration, the frequency peak at the initial response appears at 0.34Hz. The frequency decreases slightly to 0.32Hz during the largest excitation, but increases to 0.34Hz near the end of the response. The similar result was also observed during aftershock 1 (March 11, 2011 15:16). Changes in transverse and vertical frequencies indicate non-linearity of the response. However, it should be mentioned that girder accelerations are subjected to the conditions of ground motions. Therefore to have a complete understanding of the change in modal parameters, a system identification technique should be utilized, which will be explained further in this paper.

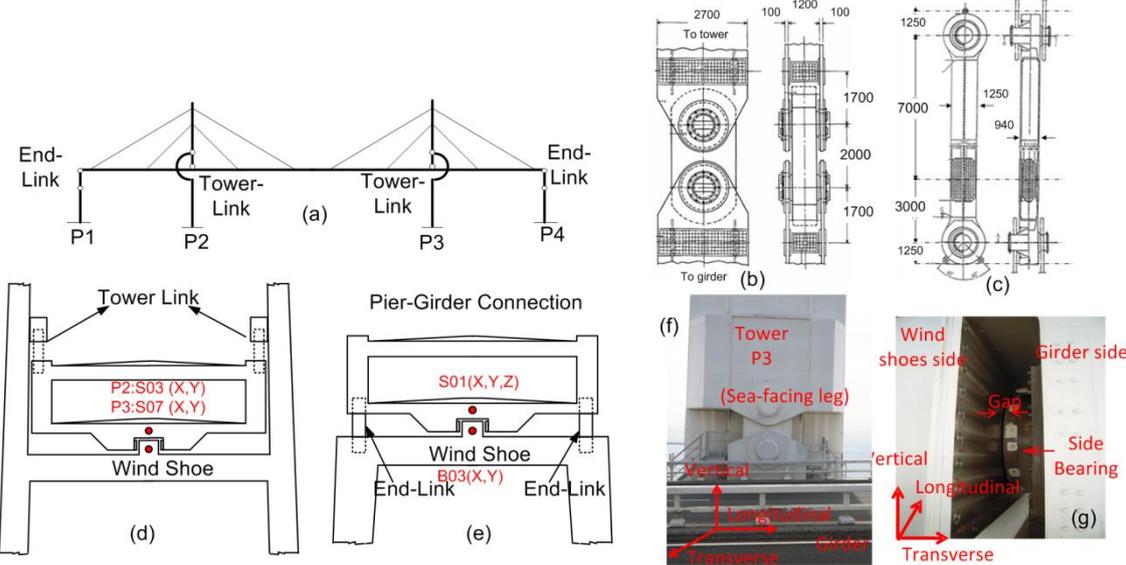
**Figure 3.** (a) Characteristics of pier-to-girder and tower-to-girder connections, (b) detail figure of tower-link, (c) detail figure of end-link, (d) Schematic figure of tower-to-girder connection, (e) Schematic figure of pier-to-girder connection, (f) photo of tower link and (g) snapshot photo of wind shoe transverse gap between tower/pier and girder.

Girder motion in longitudinal direction is accommodated by link-bearing connections (LBC), namely, end-link at the end of girder (P1 and P4) and tower-link at the towers (P2 and P3). The LBC is a double head pendulum with the length of 10m and 2 m, for the end-link and the tower-link, respectively. The upper and lower head connect the end-link to girder and pier, respectively. Meanwhile, it is the opposite condition for the tower-link (Figure 3). Each of pendulum head is made of steel discs and connected by bolts on its circumference.

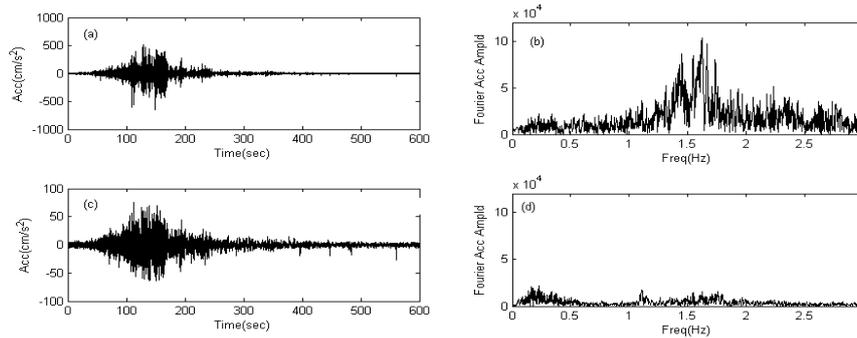
**Figure 4.** (a) Longitudinal acceleration recorded on pier P1 (B3X), (b) Fourier spectrum of acceleration B3X, (c) Longitudinal acceleration recorded on the girder above P1 pier (S1X) (d) Fourier spectrum of acceleration S1X

In design, the LBCs are expected to slide during an earthquake so that large vibration energy from the pier or tower would not be transferred to the girder and vice-versa (Maeda et al. 1991). In such condition, relative displacement between pier and girder; and between tower and girder will be sufficiently large and the high frequency components of the pier and tower vibration will not be transferred to girder. Figure 4 shows that pier longitudinal acceleration (B3X) was dominated by

frequency peaks around 1.5Hz and 2Hz, while the girder longitudinal acceleration (S1X) located on the top of B3X was dominated by frequency peaks around 0.13Hz. Spectra plots of accelerations show that vibration energy at the girder is significantly smaller compared to that of the pier. The maximum acceleration on the pier is about  $500\text{ cm/s}^2$  while the maximum acceleration at the girder is only about  $50\text{ cm/s}^2$ . The facts that girder longitudinal acceleration is dominated by low frequency component, significant reduction in high frequency components of girder longitudinal acceleration and the large difference of vibration amplitude between pier and girder indicate that vibration energy from the pier was not transferred to the girder. Similar results were also observed on longitudinal responses of tower at the deck level (T5X and T6X).

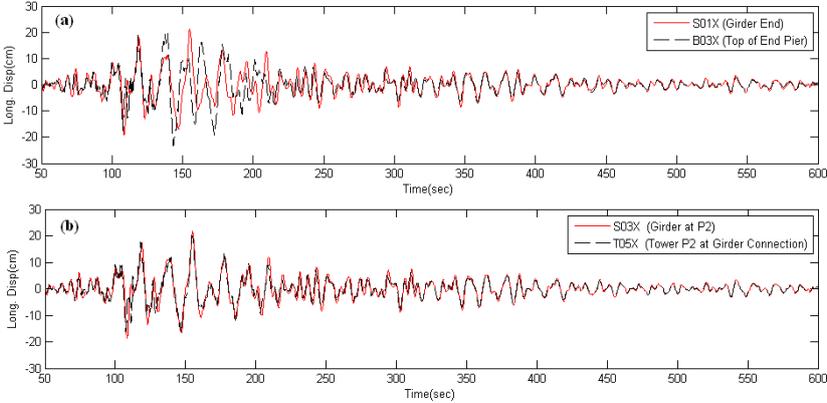
Figure 5. Comparison of longitudinal displacement (a) at end-pier P1 (B3X-S1X), (b) at tower P2 (S3X-T5X)

damage to the pier-to-girder connections. The seismic records show, however, that the girder maximum longitudinal displacement (processed from acceleration) was relatively small, in the order of 20cm and is far below the maximum allowable displacement 1.5m anticipated in the seismic retrofit program. Relative displacement between girder and tower or between girder and piers at connections can be used as indicators of pier-to-girder and tower-to-girder performance during earthquakes. The results show that relative displacement between pier and girder in longitudinal direction are in order of 5-10cm (Figure 5). In fact at P1, pier-cap displacement (B3X) was lagged behind the girder (S1X) displacement during the largest excitation (time: 150-200sec) suggesting that girder movement was completely decoupled from pier movement for that short period of time. Meanwhile relative longitudinal displacements between girder and tower at connection are smaller than that of pier (1-5cm).

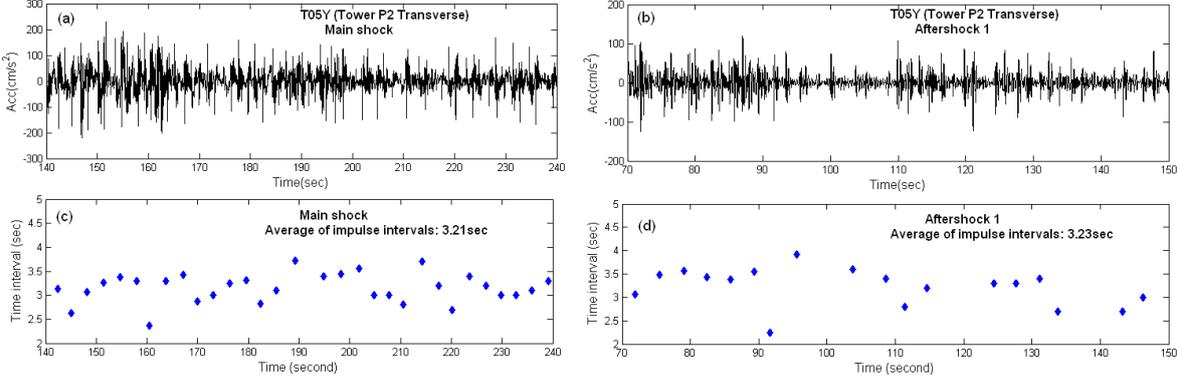
Figure 6. Accelerations of tower at deck level showing spike indicating impulses: (a) main shock (b) aftershock 15:16. Time interval of successive pulse responses (c) main shock (d) aftershock 15:16.

Figure 6 shows a close-up look of the acceleration response recorded by sensors T5Y on the wind shoes during the main shock, where one can see clearly periodic impulse indicating the occurrence of transverse pounding between tower and girder. Similar periodic impulses are also observed during the largest aftershock (i.e. March 11 15:16 JST). By observing time intervals between successive impulses during the largest excitation, we can estimate the structural mode corresponding to the motion when pounding occurs. The average time interval between consecutive impulses is about 3.2 second that corresponds to periodic motion with frequency about 0.32Hz. This result indicates that the transverse impulse at the tower-to-girder during the largest excitation period of the main shock was mainly caused by the girder first transverse mode.

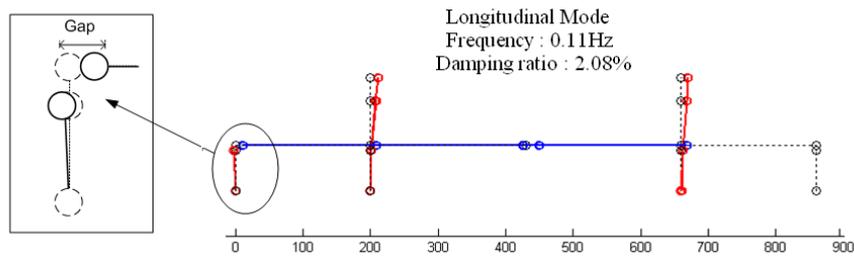
**Figure 7.** Longitudinal Mode shape with slip characteristic at the end-pier and girder connection

Figure 7 shows the mode shape of longitudinal mode identified from main shock, frame 4 (t=150-200 during the largest excitation) and the mode was identified at 0.13Hz. Results of identification for the entire main shock response show that the mode was identified at around 0.12Hz-0.13Hz with large relative modal displacement between pier and girder indicating the *slip mode*. This is in agreement with the result of displacement of girder and pier at the pier-to-girder connection that shows a large relative displacement. It is also supported by the frequency characteristics of girder and pier accelerations at the pier-to-girder connection.

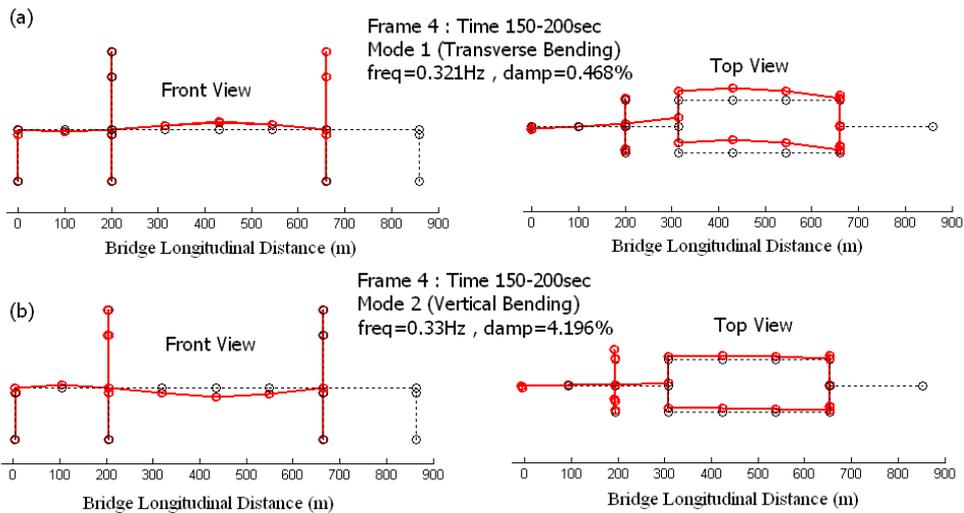
**Figure 8.** Characteristics of mode shapes with strong transverse-vertical coupling during the largest excitation of main shock 14:47 (Frame 4,  $t=150-200$ s): (a) girder first transverse mode and (b) girder first vertical mode.

The second and the third identified global mode were the first transverse bending and the first vertical bending, respectively. The two modes have distinct characteristics in that their natural frequencies and modal displacements depend on the amplitude of input excitation. During a large excitation, such as the 100-200 seconds of the main shock, frequency of the first transverse mode increases from 0.27Hz to 0.32Hz, while frequency of the first vertical mode decreases from 0.35Hz to 0.33Hz. The change in frequency is followed by the change in mode shape characteristics especially the girder transverse-vertical coupling pattern. During large excitation, strong transverse-vertical coupling of girder modal displacement was observed in both transverse and vertical modes, in such that the vertical mode has significant modal displacement in transverse direction and vice versa (Figure 8). During smaller excitation, as in the beginning and near the end of response, the transverse-vertical coupling becomes weaker resulting in the pure vertical and transverse mode (Figure 9). To quantify the coupling degree, an index  $\eta$  is defined as:

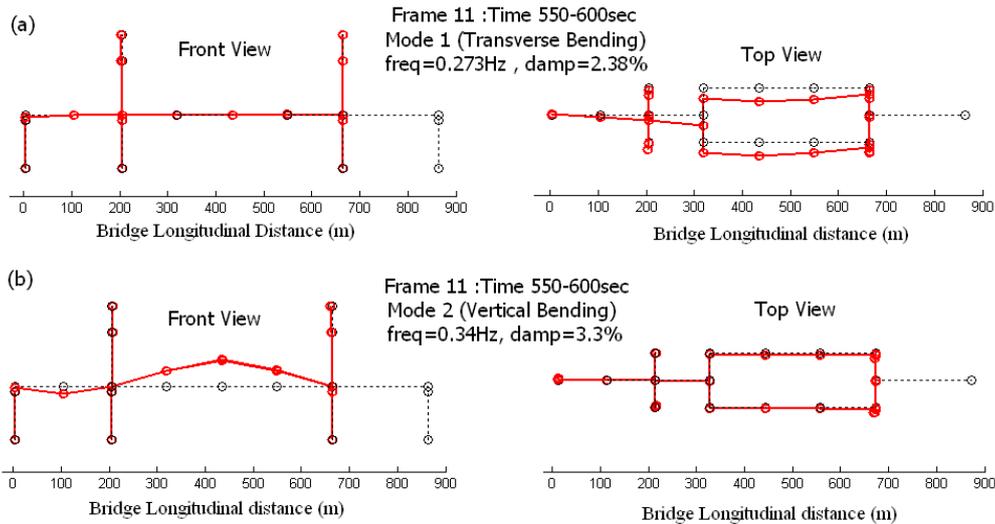
**Figure 9.** Characteristics of mode shapes with weak transverse-vertical coupling during the end of main shock 14:47 (Frame 11,  $t=500-550s$ ): (a) girder first transverse mode and (b) girder first vertical mode

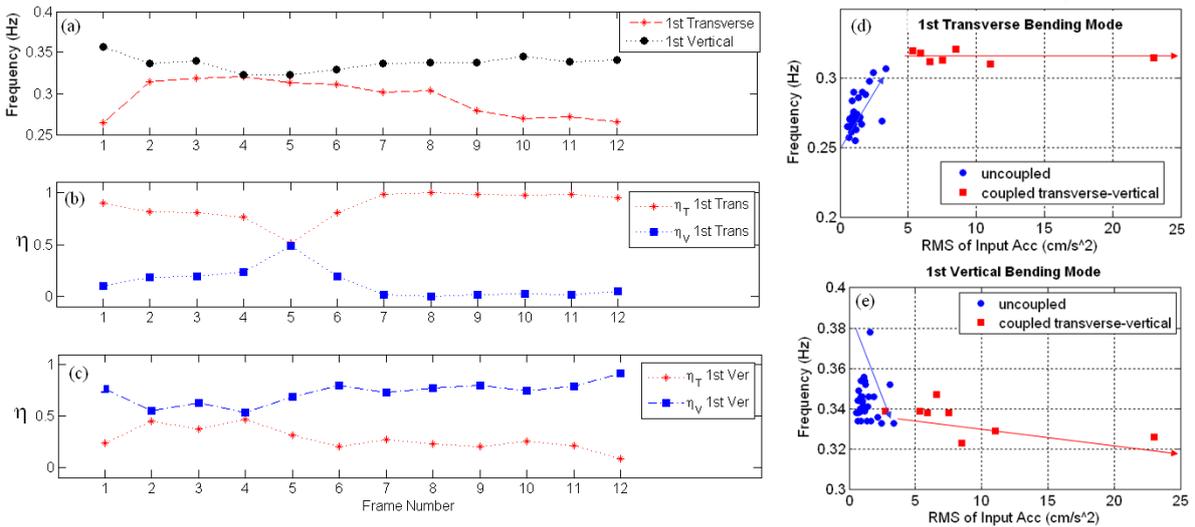
**Figure 10.** Main shock: (a) variation of natural frequency of the first transverse and first vertical bending for the main shock, (b) variation of coupling index  $\eta$  of the 1<sup>st</sup> transverse mode, (c) variation of coupling index  $\eta$  of the 1<sup>st</sup> vertical mode. Summary on variation of natural frequencies and transverse-vertical coupling of mode shapes with respect to input acceleration for main shock and nine aftershocks: (d) first transverse bending mode and (e) first vertical bending mode.

where  $\phi$  denotes the modal displacement of girder at the middle of center-span (i.e. node S5R) while the subscript V and T denotes the vertical and transverse, respectively. Variations of natural frequency and coupling behavior of the first lateral and first vertical bending modes with respect to input amplitude for all records analyzed are shown in Figure 10.

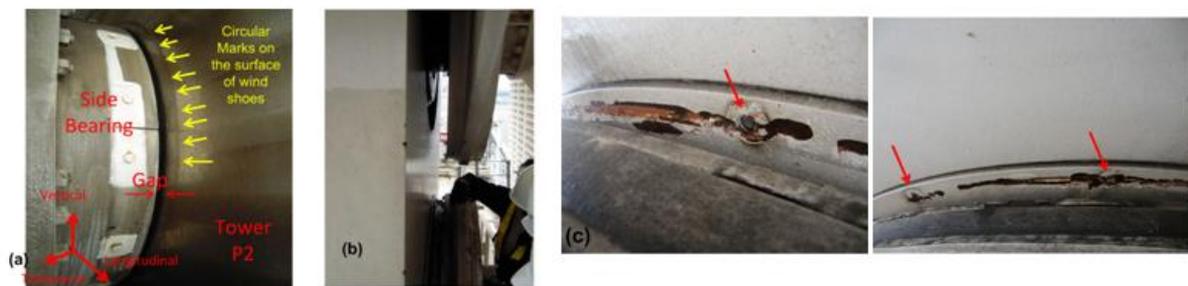
**Figure 11.** Circular scratch marks on the surface of wind shoe as a result of side bearing movement indicates girder longitudinal movement of about 8cm. (b) Location of head of tower link (P2) bottom head is connected to girder, top head is connected to tower. (c) Scratch marks on the surface of the bottom link head caused by combination of vertical and transverse movement of the girder. The arrows point to locations of three broken bolts caused by the movement.

1. In longitudinal direction, circular marks was found on the surface of wind shoes of pier P1 and tower P2 suggesting that the girder had experienced large relative longitudinal movement. The marks show that relative displacement between girder and tower (and pier) in the order of 8-10cm had occurred (Figure 11(a)). For this relative displacement to occur, the link-bearing connection between girder and tower (and pier) must have slipped. This physical evidence supports the results of response analysis and the type of longitudinal mode generated by system identification. In

addition, since the wind shoe and girder is separated by small lateral gap, the mark left by girder on the wind shoe's side surface would only be possible if the wind shoes and girder jammed at some point in time during the excitation.

2. In transverse direction, several marks of scraped paint were observed on the link head of tower P2. Nuts of several bolts on the upper disc of the lower head of P2 tower link were crushed and signs of scraped paint can be clearly seen on the surface of the disc (Figure 11(c)). The scraped paint and broken nuts could be caused by transverse pounding between tower and girder at tower link and by combination of transverse and excessive vertical motion of girder at tower-to-girder connection. These physical evidences show that girder and tower have experienced large transverse vibration and may explain the occurrence of periodic impulses on the accelerations recorded by sensors near the pier-to-girder and the tower-to-girder connections.
