# **A Tutorial on Improving the Seismic Performance of Stone Masonry Dwellings: A Compendium of Worldwide Experiences**

Stone masonry is a traditional form of construction that has been practiced for centuries in regions where stone is locally available. Unfortunately, these buildings show poor performance even under minor earthquake shaking. Motivated by the colossal human and property loss associated with stone masonry buildings, Editorial Board of the World Housing Encyclopedia decided to support the development of a tutorial on improving seismic safety of stone masonry building. The document, called *A Tutorial: Improving the Seismic Performance of Stone Masonry Buildings*, was developed by the authors of this paper. The tutorial is expected to fill a gap related to practical advice on how to incorporate seismic resilience into stone masonry construction. This is a challenging task, because the construction of these buildings is usually informal (non-engineered), incremental, and controlled by the availability and affordability of local construction materials. This paper describes the content of the tutorial and outlines the key recommendations.

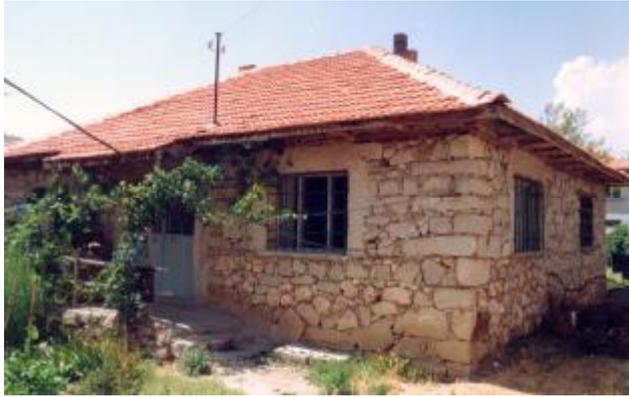
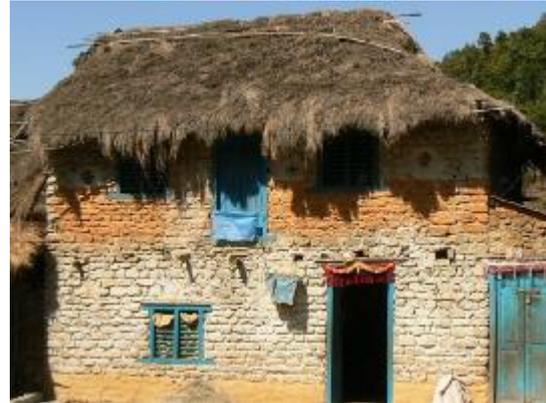
**Figure 3.1.** Stone masonry construction around the world: a) a typical stone masonry house in Turkey (photo: M. Erberik), and b) a typical rural house in Nepal (photo: M. Schildkamp)

Chapter 1 provides an overview of stone masonry construction practices around the world, construction technologies, and the key components of a stone masonry building. Stone masonry buildings are common in earthquake-prone regions of the world, such as Mediterranean Europe, North Africa, the Middle East, Iran, New Zealand, South and Southeast Asia. In worldwide applications, stone masonry is mostly used for construction of one- to three-storey buildings. Figure 3.1. shows typical stone masonry buildings in various countries.

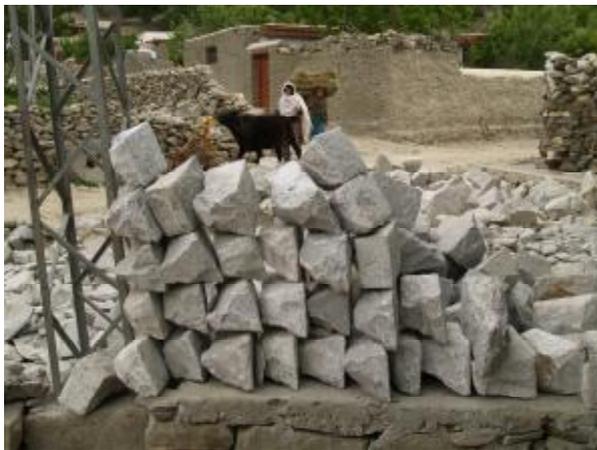
**Figure 3.2.** Stone masonry construction: a) semi-dressed wedged stones ready for construction in Pakistan (photo: T. Schacher), and b) stone masonry construction in Maharashtra, India, showing exterior wythes and stone rubble in mud mortar in between (photo: S. Brzev)

The key components of a typical stone masonry building include floor/roof systems, walls, and foundations. Stones from different sources are used for wall construction, including river stones, field stones, and quarried stones. These stones are often used without additional shaping, especially when the tools, expertise, or labour required to shape these stones are either not available or not affordable. Stone masonry walls usually consist of two wythes, and the space between the wythes is filled with mud, small stones and pieces of rubble. Through-stones (long stones that extend through all wythes), which are essential for bonding the wythes and ensuring wall integrity, are usually absent. Wall thickness is usually on the order of 500 mm, but it could be excessively large, in some cases up to 2 m. This type of stone masonry construction is called random rubble stone masonry. In some cases, stones can be partially or fully shaped (dressed) to better suit construction, as shown in Figure 3.2a). Construction of a random rubble stone masonry wall is shown in Figure 3.2b). Stone masonry walls are usually constructed using low-strength mortars, such as mud or lime:sand mortar. A higher - strength cement:sand mortar has been used in the last few decades, however its use does not necessarily imply an increase in the wall strength. In areas where flat stones are available, walls are often built without any mortar (that is referred to as dry masonry).

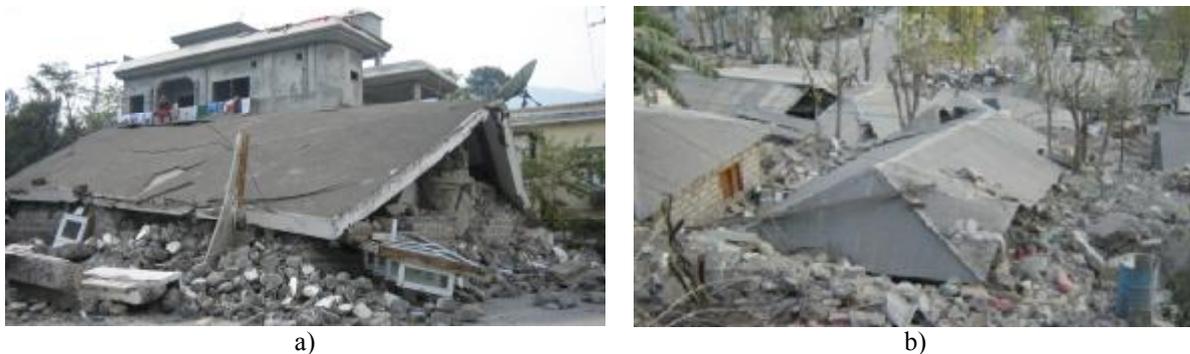
**Figure 4.1** Roof collapse due to a loss of the gravity load-bearing capacity of stone walls in the 2005 Kashmir, Pakistan, earthquake: a) reinforced concrete roof, and b) timber and steel roof (photos: M. Tomazevic)

*Roof collapse* is one of the major causes of fatalities in masonry buildings during earthquakes. It can take place when either the walls lose the ability to resist gravity loads and collapse, or when the roof structure collapses. Roof collapse is often caused by inadequate wall-to-roof anchorage. The roof structure can simply "walk away" from the walls and cave into the building. Roof collapse can also be caused by the collapse of supporting walls, as shown in Figure 4.1. Some stone masonry buildings have heavy roofs that contribute to their seismic vulnerability. Heavy RC roof slabs contributed to the collapse of buildings in the 2005 Kashmir earthquake, as shown in the figure.

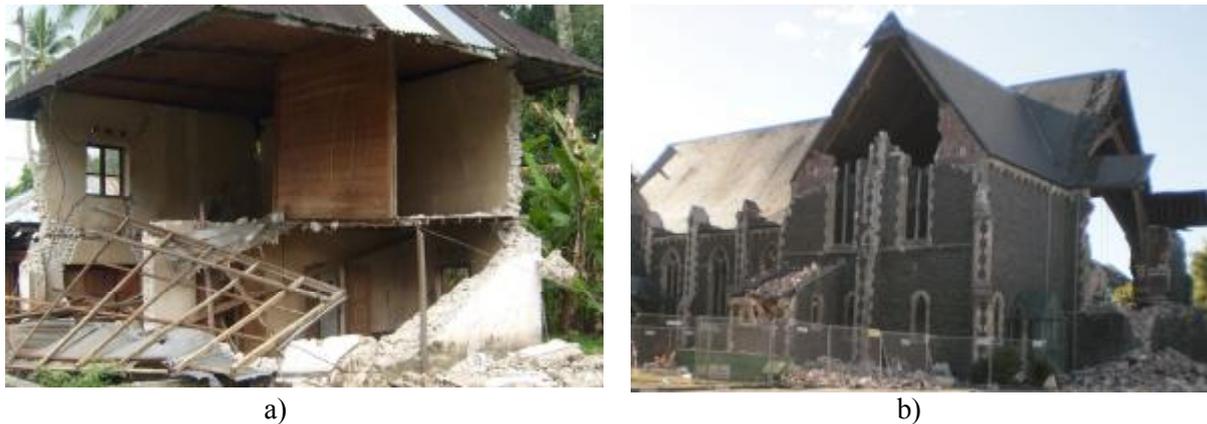
**Figure 4.3.** Out-of-plane collapse of stone masonry walls: a) the 2009 Padang, Indonesia, earthquake (Bothara et al. 2010), and b) collapse of gable walls in the 2011 Christchurch, New Zealand, earthquake (photo: J. Bothara)

*Out-of-plane wall collapse* is one of the major causes of destruction in stone masonry buildings. This is particularly pronounced in buildings with flexible floors and roofs, large distance between transverse (cross) walls, and weak connections between the structural components. As a result, each wall vibrates on its own when subjected to earthquake ground shaking, and ultimately collapses (topples), as shown in Figure 4.3a). Out-of-plane toppling of gable walls in stone masonry buildings with pitched roofs is common, because these walls are taller than other walls and tend to vibrate as free-standing cantilevers (see Figure 4.3b).

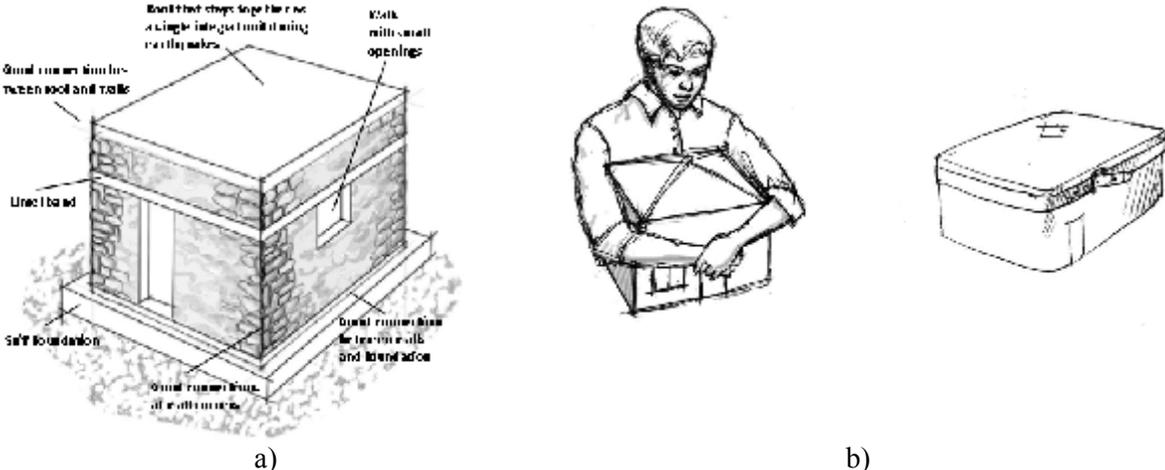
**Figure 5.1.** Key requirements for ensuring box action in a stone masonry building: a) a summary (adapted from Murty 2005), and b) a seismic band acts like a belt (GOM 1998)

integrity of a building can be achieved by developing a box action by ensuring good connections between all building components—foundations, walls, floors, and roof. Key requirements for the structural integrity in a masonry building are illustrated in Figure 5.1a). A seismic band (ring beam) is one of the critical provisions for ensuring structural integrity. Usually provided at lintel, floor, and/or roof level in a building, the band acts like a ring or belt, as shown in Figure 5.1b). Seismic bands may be constructed using either RC or timber. Proper placement and continuity of bands and proper use of materials and workmanship are essential for their effectiveness.

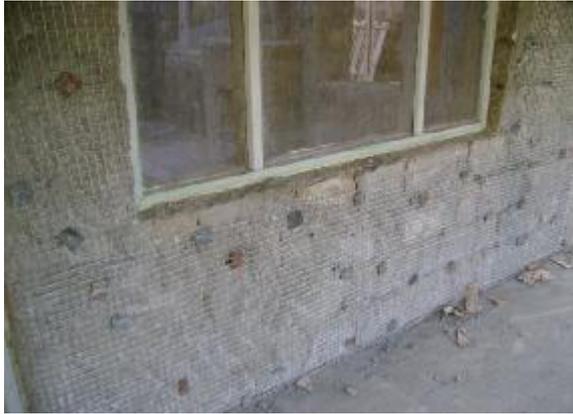
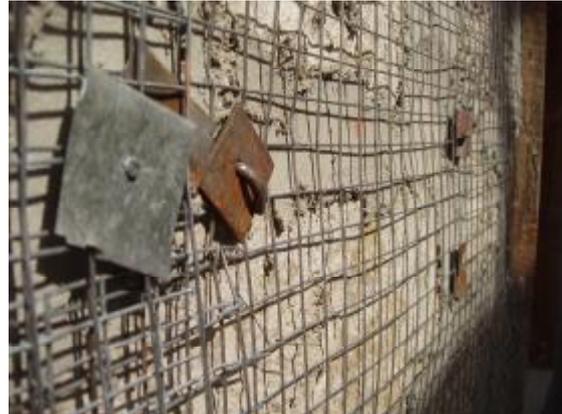
**Figure 6.2.** Jacketing of stone masonry walls in Pakistan after the 2005 Kashmir earthquake: a) a wall surface showing reinforcement and anchors in place before the plaster application (photo: Q. Ali), and b) a detail of steel mesh reinforcement and through-wall anchors (photo: T. Schacher).

Another important retrofit strategy is to enhance the seismic resistance of existing masonry walls. That can be achieved using one of the commonly used wall retrofit techniques, such as the installation of through-stones or jacketing. Jacketing consists of covering the wall surface with a thin overlay of reinforced mortar, micro-concrete, or shotcrete. Jacketed wall surfaces must be interconnected by means of through-wall anchors. An adequate bond between the new jacket and the existing wall surface must be ensured. When properly implemented, jacketing provides confinement and ensures wall integrity for in-plane and out-of-plane seismic effects. Jacketing was used to retrofit stone masonry buildings in Pakistan after the 2005 Kashmir earthquake, as shown in Figure 6.2.
