# LOG-IDEAH: LOGic trees for Identification of Damage due to Earthquakes for Architectural Heritage

## **SUMMARY:**

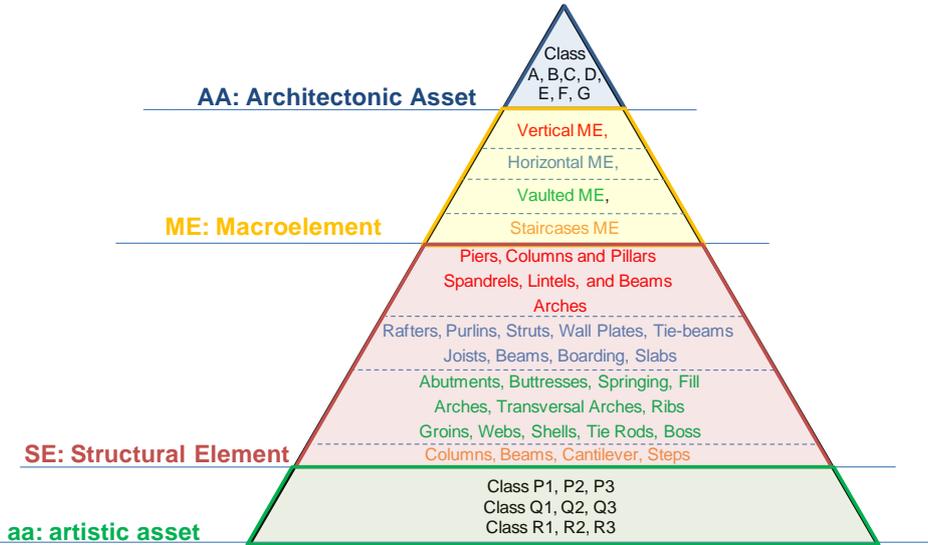
**Figure 2-1** Hierarchic Pyramid of Architectural Assets

LOG-IDEAH depends upon a hierarchical approach in which the architectural asset is deconstructed into macroelements, the macroelements into structural elements and the structural elements are identified as being linked to or being in itself artistic assets.

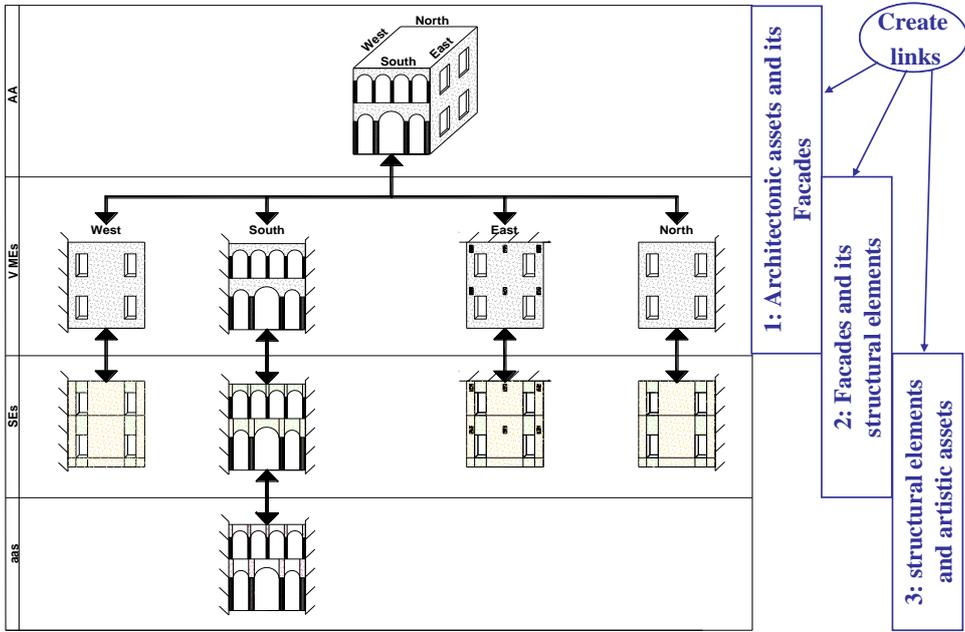
Figure 3-1 Relationships between AA, VME, SEs, aas

basis of the damage collected at SE and aa level, interpreted first at VME level and then at AA level. This entails that the essence in the survey of an AA, such as the mansion represented in Figure 3-1, is to deconstruct the AA in question, into VMEs, west VME, south VME, east VME and north VME in Figure 3-1; the VeMEs into SEs, piers in yellow, spandrels and arches in green in Figure 3-1; and the SEs into aas, decorated columns in pink in Figure 3-1.

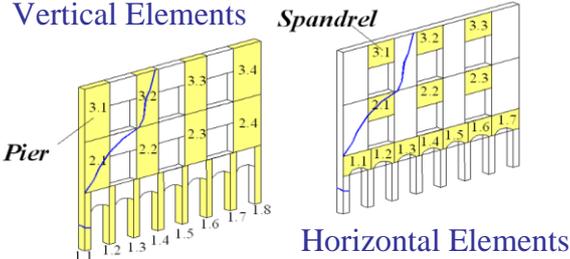
**Figure 3-2** Correlation Identification and naming of the structural elements of a façade

This process is accomplished by defining a grid on the façade, which defines a unique topology, see Figure 3-2, by associating two labels (nf, i) to each vertical (piers/columns/pillars) and horizontal (spandrels/arches) element of the façade, where (nf) and (i) identify the horizontal alignment (floor number) and the vertical alignment (position of the element at each floor as identified by the presence of openings) respectively. The example in Figure 3-3, which refers to the façade 10.4sw of the historic building introduced previously, illustrates how the mentioned façade is deconstructed into structural elements to enable reference to pier 2 on floor 1.

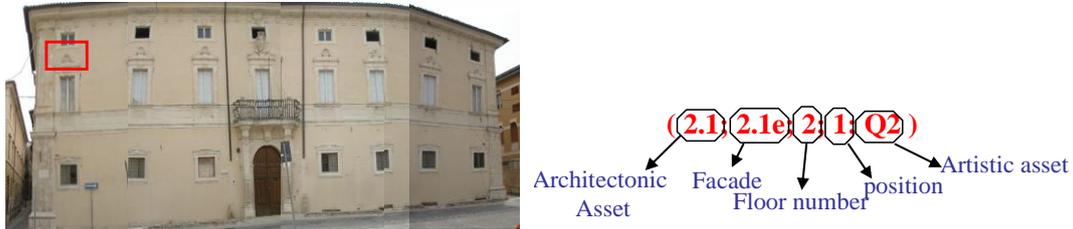
**Figure 3-4** Artistic enumeration convention of the façade 2.1e

inspected AA, the name of the observed façade, position of the SE to which the artistic asset is associated, and name of the artistic asset type. For instance, in order to define the artistic asset highlighted in red in the façade 2.1e in Figure 3-4, the string (2.1, 2.1e, 2, 1, Q2) links the architectural asset 2.1 to the façade 2.1e, the façade 2.1e to the position of the SE (first position on the second floor) to which the aa in question is located and the position of the SE to the type of aa, that is Q2, according to a classification introduced in the PERPETUATE project.

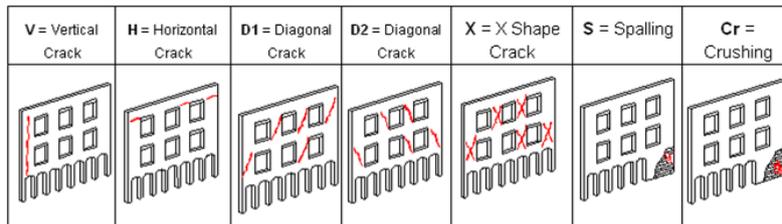
**Figure 4-1** Structural damage types

The approach used is first to construct a rectilinear grid of each façade based on the structural elements (SE) and (aa) and then to associate with them the damage type and damage level. The possible structural damage types are listed in Figure 4-1 while damage levels are the following: LD: light damage, SD: significant damage, NC: near collapse and C: collapse. Figure 4-2(a) shows how the seismic damage types and levels of a façade are reported in the string (Pier\_cracklocation) and (Spandrel\_cracklocation) defined for the damaged piers and damaged spandrels respectively. Once these strings are defined, the reliability of the collected data is also included in the string. In this case the reliability is classified as High, since the data has been collected on site and photographic documentations is also available.

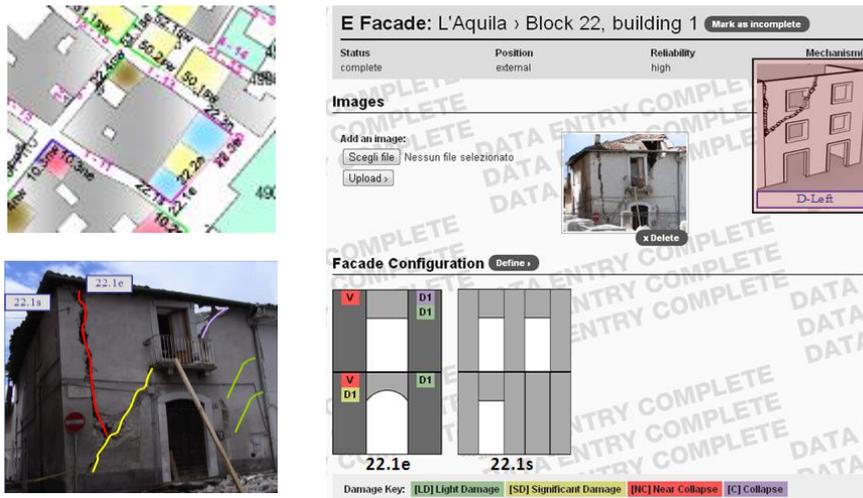
Figure 5-1 Extract from completed data entry in web browser

The record of the collected seismic data has been facilitated by the use of a web-site (<http://perpetuate.cs.bath.ac.uk/>) which permits users to: create of new architectural asset records, effectively from anywhere, draw simplified sketches of inspected façades, record damage type and damage level to structural elements and artistic assets, upload photographic records of assets and asset damage, and assess probable collapse mechanisms using the reasoning process described in the previous section. Surveys are in progress and at this stage have collected records from buildings in L'Aquila and the Casbah in Algiers. Since LOG-IDEAH will be applied to both case studies, the system will be trained first on a sample of buildings damaged by L'Aquila earthquake and then on a sample of buildings in the Casbah of Algiers that has weakness and crack patterns not necessarily caused by seismic events. Information regarding the buildings and their structural elements is stored in XML format. The XML representation is converted to AnsProlog code and passed to clingo for processing. Integration between web-site and LOG-IDEAH is currently in progress. The Figure 5-1 shows the record of the observed seismic damage and the feasible collapse mechanism of the facades 22.1e and 22.1s, which are the only facades that can be inspected since the building in question has a corner position.

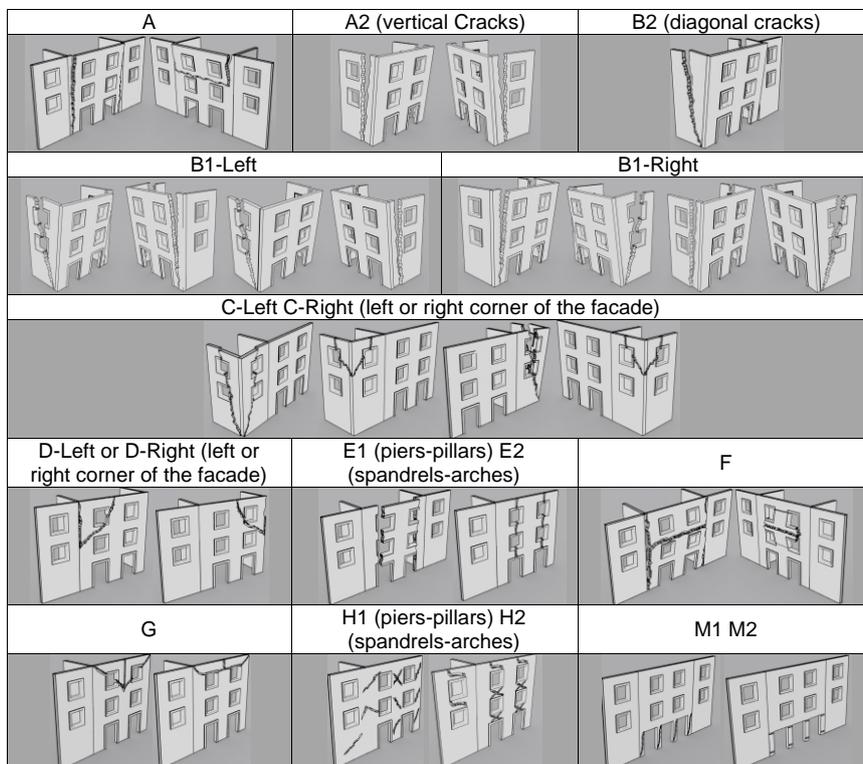
Figure 6-1 Collapse mechanisms

Therefore, by considering the numerous situations in which inspectors require a support for better understanding the seismic behaviour of an architectural asset, 19 possible collapse mechanisms of an AA, see Figure 6-1, have been identified and described by their associated crack patterns. Afterwards, this declarative description of the failure modes has been used for the implementation of logic trees, which identify the collapse mechanisms by matching the observed crack pattern with the failure modes of Figure 6-1. The rules developed in the logic trees for the pattern recognition are in some cases mutually exclusive, in some cases possible alternatives. Indeed, once the procedure has chosen to recognise or not to recognise a specific pattern as a mechanism of collapse, it is left to the operator to validate the choice. Therefore, when the mechanism has been identified, the operator has the following options: accept the mechanism of collapse proposed by the logic tree or reject the mechanism of collapse proposed by the logic tree and research another mechanism of collapse by enriching the data selected at the beginning of the procedure with more information already collected on site or by pictures, or adding new information. Once the procedure has found the feasible mechanisms, it is also estimated whether the mechanisms has:

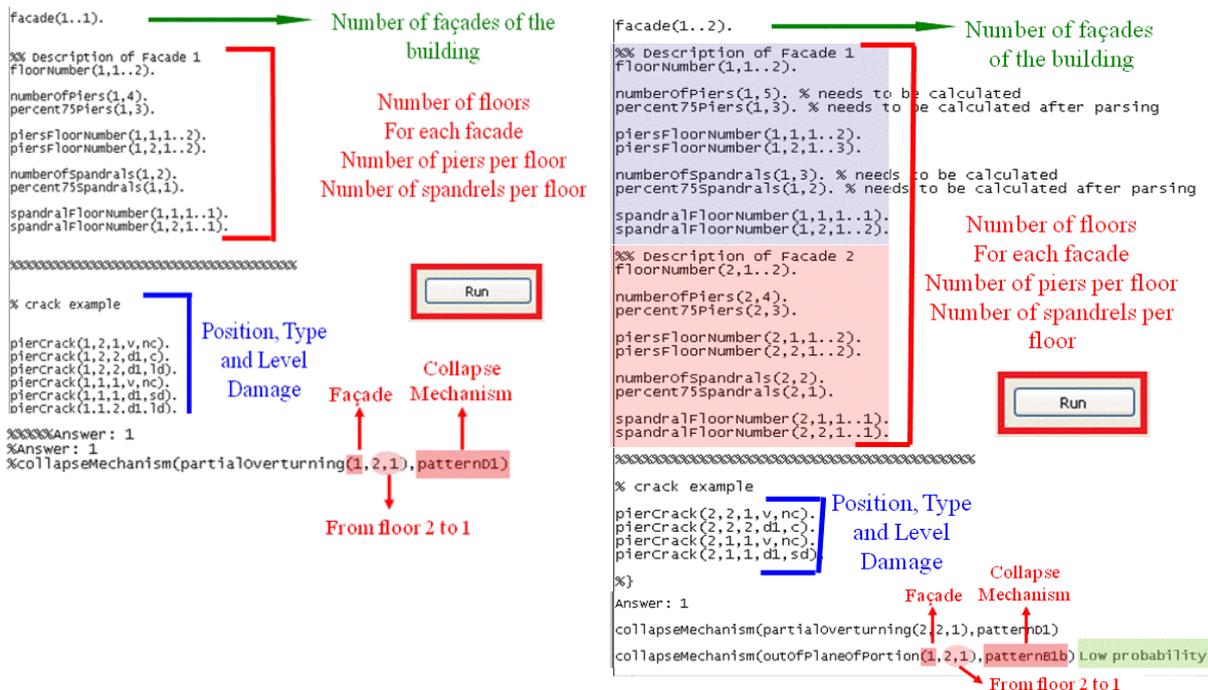
Figure 6-2: LOG-IDEAH applied a) on the façade 22.1e and b) on both façades 22.1e and 22.1s

By way of example the procedure is applied to identify the feasible collapse mechanisms for the building 22.1 introduced in section 5. To illustrate how the uncertainties affects the output, this is presented first for the facade 22.1e and then for both facades 22.1e and 22.1s. In order to identify the feasible failure modes, the procedure extrapolates the following information from the XML files created in uploading the data to the web interface: total number of inspected façades, total number of floors per façade, total number of piers and spandrels per floor, description of damage type, damage level and damage position, as it is highlighted in Figure 6-2 In case a) where the only inspected facade of the building is the 22.1e, the most severe cracks are the diagonal crack in yellow and violet and the vertical crack in red, highlighted in Figure 6-3. The two cracks describe the formation of a hinge at the bottom of 22.1e, which determines an overturning of the facade. By analysing the collected data of 22.1e with LOG-IDEAH, the procedure identifies the collapse mechanism D1-left which coincides with the collapse mechanism observed on site and recorded in the web browser. The identified failure mode by LOG-IDEAH has a HIGH PROBABILITY of occurrence, since this failure mode has been identified on the basis of a clear crack pattern (yellow, violet and red cracks) which describes an out of plane of the entire façade (from the floor 2 to the floor 1 as the system shows in Figure 6-2). However in case b) the data collected for both facades 22.1e and 22.1s are analysed and LOG-IDEAH identifies not only the collapse mechanisms D1-Left for the façade of 22.1e but also B1-Right for the façade 22.1s, see Figure 6-2b, that has not been recognised on site. As in the previous analysis, D1-Left occurs with HIGH PROBAILITY for the reasons mentioned above, while B1-Right occurs with LOW POSSIBILITY because it derives from an incomplete survey, since for the facade 22.1w, see Figure 6-3 connected to the adjacent building, the seismic damage has not been collected. Therefore, even thought the mechanism B1-Right derives from a bad connection between 22.1s and 22.1e and good
