Replacement of the Old Rubber Bearings of the First Base Isolated Building in the World

Igor Gjorgjiev, Mihail Garevski

Institute for Earthquake Engineering and Engineering Seismology, Macedonia

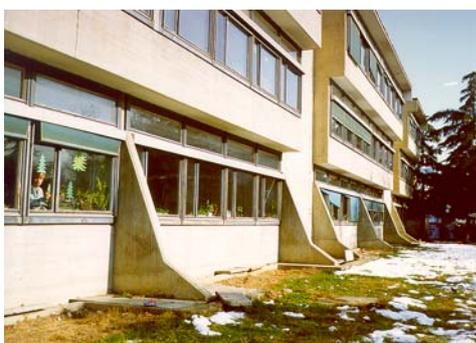
The main school building consists of a ground floor and two storeys (Figure. 1a). The proportions of the structure at plan are 13.0 m/61.5 m, while its height is 11.0 m. It represents a reinforced concrete box system. The bearing wall system is composed of shear walls with a thickness of 0.18 m. The floor slab is 0.20m thick. The building has a strip foundation forming a beam grid, which is sufficiently rigid to sustain all the effects from the upper structure without heavier deformations. The structure was totally base isolated by its placement on special rubber bearings (highly flexible elements) incorporated between the foundation structure and the first floor slab (Figure. 1b). There were a total of 54 (3D-full base isolators) bearings made of natural rubber which did not contain reinforcing steel plates. The bearings were with a square shape, a side of 0.7 m and a height of 0.35 m. They were fabricated by gluing together several (seven sheets) rubber layers vulcanized to the end steel plates. In addition to the rubber bearings, the isolation system also consisted of special prisms, the so called mechanical fuses (foam glass elements), made of porous and easily breakable material, whose basic purpose was to prevent unwanted possible vibrations of the structure due to the surrounding ambient, wind, traffic and alike. In the case of an earthquake with a defined intensity, i.e., intensity of 5 degrees MCS according to the design predictions, the stiff brittle elements were to be smashed so that the rubber bearings would be the only to affect the dynamic behaviour of the building.

a) Pestalozzi school building

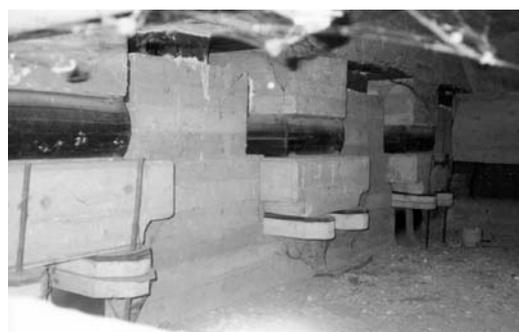
b) Old isolation system

Prior to the beginning of replacement of the bearings of the considered structure, it was visually inspected, paying special attention to the state of the base isolation system. From the inspection of the old isolation system, it was concluded that the rubber elements were in a relatively good conditions (Garevski, , M.; Kelly, J. M. 2001). Some of the bearings were observed to have suffered separation of rubber layers at their ends, the upper and the lower part. As to the quality of material, i.e., rubber, it remained soft and elastic. The bearings, which were located at the ends of the structure and in the space which was more intensively exposed to external effects were in a worse condition than those situated inside the structure. In addition to the separation of the layers at the ends of the bearings, these bearings evidently suffered also vertical cracks in the rubber whose depth could not be reliably defined (Figure 2). The experimental results showed that failure of the isolator took place at its horizontal displacement of 25 cm. Due to the limitation of the seismic gap, it was clear that it could not be damaged since the experimental tests showed that, under horizontal displacements of 20 cm, there were no damages and that there was a linear force - deformation relationship.

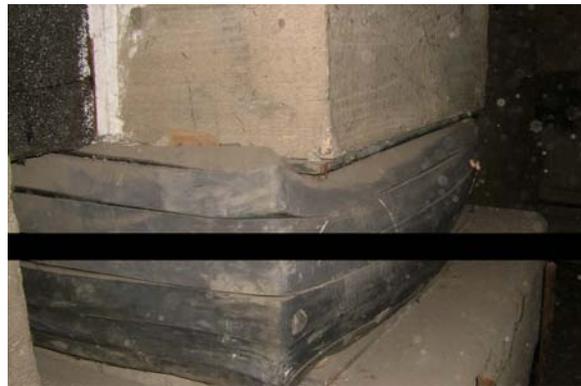
Figure 2. Old rubber bearings

- the experimental defining of the maximum displacement of the bearing at which it was torn was done for only one bearing, which was in a relatively good condition since it was inside the school. Many of the bearings, however, were placed along the perimeter (front) walls of the structure. These were more intensively exposed to atmospheric effects and had visible cracks due to the ozone effect. Because of these cracks, these bearings were expected to disintegrate at displacement which was less than the maximum allowed one (20 cm). Their tearing would have caused redistribution of the seismic forces over the remaining bearings, which would have been unable to sustain the seismic force in such conditions.

- the risk of loss of the necessary bearing characteristics of the isolators was to be constantly increased with the propagation of the cracks resulting from the ozone effect and the effect of tensile forces. The replacement of the old bearings by more sophisticated ones meant no need for other replacements to the end of the serviceability period of the school building.

Due to lack of inner steel plates, the old bearings of the Pestalozzi school building had very large proportions and low vertical bearing capacity. This resulted in occurrence of large vertical and lateral

deformations of these bearings. Due to the ozone effect the process of ageing of the rubber and occurrence of vertical fine cracks was also observed. The performed tests has been shown that the bearing capacity of the bearings in horizontal direction was not at all changed for the passed 40 years. The testing of a single bearing proved that failure of the bearings occurred at 25 cm in horizontal direction. In serviceability conditions, this deformation of the bearings could not have been achieved since the seismic gap of the school was 20 cm.

Although, in the preceding paragraph, it was mentioned that the old bearings still satisfied the design parameters, the afore mentioned NATO project anticipated replacement of the old bearings by new ones that were developed within the project. The need for installation of new bearings in this school building was justified by the following arguments:
