Reliability Analysis and Deterministic Validation with Experimental Data of a Historical R.C. Bridge.

K. Islami, F. Carturan, C. Pellegrino & C. Modena

Department of Civil, Environmental & Architectural Engineering, University of Padua, Padua, Italy

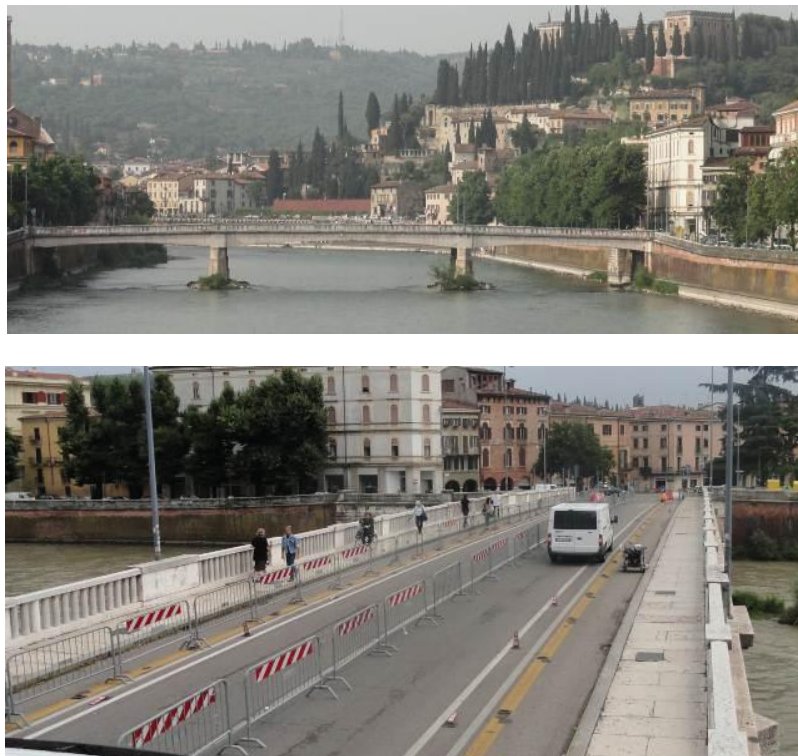
Figure 1. – The analysed bridge (photo 2011).

The original bridge situated in the centre of Verona in Italy was destroyed in 1945 by the Second World War bombarding and a new bridge was completely rebuilt the following year. The main structure component is a reinforced concrete segmental beam with external stone facing.

The structure bears a four-lane roadway, two for each direction of travel, plus two sidewalks with a cross section of 14.32 m and a slab of 18cm thick. The static schema consists of seven longitudinally main girders and eleven cross beams with stiffening function, connecting all main girders in the transverse direction. There are also some other cross joists at regular intervals between the five central longitudinal beams.

The bridge has a total length of 90.5m; it consists of three spans of segmental tapered beams: the central span is 33.50m long, while the two side span 27.0m each. The height of the sections of the “arched” beams is 1.0m at the key positions and 1.5m at the bases.

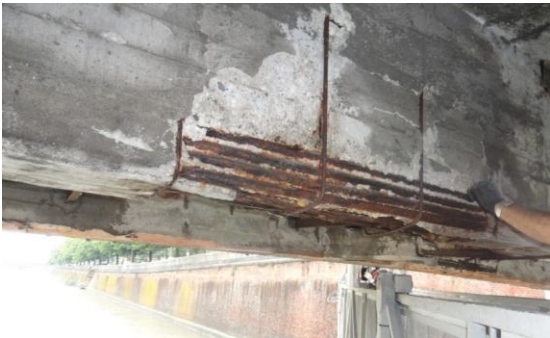
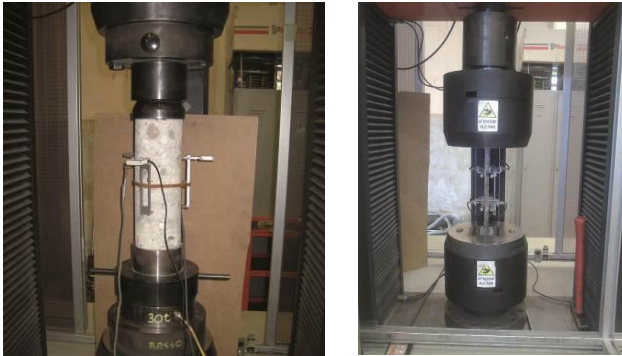
Figure 3. - Damage on the longitudinal edge girders; Core sampling; Laboratory tests.

On June 2011 a survey underneath the deck was carried out, in order to obtain a general framework for structural damage and material deterioration. It revealed severe damage on the longitudinal edge girders at the middle of the spans, in particular at the points where the bridge deck drains are located, due to water percolation (Figure 3).

The main girders and cross beams are highly deteriorated, the concrete is mouldy and carbonated. Moreover, some localized shear cracks have been detected at centreline of cross beams. The reinforcing steel bars are fully visible where water percolates, as the concrete cover has been eroded by water and pollutant chemical elements as antifreeze salts. A strong corrosion of steel bars, in addition to concrete carbonation, determines a reduction of net resistant beam section.

Four kinds of rebar were extracted and subjected to tensile tests which revealed an actual tensile strength of 360.2MPa and a Young's elastic modulus of 144000MPa. In addition, 10 circular concrete core samples were taken and subjected to compression tests resulting in 21.9MPa for the main girders and 19.1MPa for the cross beams, while the secant elasticity modulus is 33040MPa. All destructive tests were performed at the Laboratory of Structural and Transportation Engineering, University of Padua, Italy.

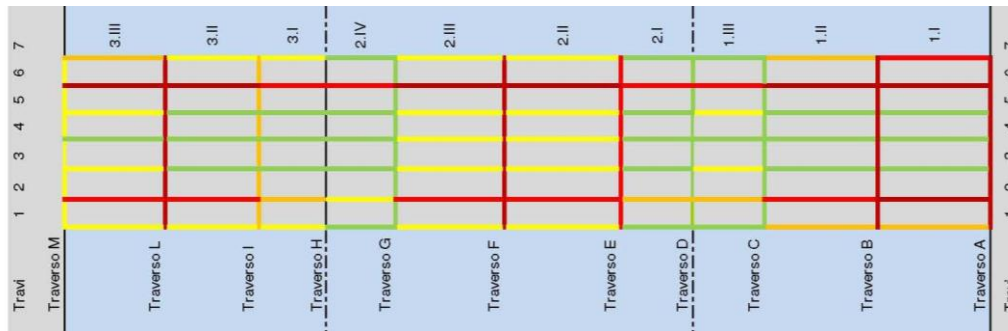
Figure 4 - Outline of the state of degradation

In Figure 4 it is shown the summary of the levels of deteriorating with five colors, having indicated with red the worst case. It can be observed that the girders number 2 and 6 are the most damaged due to the water percolation from the above lanes.

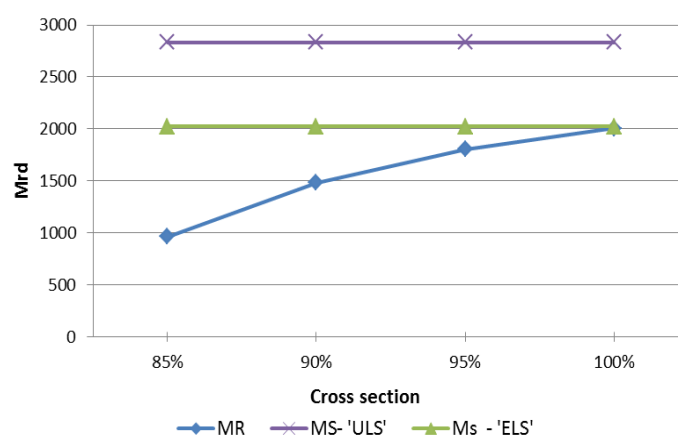
Figure 7. Beam nr. 6, section 4. Comparison. Mrd for the different levels of cross section.

It was noted (even through some other statistical approaches) that the section of the longitudinal beam number 6, the most deteriorated, resists, albeit slightly, for the entire section. Considering 3 rows of bars instead of 4, the section does not withstand the loads, surely even with the elimination of amplification factors of the Limit States (Figure 7).

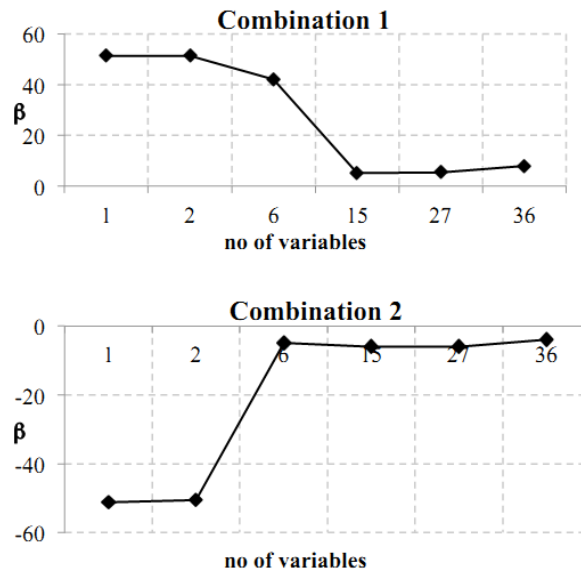
Figure 12. Variation of reliability index vs. the number of variables accounted in the combinations 1 and 2.

The bridge reliability index calculation can be improved by acquiring more data to reduce uncertainties of structural parameters. Bridge reliability index varies with the number of variables related to materials' characteristics and cross-sections' geometry used for the analysis (see Figure 12 for combinations 1 and 2). Using the damage model for the rebar corrosion, the reliability index varies with time. In Figure 13 the trend of the reliability index for a performance function where the bending moment is the accounted parameter, shows that it goes under the level of 3.8 for an age of 42 years.
