# Seismic Loss of Functionality in High-Rise and Low-Rise Office Buildings: Server Room Damage of E-Defense test

A shaking table test of high-rise and low-rise office buildings was conducted at the E-Defense three-dimensional shake table facility. The objectives of this experiment are to investigate the seismic loss of functionality of buildings due to interior space damage subjected to a subduction earthquake and a fault earthquake. The high-rise building is remodelled and scaled down to a steel frame specimen with three substitute layers which enables to achieve a 120m high building and also to achieve a 4-story building. This paper reports the seismic loss of functionality of telecommunications equipment which is installed in a server room of a building specimen. Focusing on the raised floors in a server room, types of server rack and methods of anchoring, verification and analysis of damage subjected to a great earthquake are studied.

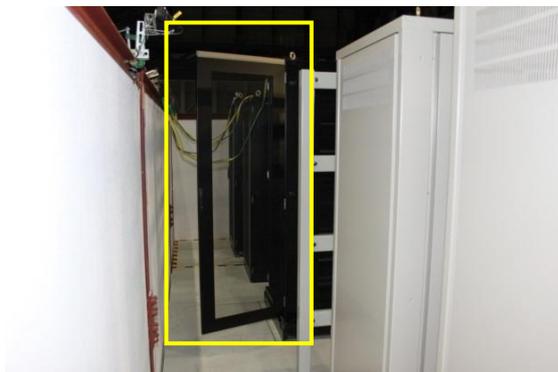
(a) Open of the door (After-shock 330%)

**Figure 10.** Various damage of telecommunications equipment
