Evaluation of Tsunami Load and Building Damage Mechanism Observation in the 2011 off Pacific Coast of Tohoku Earthquake

SUMMARY:

On-the-spot investigations at the Tohoku inundation area were conducted after the 2011 Tohoku Earthquake. A damaged two-story steel building located at Onagawa city was chosen to evaluate the tsunami-induced force. The results estimated that the tsunami load that acted on the outer wall of the building was over 24.0 kN/m² based on the evaluation of the ultimate design strength and the outer wall area of the building. In the Tsunami Evacuation Building Design Guideline, the tsunami load is assumed to follow a triangle distribution along the height. This distribution assumes the tsunami load as a hydrostatic force, but it was contradicted the observed failure pattern. Uniform distribution along the height, which assumes a hydrodynamic force, is found to better explain the failure mechanism.

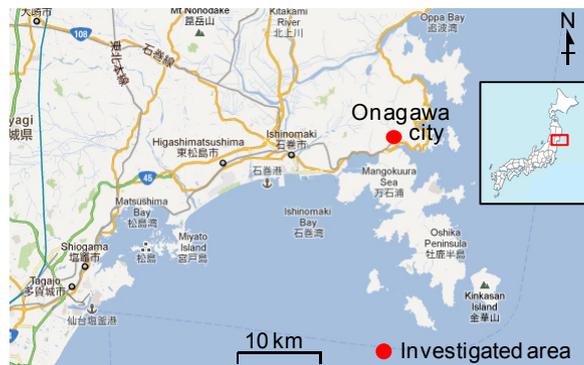
Figure 1. Investigation area (Onagawa city of Miyagi province)

On-the-spot investigations in Onagawa city (Figure 1) were conducted on April 14th and May 5th of 2011. Among the damaged buildings, wood houses sustained most serious damage. Most of them were washed away by the tsunami (Figure 2(a)). In many cases in steel buildings, curtain walls were destroyed, but the deformed steel frames remained (Figure 2(b)). Many reinforced concrete buildings survived, but some overturned cases were observed (Figure 2(c)). A variety of tsunami loads acting on different structure systems or different dimensions lead to different damage mechanisms. To examine the tsunami load, a damaged two-story steel building was chosen as the building to look into. The building sustained an large shaking (MM10), and tsunami height reached 15 m.

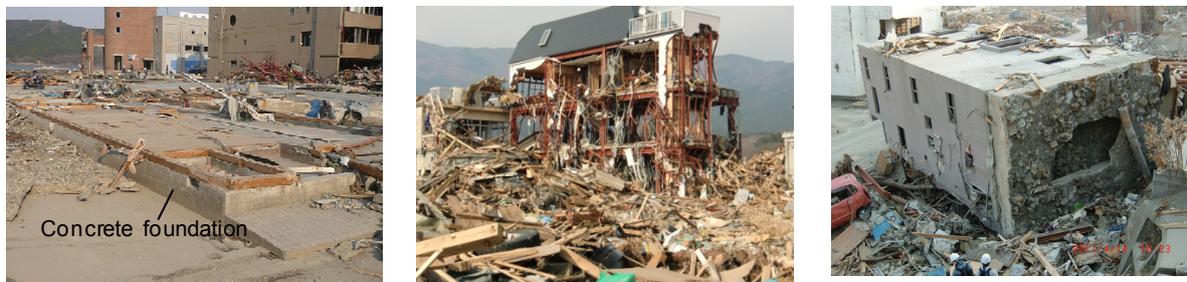
Figure 2. Major damage patterns of buildings

(a) Wood building foundation

(b) Damaged steel building

(c) Overturned RC building

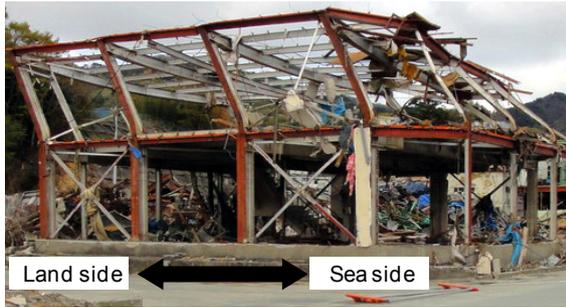
Figure 5. Observed building

longitudinal and transverse directions are 12.4 and 13.7 m in length, respectively. Braces were placed between column C1-C2, C3-C4, C5-C6 and C7-C8. Figure 5 shows an overview of the damaged building. No plastic deformation was observed at the first story. The second story sustained serious plastic deformation. Tsunami load acted on the south side of the building and caused the second story to significantly lean to the land side. Based on the strength of structural members, the longitudinal ultimate strength of the second story of the observed building was estimated to 493 kN. The longitudinal elastic limit strength and the ultimate strength of the first story were 1,418 kN and 1,699 kN, respectively.
